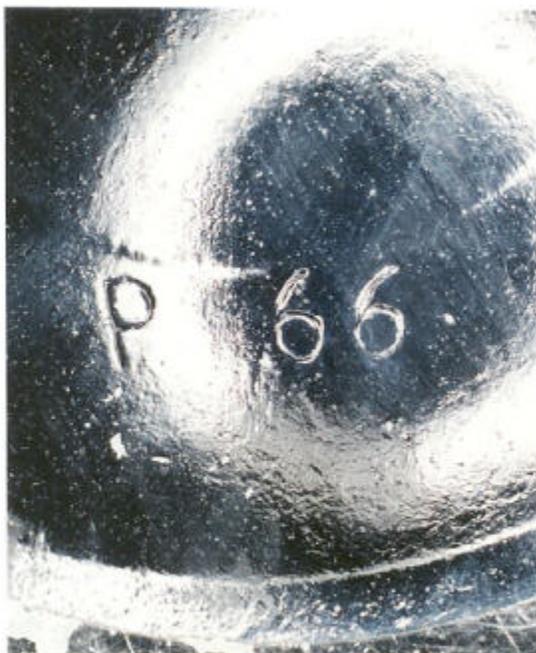
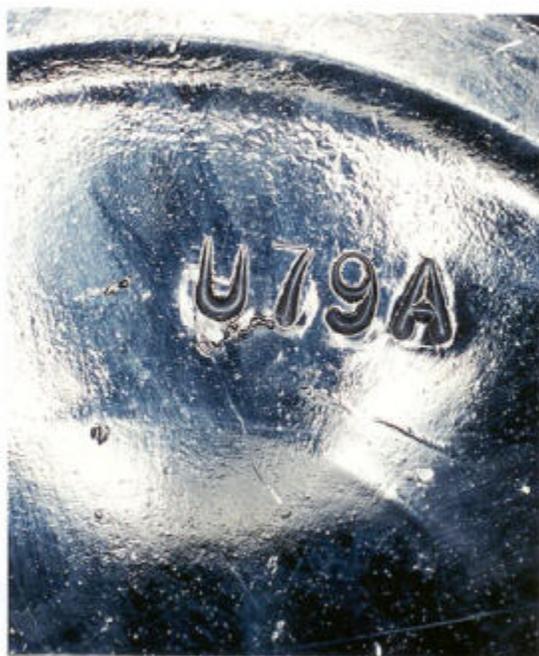
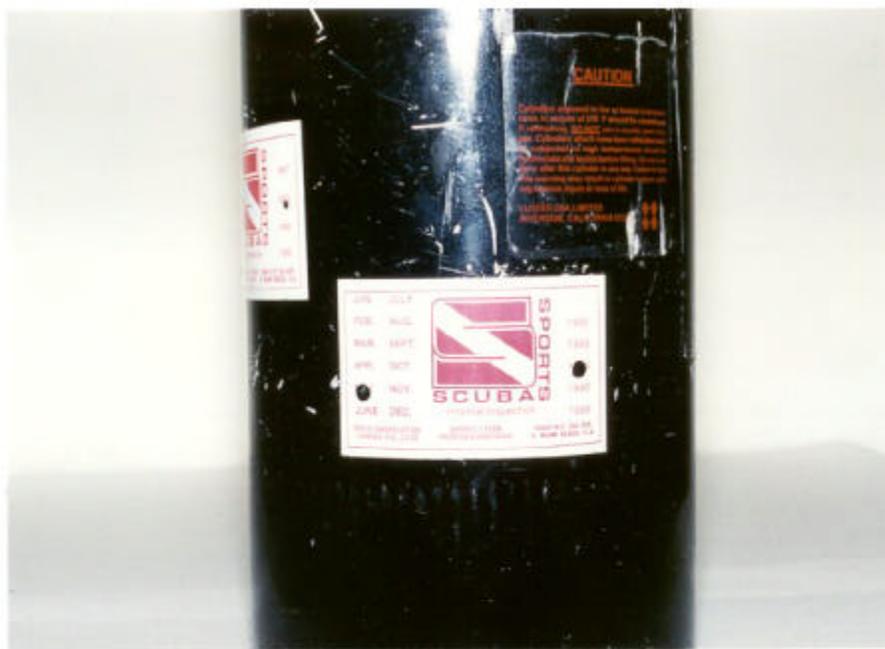
Figures 9-10: As-received views of the cylinder showing identification markings on its bottom (figure 9), caution sticker, and date of internal inspection (figure 10).

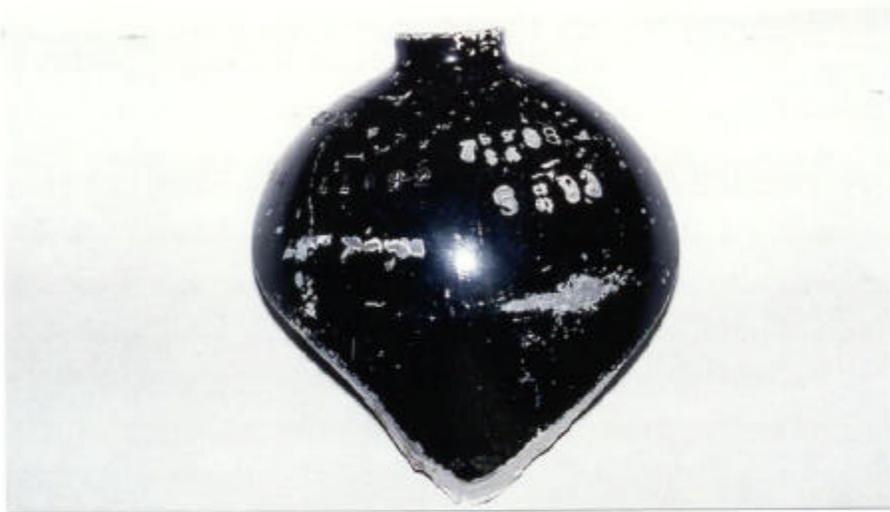
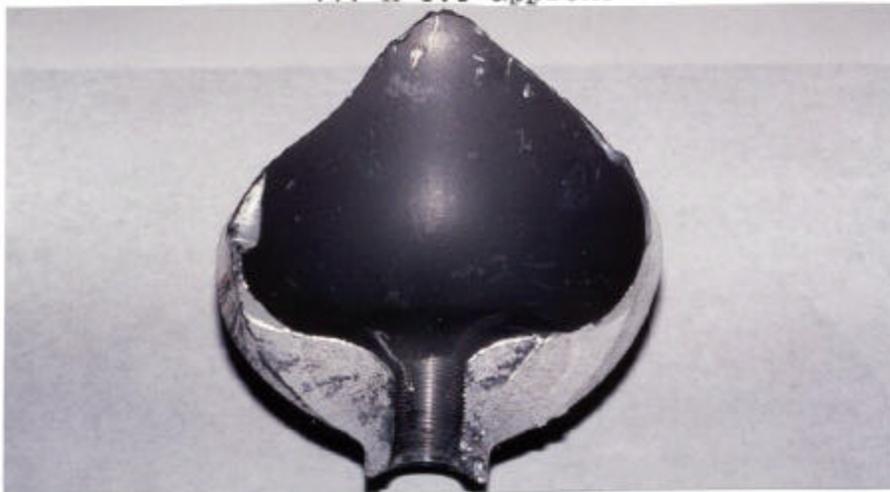
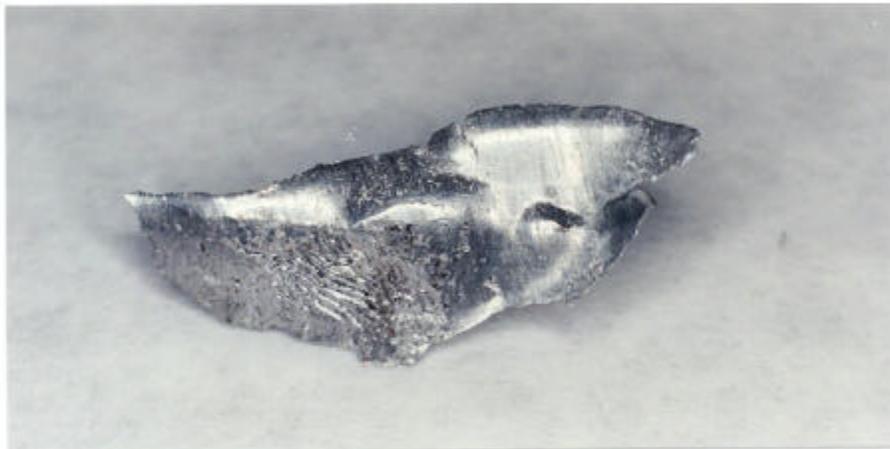
Figure 11-13: As-received views of two smaller pieces of fracture.

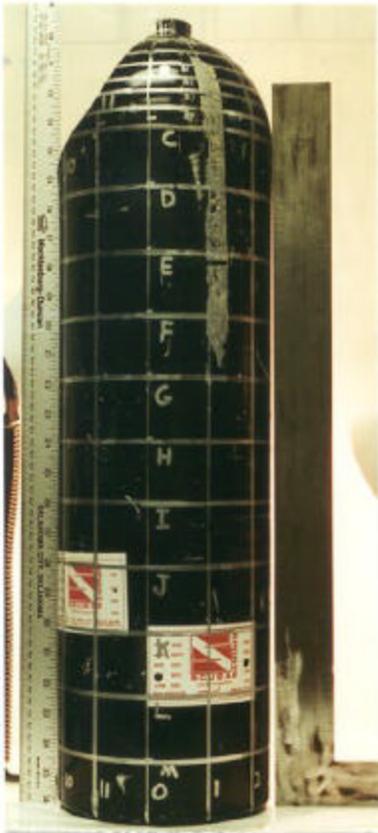
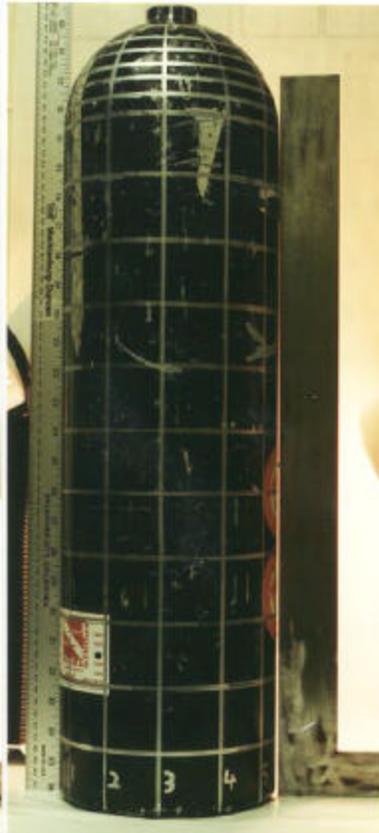
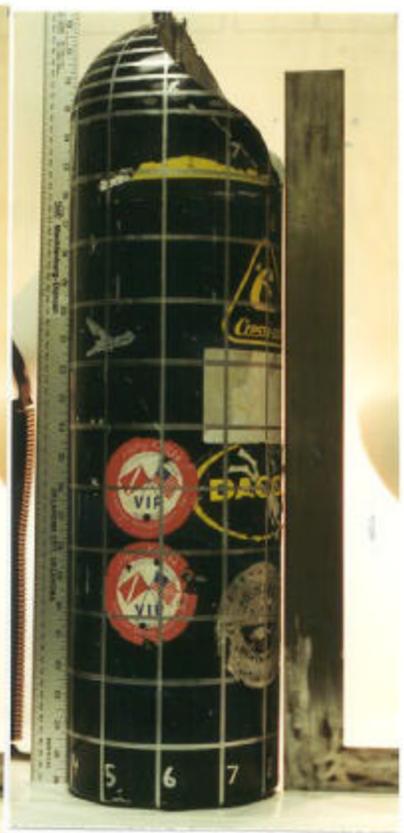
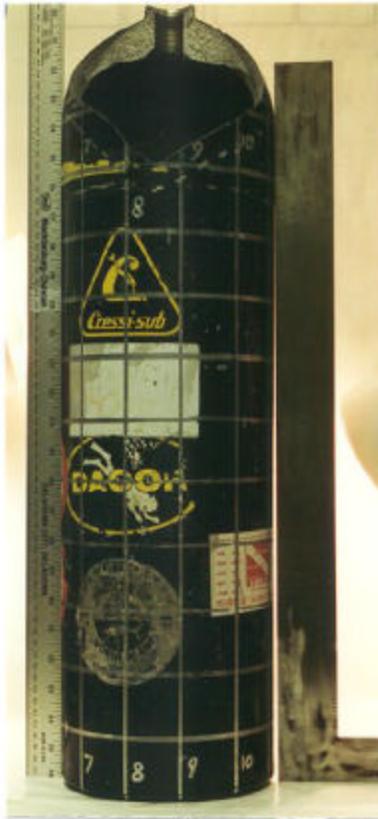
Figure 14-17: Photographs exhibiting the grid layout. They also show overall straightness of the cylinders. There appears to be slight bulging near the base of the dome part of the cylinder.

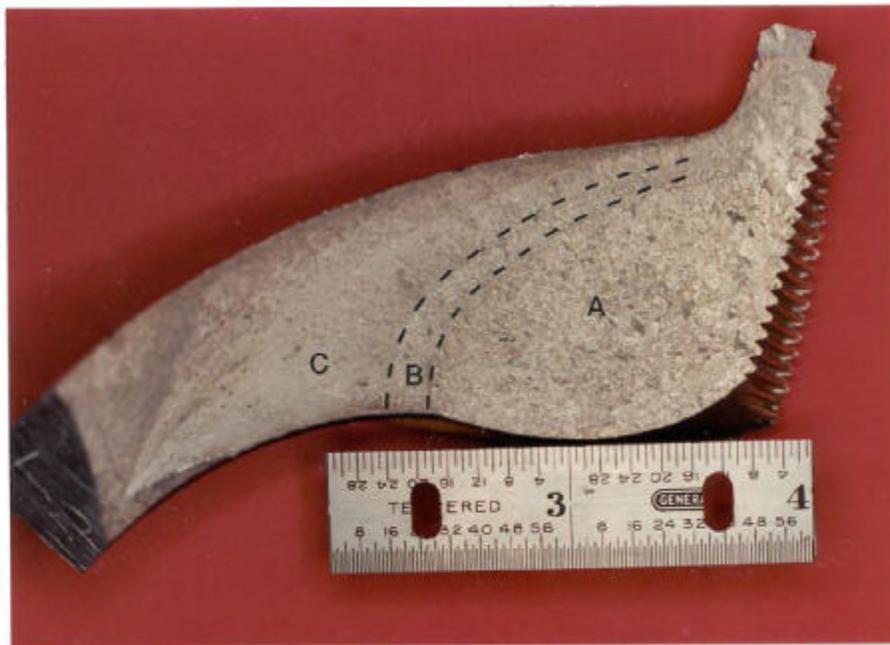
Figure 20: An enlarged view of section 1 (figure 18B) shows three distinct regions on the fracture surface marked A, B and C.

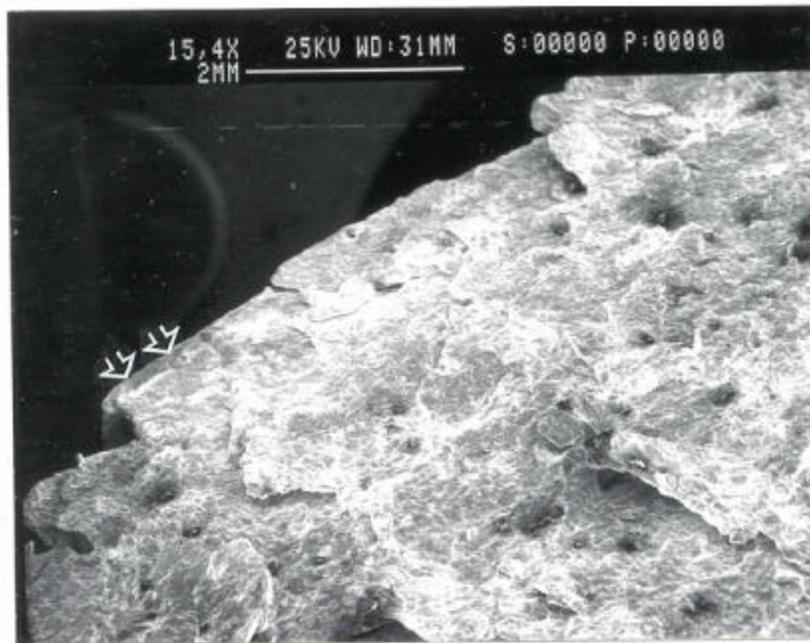
Figure 21: A low magnification SEM fractograph of region A shows areas near the last thread, X15.

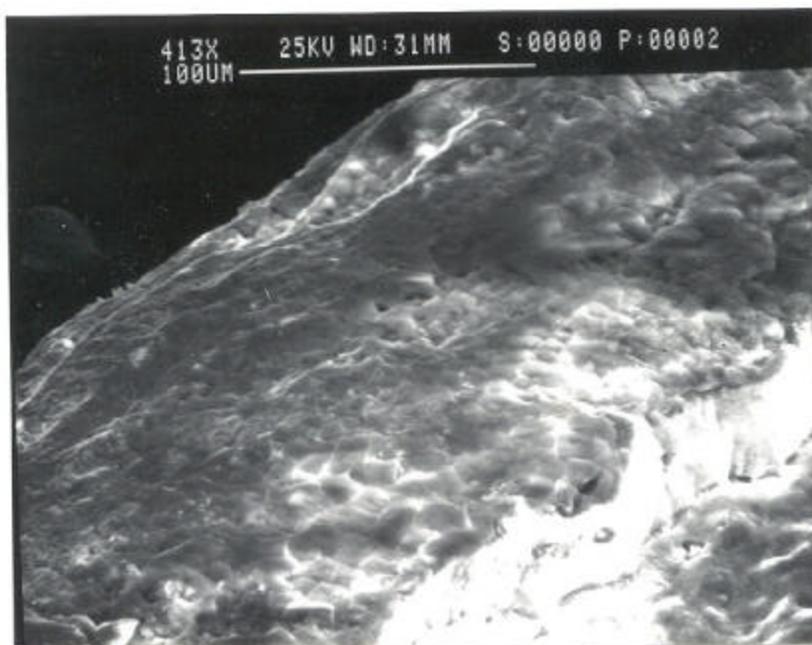
Figure 22: Enlarged view of the edge indicated by arrows in Figure 21, exhibits a featureless metal fold formed during extrusion process, X413.

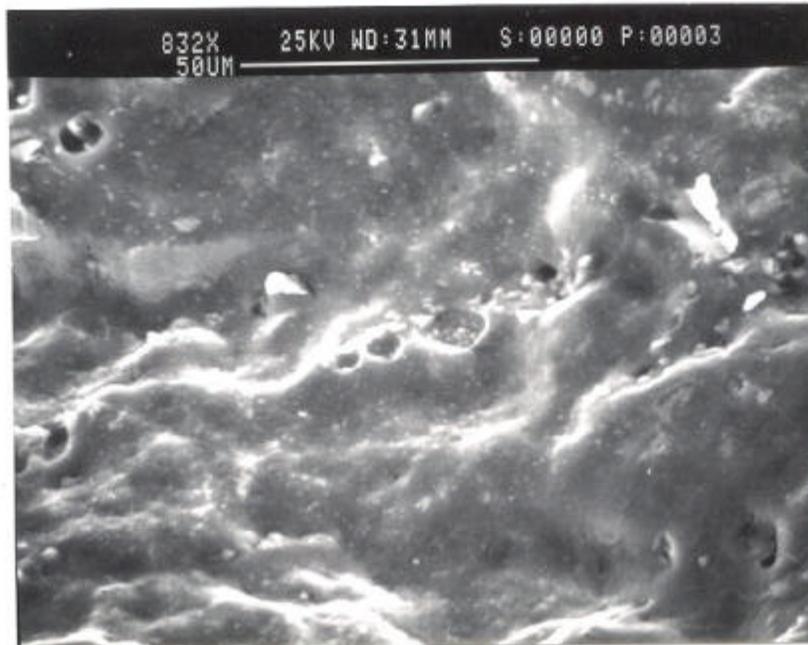
Figure 23: Fractograph of an area deeper in region A shows featureless fracture. Some evidence of dimpled rupture and intergranular failure was also observed, X832.

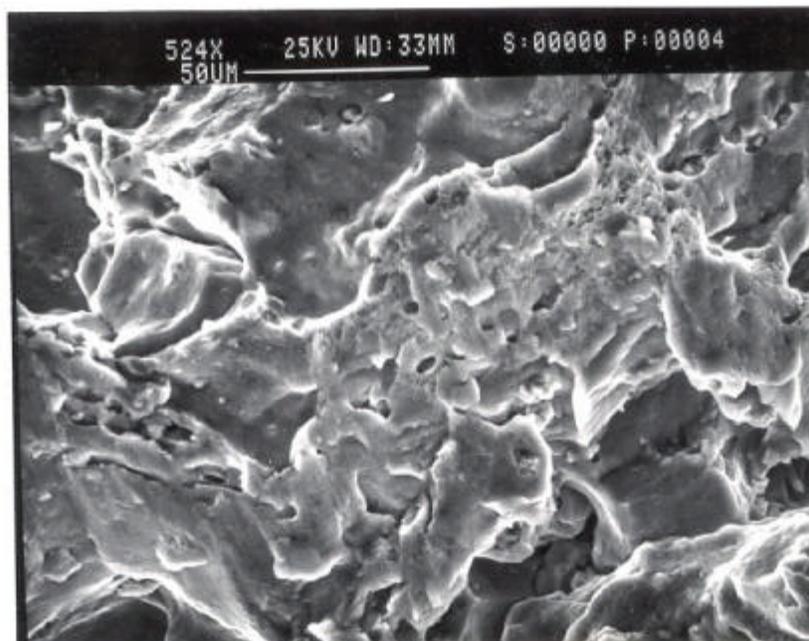
Figure 24: Fractograph from an area in region A (near region B) is featureless as in figure 23. However, evidence of dimpled rupture and grain boundary decohesion is more discernible, X524.

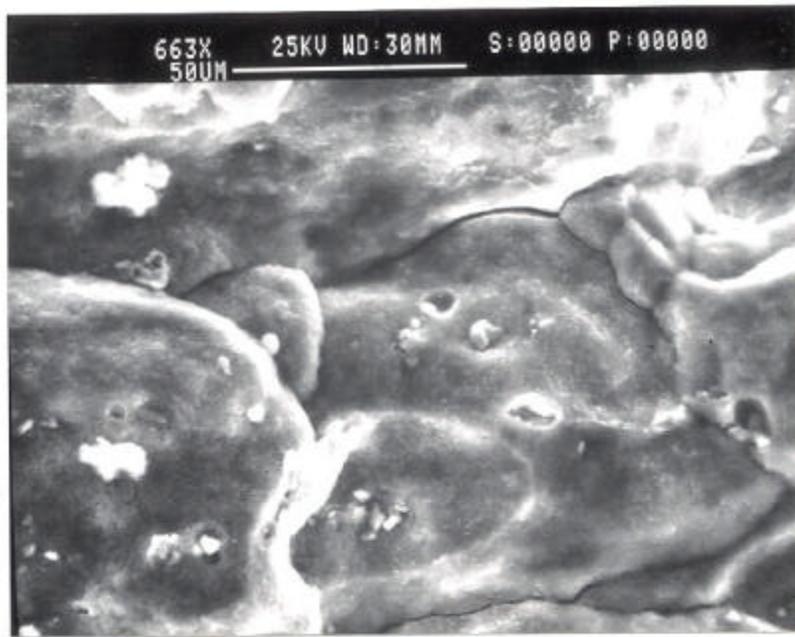
Figure 25: Fracture in region B exhibited featureless regions. It also clearly indicated evidence of grain boundary failure, X663.

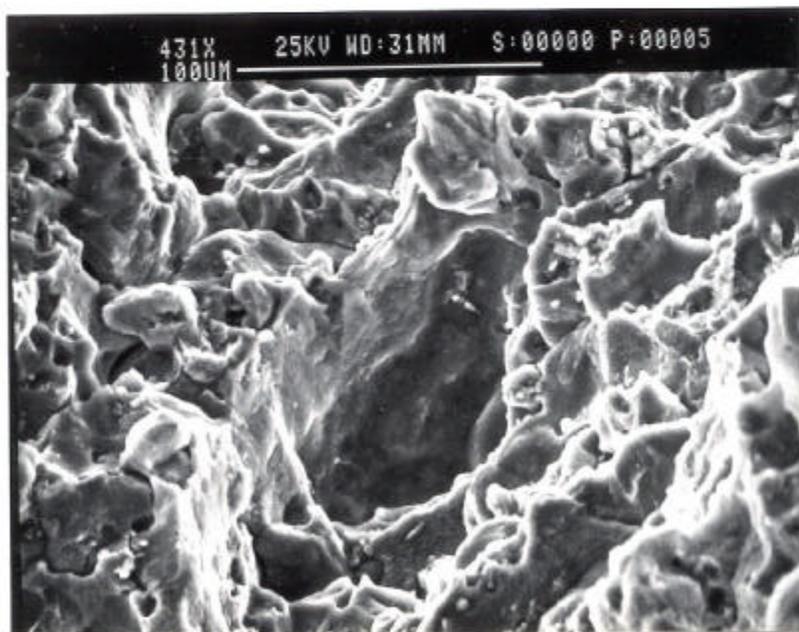
Figure 26: Fractograph from an area in region C. It shows similar features as in figure 24.

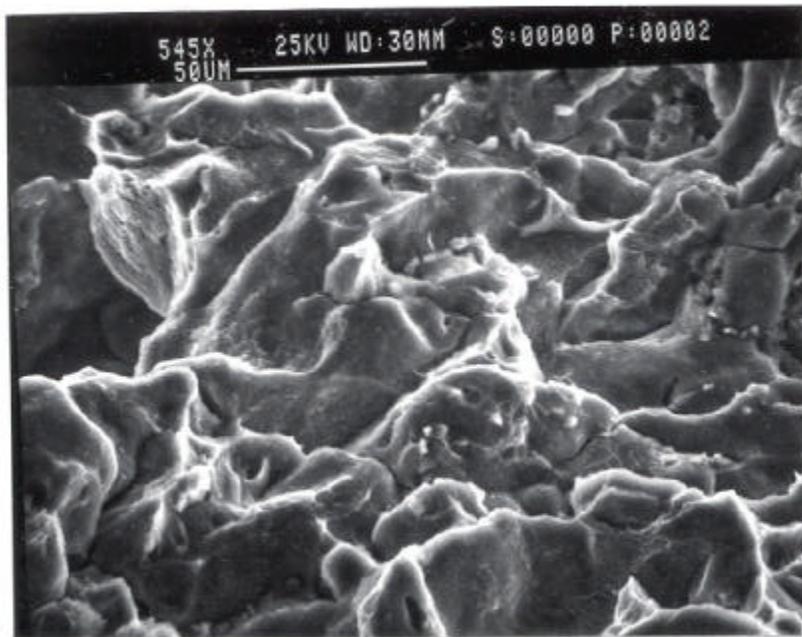
Figure 27: Fractograph from an area deeper in region C. It exhibits clearly defined intergranular failure, X545.

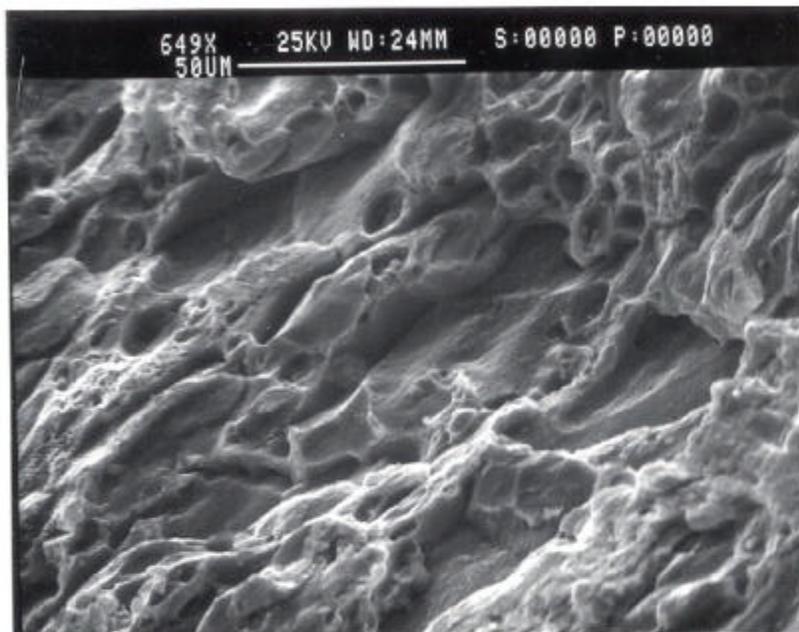
Figure 28: A typical fractograph of the fracture surface in sections B and C showing largely intergranular failure. Some evidence of dimpled failure can also be observed, X649.

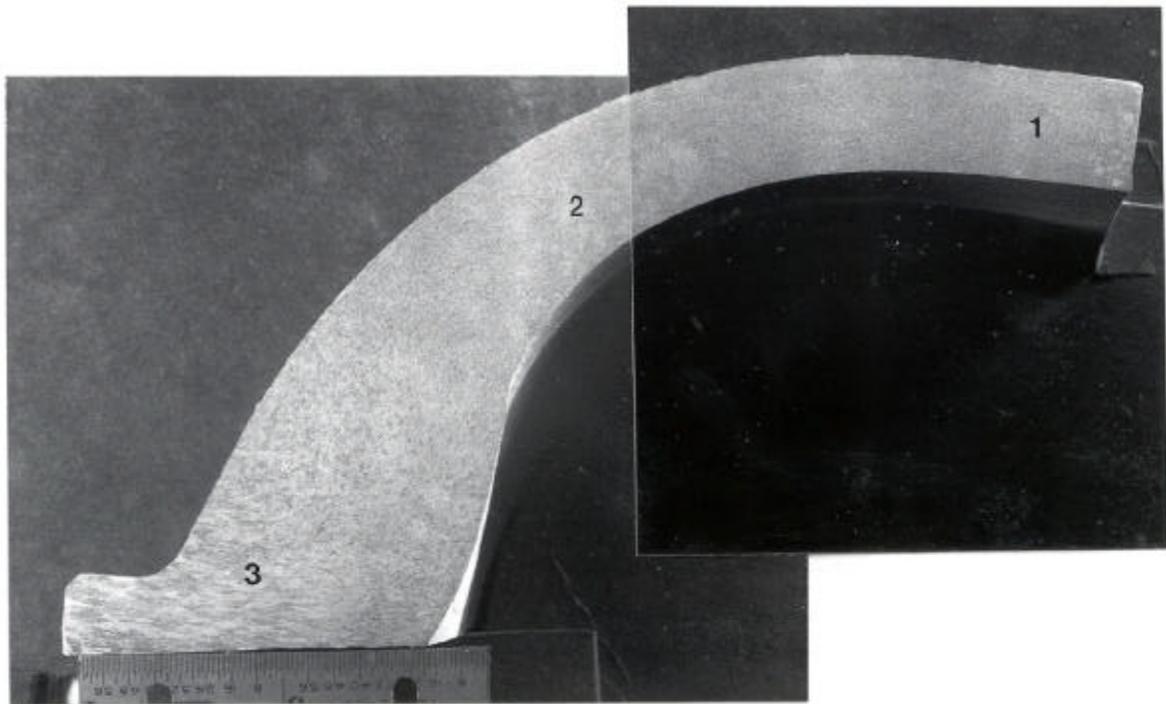
Figure 31: Macrograph of the section indicated in figure 30. It exhibits fine grain structure in the barrel section and coarse grains near the neck region, X1.14, Keller's Etch.
