**CHEMICAL AND METALLURGICAL ANALYSIS
OF A RUPTURED DOT-3AL
SPECIFICATION COMPRESSED GAS CYLINDER**

December 15, 1994

U.S. DOT/RSPA
400 7th Street, S.W.,
Washington, D.C. 20590-0001

ARTECH File No. 9509.002

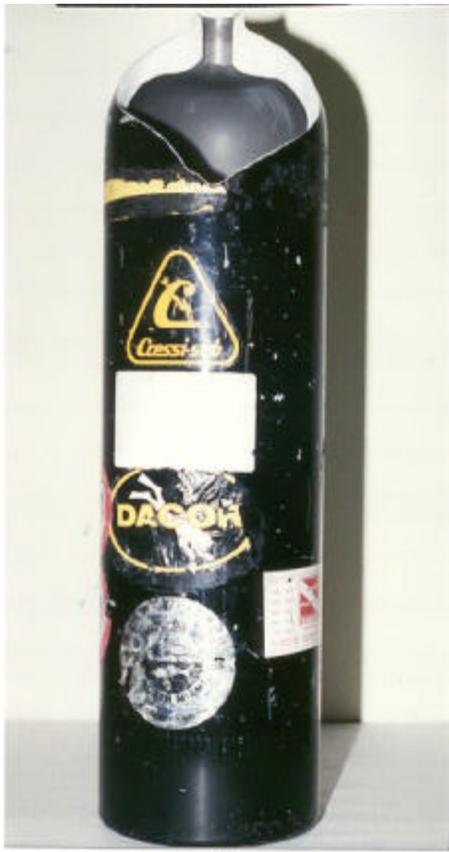
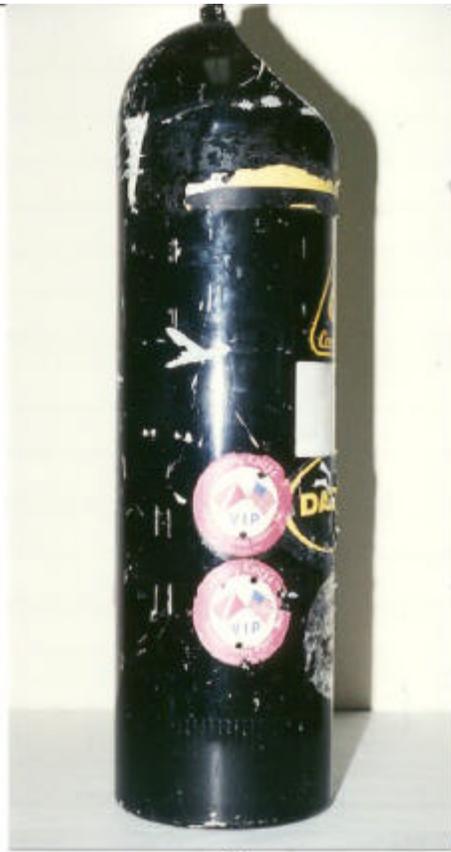
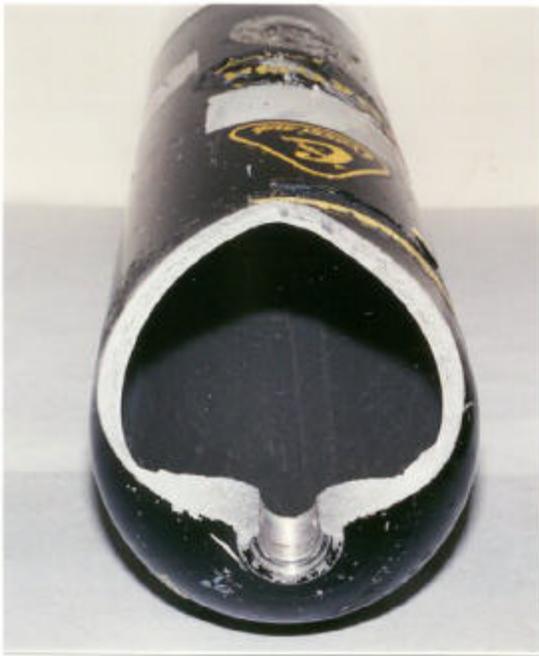
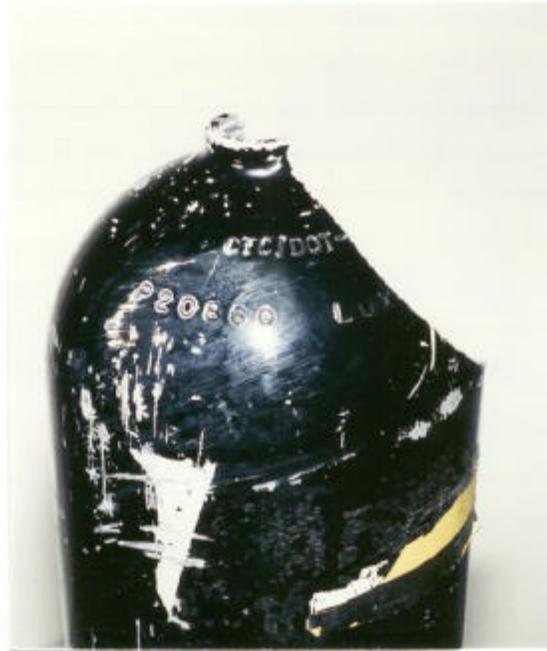
Figures 1-4: As-received views of the subject cylinder's general conditions, identification markings and an overall view of the fracture surfaces.

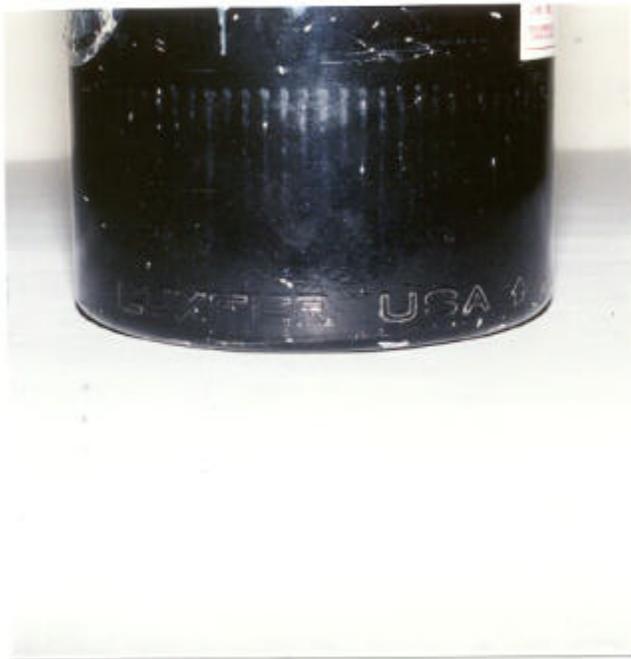
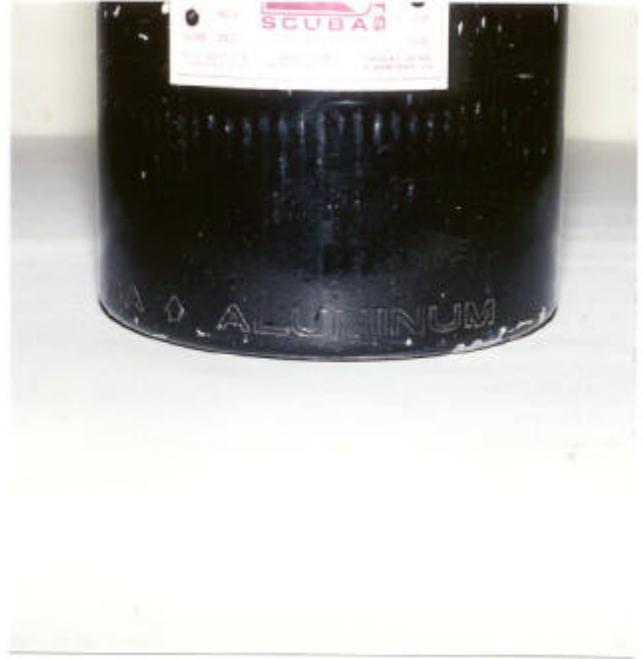
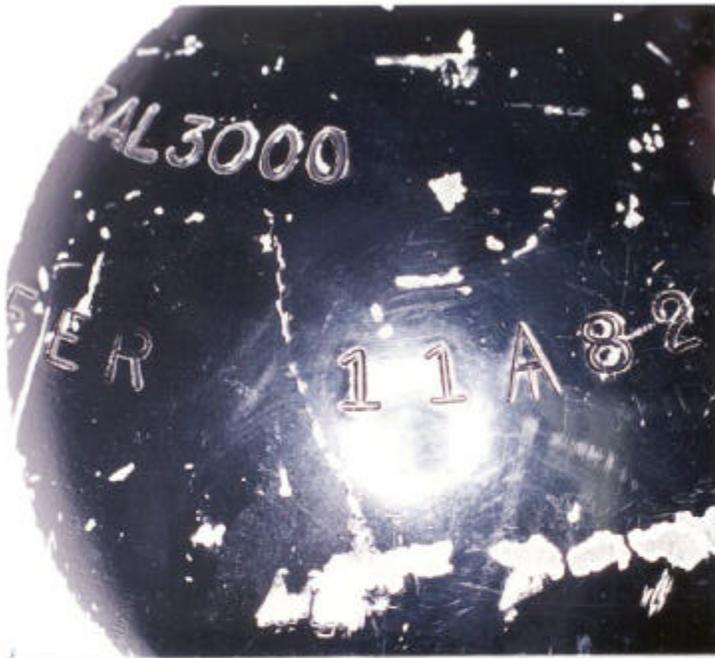
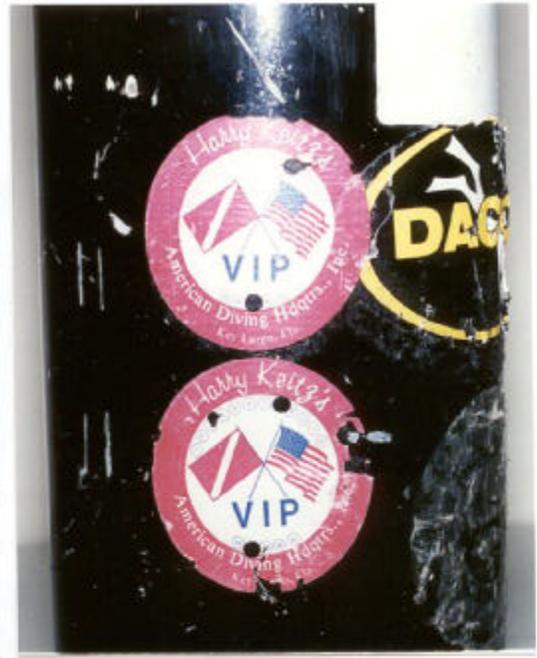
Figure 5-8: As-received views of the subject cylinder showing manufacturer's name Luxfer USA (Figure 5) and other identifying markings.
