Figure 4. Cylinder fragment 2A-1.

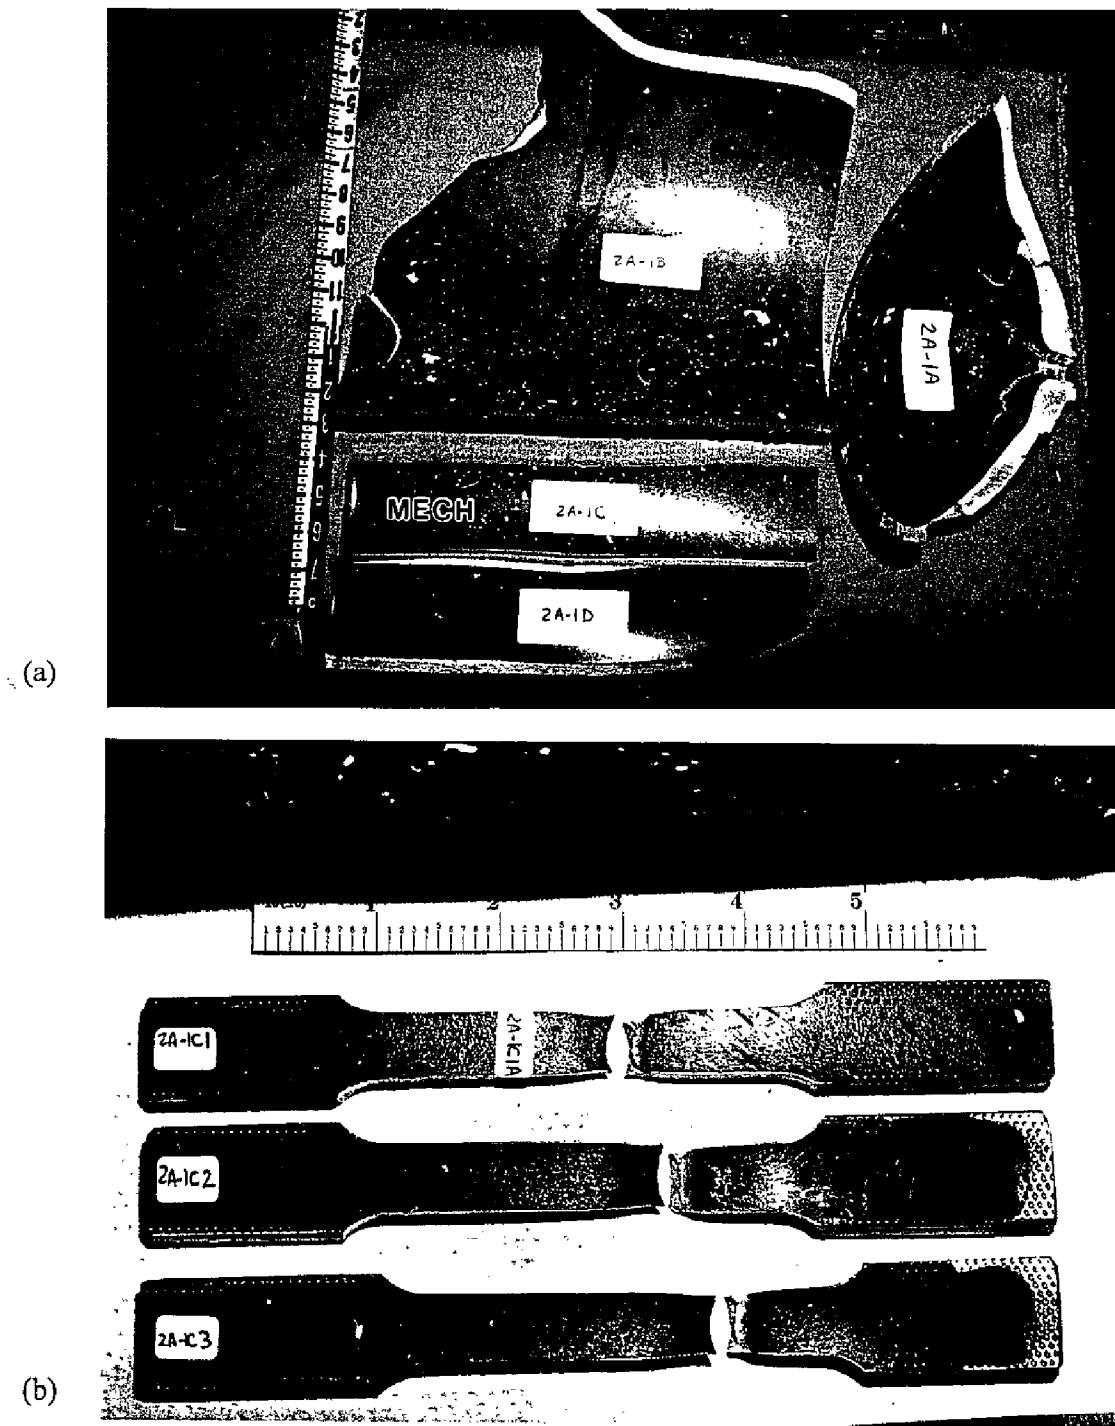
(a) Sections cut. Mech denotes the piece used for machining tensile test coupons.

(b) Tensile test coupons in the post-tested condition.

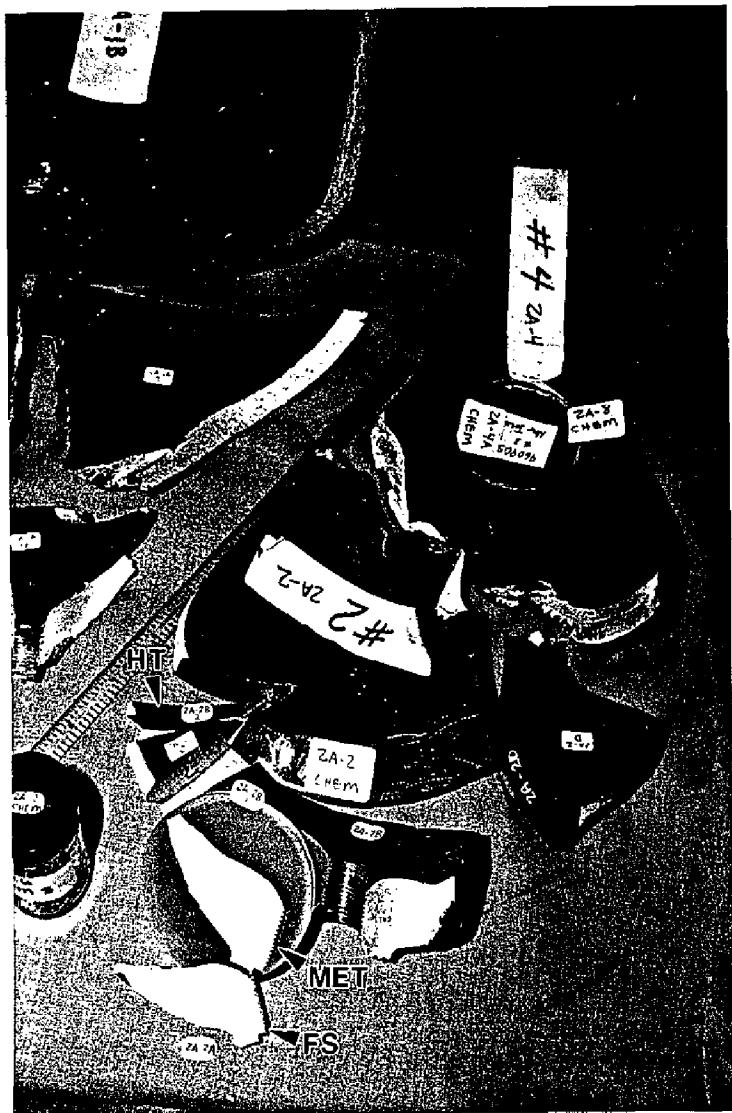
Figure 5. Sectioning of fragments 2A-2 and 2A-4.

Note: FS denotes the wafer containing a portion of the flat-faced fracture surface, MET denotes the wafer cut below the FS wafer and used for metallographic examination, and HT denotes the section used for Rockwell hardness measurements.

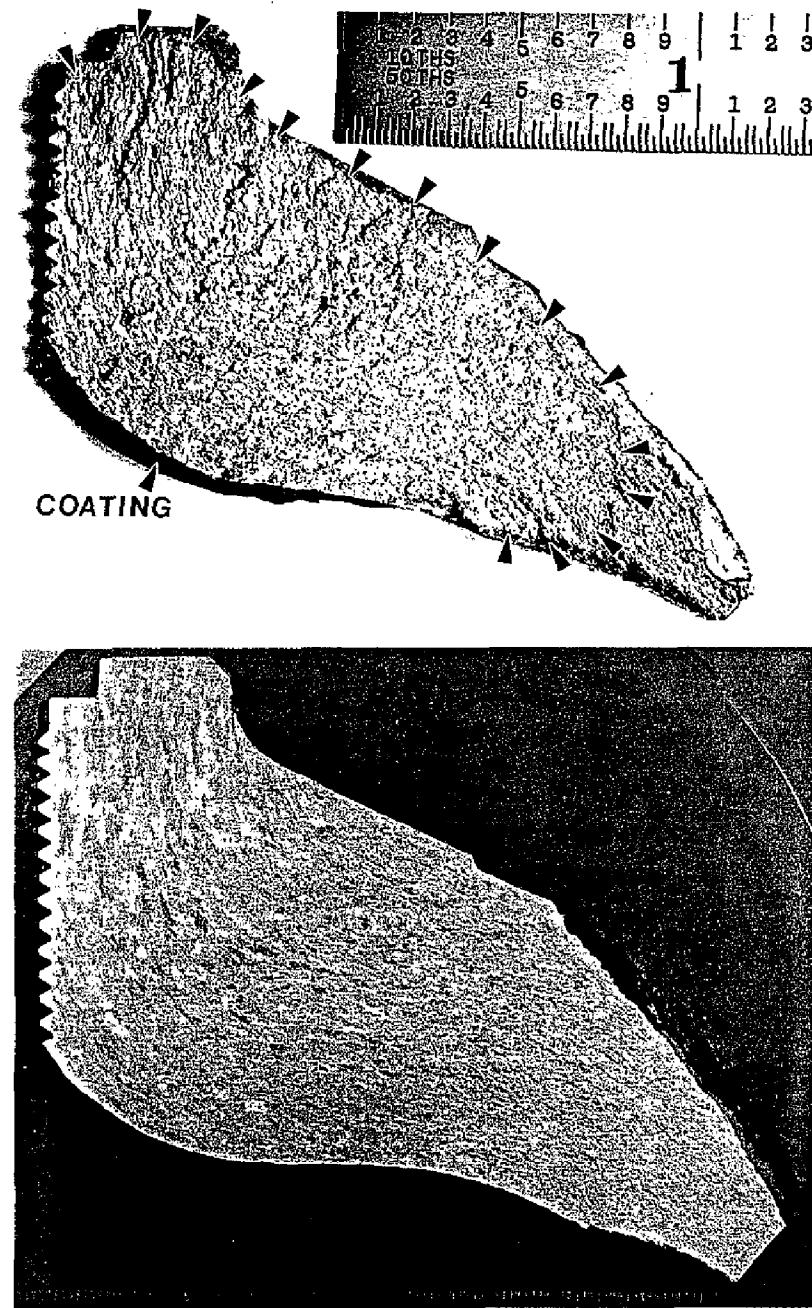
Figure 6. Wafers FS and MET from Figure 5.

(a) Portion of flat-faced fracture surface from neck region of fragment 2A-1. Photo ID: DC17916-TRS-1-01/14/97.

(b) Macrostructure of neck region of fragment 2A-1. HF/H₂SO₄/H₂O etch. Photo ID: DC17916-PAL-1-10/31/96. Scale is in 0.02 inch increments.

Note: Inside cylinder coating on the fracture surface as shown.
Unlabeled arrows define an apparent beach mark on the fracture surface.

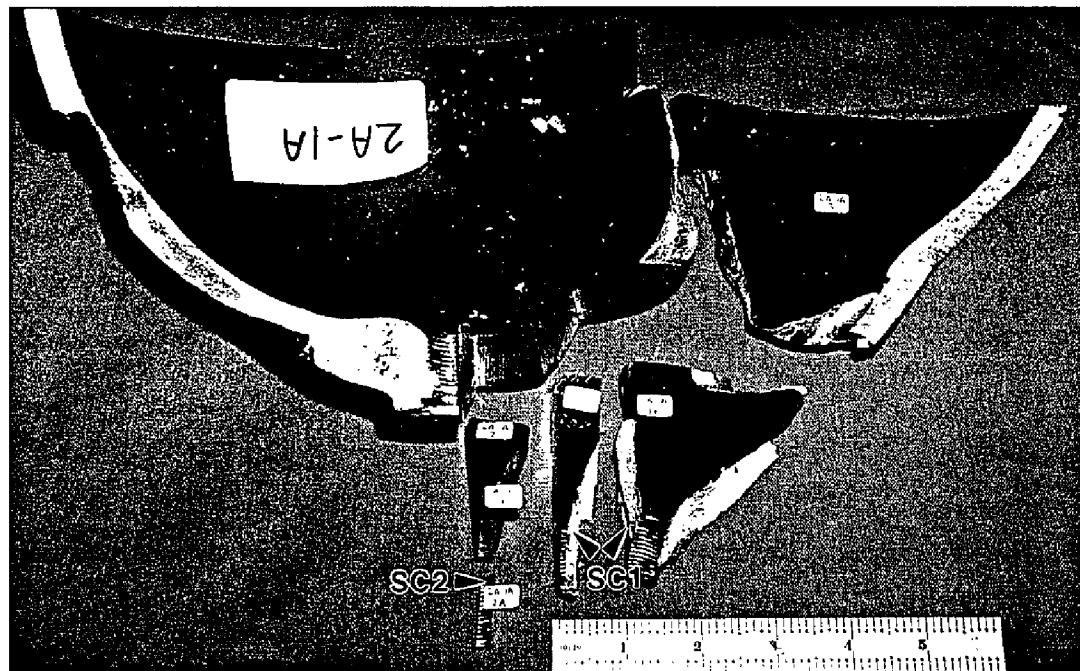
Figure 7. Sectioning of fragment 2A-1 in the neck region.

Note: The crack SC1 (see Figure 3) forced open in the laboratory and the crack SC2 contained within the sections 2A-1A2A and 2A-1A2B.

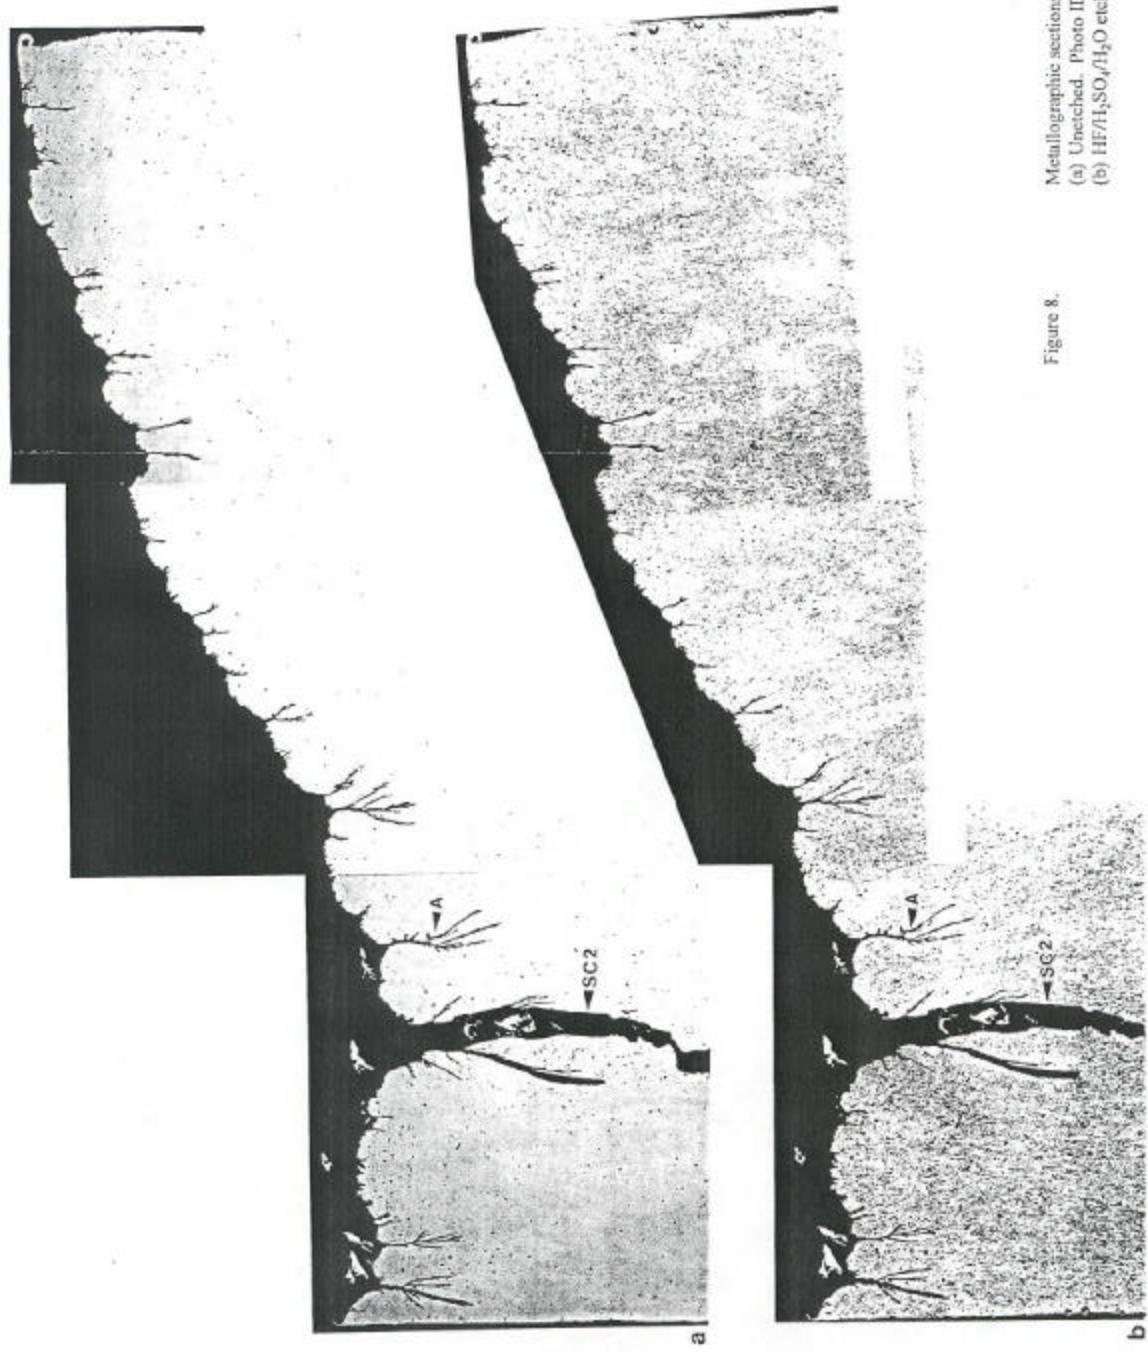
Figure 8.
Metallographic sections of 2A-1A2B containing SC2. 50X.
(a) Unetched. Photo ID: DC17916-PAL-12,3-11/08/96.
(b) HF/H₂SO₄/H₂O etch. Photo ID: DC17916-PAL-4,5,6-11/08/96.

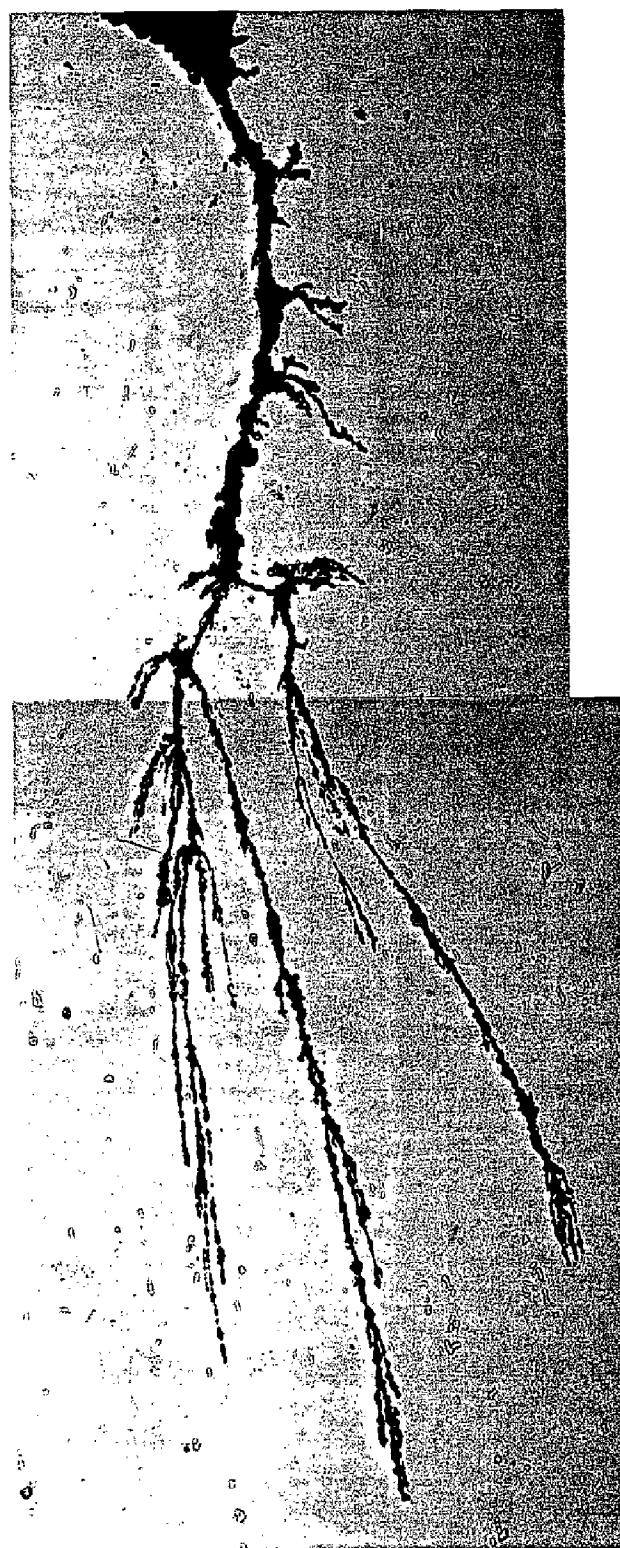
Figure 9. Close-up of crack "A" from Figure 8. 400X.
Unetched. Photo ID: DC17916-PAL-9,10-11/08/96.

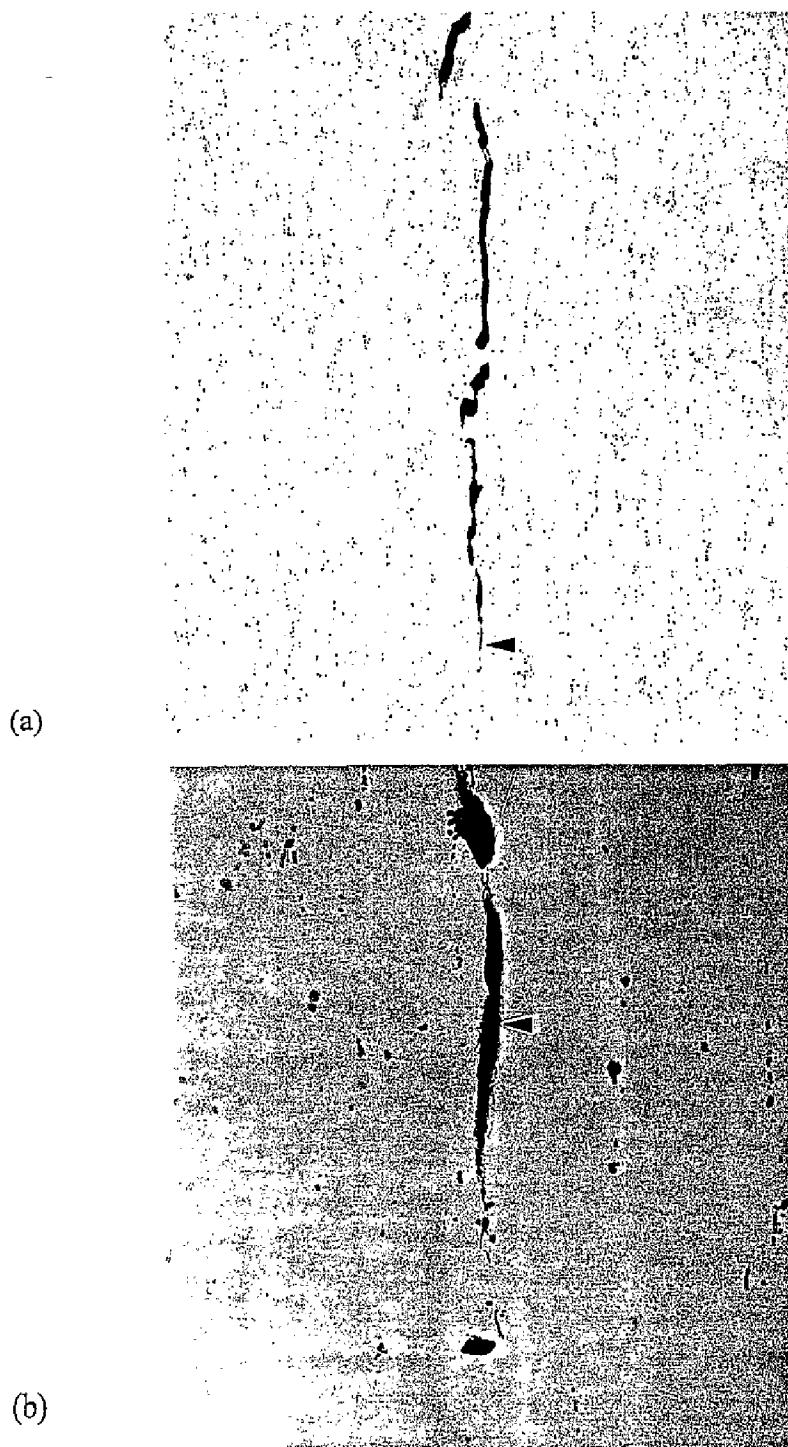
Figure 10. A crack tip from Figure 8.

(a) Tip region. 50X. Unetched.

(b) Detail of tip. 500X.. Unetched.

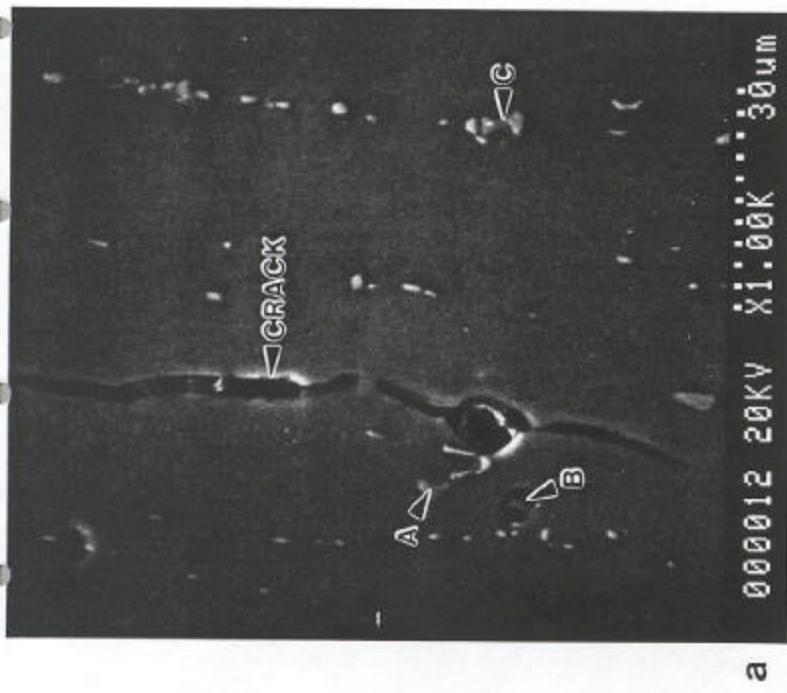
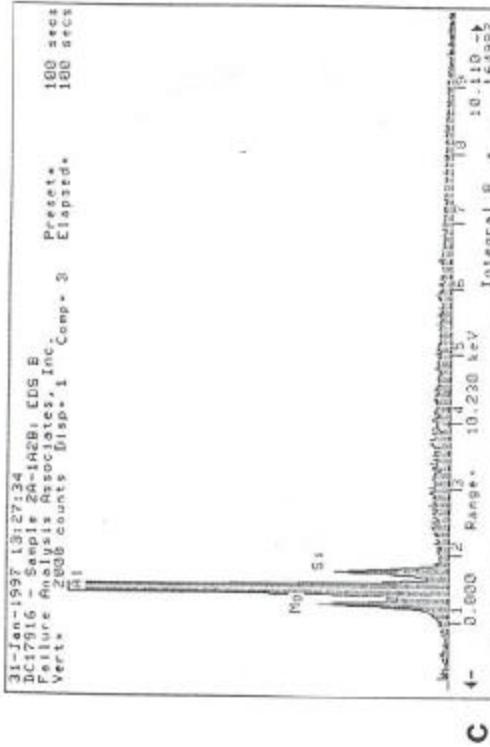
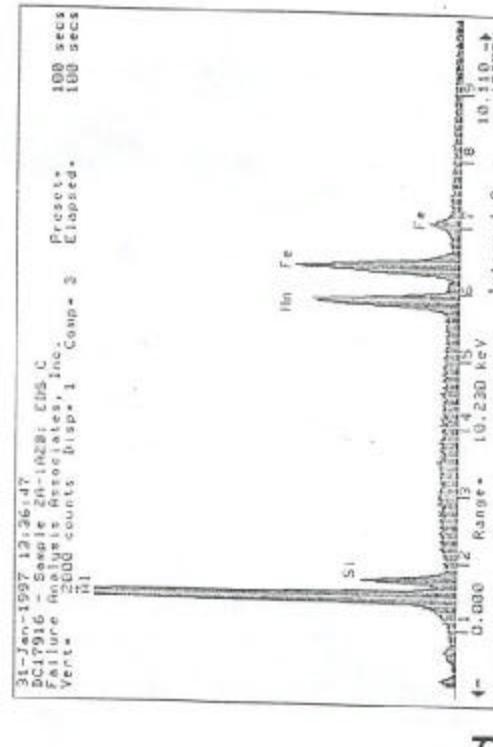
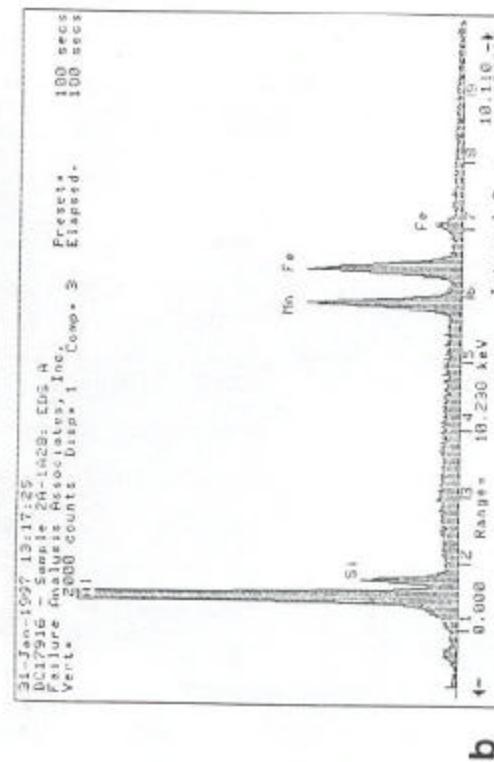
Figure 11. Precipitates near a crack tip.
Photo ID: DC17916-PAL-12-01/31/97

- (a) SEM micrograph of a crack tip.
- (b) EDS spectrum of inclusion A.
- (c) EDS spectrum of inclusion B.
- (d) EDS spectrum of inclusion C.

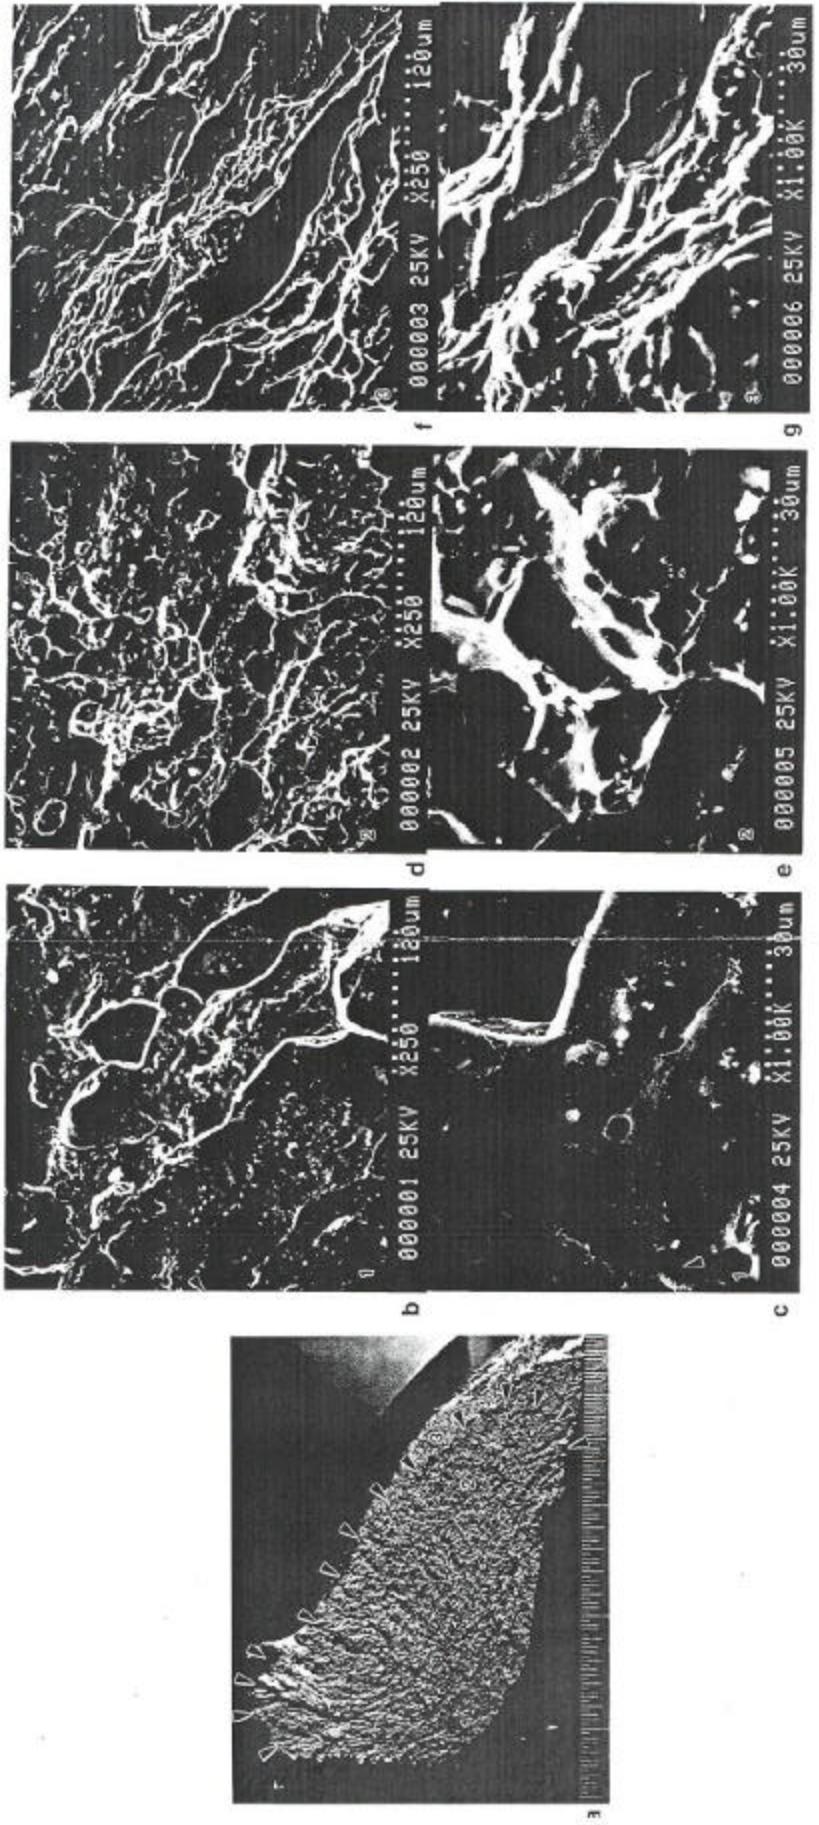
Figure 12. Fractography of fracture surface (planar region) from fragment 2A-2.

- (a) Optical fractograph depicting the neck region.
Note the locations 1, 2, and 3.
Photo ID: DC17916-PAL-4-10/10/96.
 - (b) SEM fractograph from region 1, 250X.
Photo ID: DC17916-PAL-1-0/1/5/97.
 - (c) SEM fractograph from region 1, 1000X.
Photo ID: DC17916-PAL-4-0/1/5/97.
 - (d) SEM fractograph from region 2, 250X.
Photo ID: DC17916-PAL-2-0/1/5/97.
 - (e) SEM fractograph from region 2, 1000X.
Photo ID: DC17916-PAL-5-01/15/97.
 - (f) SEM fractograph from region 3, 250X.
Photo ID: DC17916-PAL-3-01/15/97.
 - (g) SEM fractograph from region 3, 1000X.
Photo ID: DC17916-PAL-6-01/15/97.
- Note: Arrows in (a) define apparent beach mark.

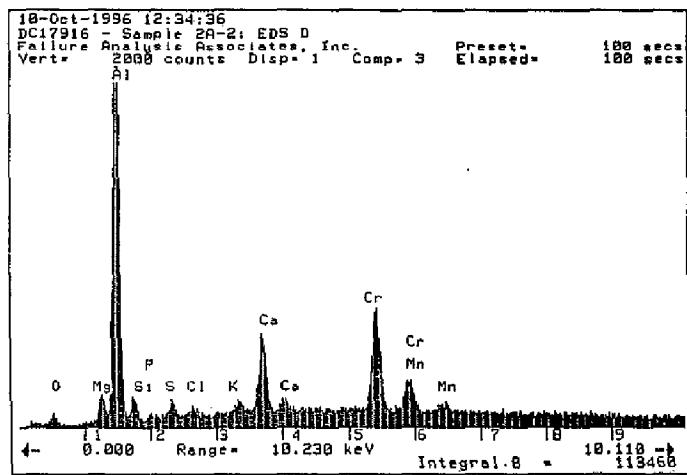
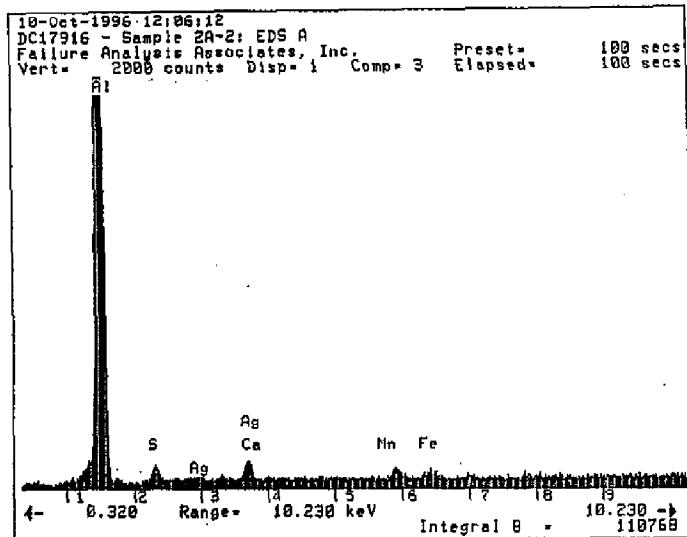
Figure 13. EDS Spectra captured from the flat-faced fracture surface.

(a) Region 1.

(b) Region 2.

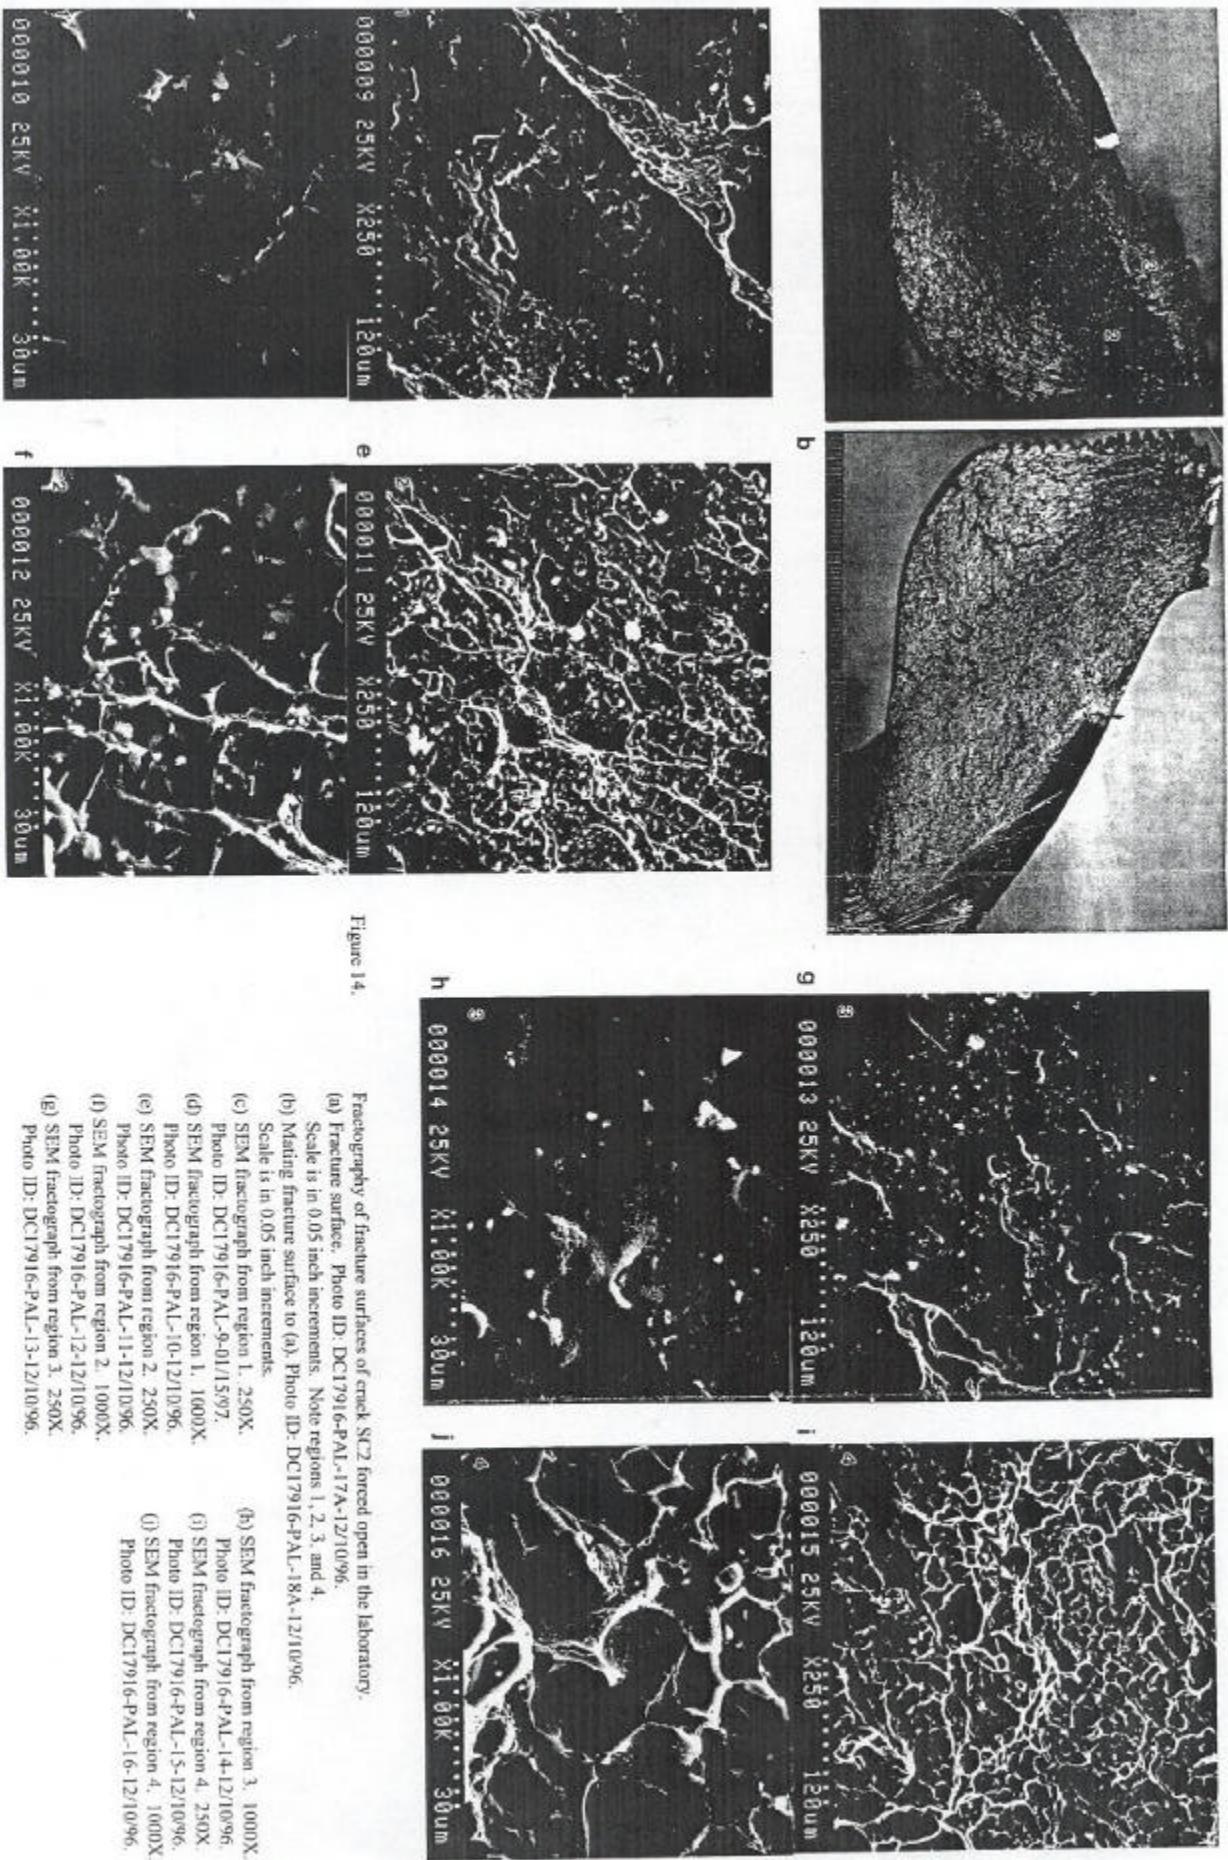
Figure 14. Fractography of fracture surfaces of crack SC2 forced open in the laboratory.

(a) Fracture surface. Photo ID: DCI7916-PAL-17A-1-2/10/96.
Scale is in 0.05 inch increments. Note regions 1, 2, 3, and 4.

(b) Matting fracture surface to (a). Photo ID: DCI7916-PAL-18A-1-2/10/96.
Scale is in 0.05 inch increments.

(c) SEM fractograph from region 1, 250X.
Photo ID: DCI7916-PAL-9-01/15/97.

(d) SEM fractograph from region 1, 1000X.
Photo ID: DCI7916-PAL-10-1/2/10/96.

(e) SEM fractograph from region 2, 250X.
Photo ID: DCI7916-PAL-11-12/10/96.

(f) SEM Fractograph from region 2, 1000X.
Photo ID: DCI7916-PAL-12-1/2/10/96.

(g) SEM fractograph from region 3, 250X.
Photo ID: DCI7916-PAL-13-1/2/10/96.
