Figure 2: Neck Stampings
(a) Exemption, serial number and first hydrostatic test.
(Photo ID: DC18234-R2E3)
(b) Inspection markings
(Photo ID: DC18234-R2E5)

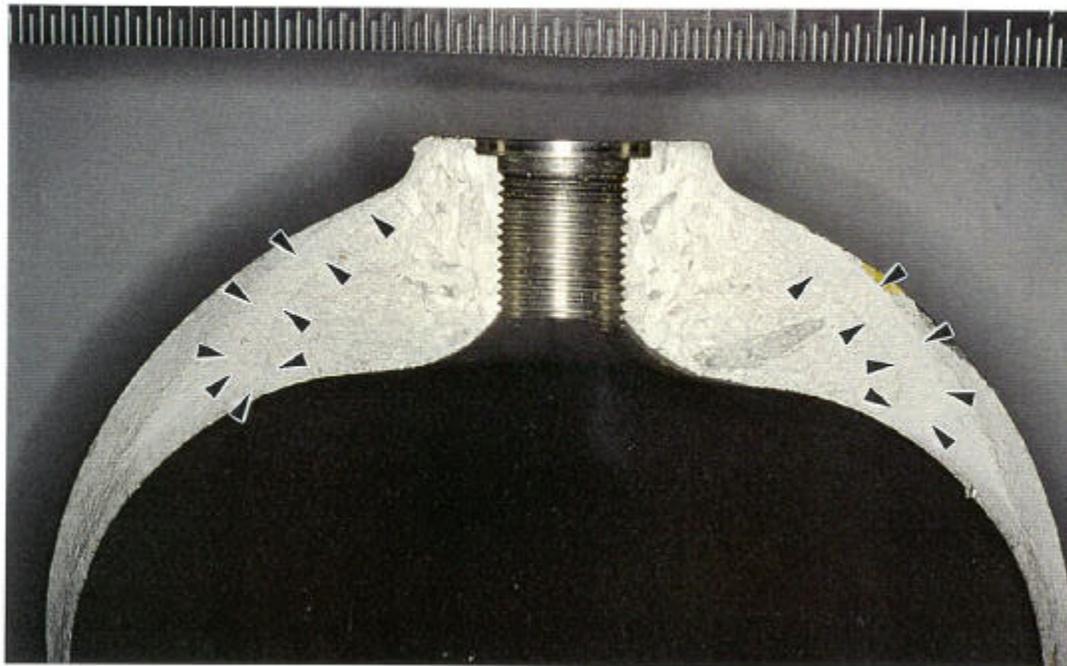
Figure 3: Detail of the fracture surface at the cylinder neck.

(a) Fracture surface at cylinder neck (Photo ID: DC18234-R2E29)

Note the beachmarks shown at the arrows.

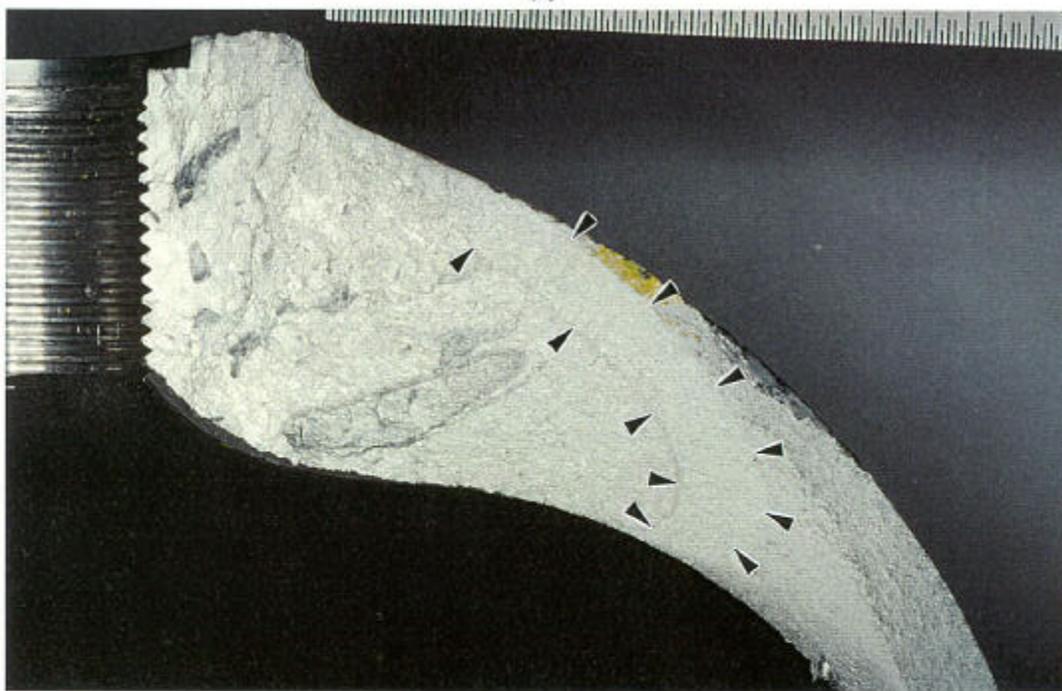
(b) Detail of fracture surface at the neck. (Photo ID: DC18234-R2E6)

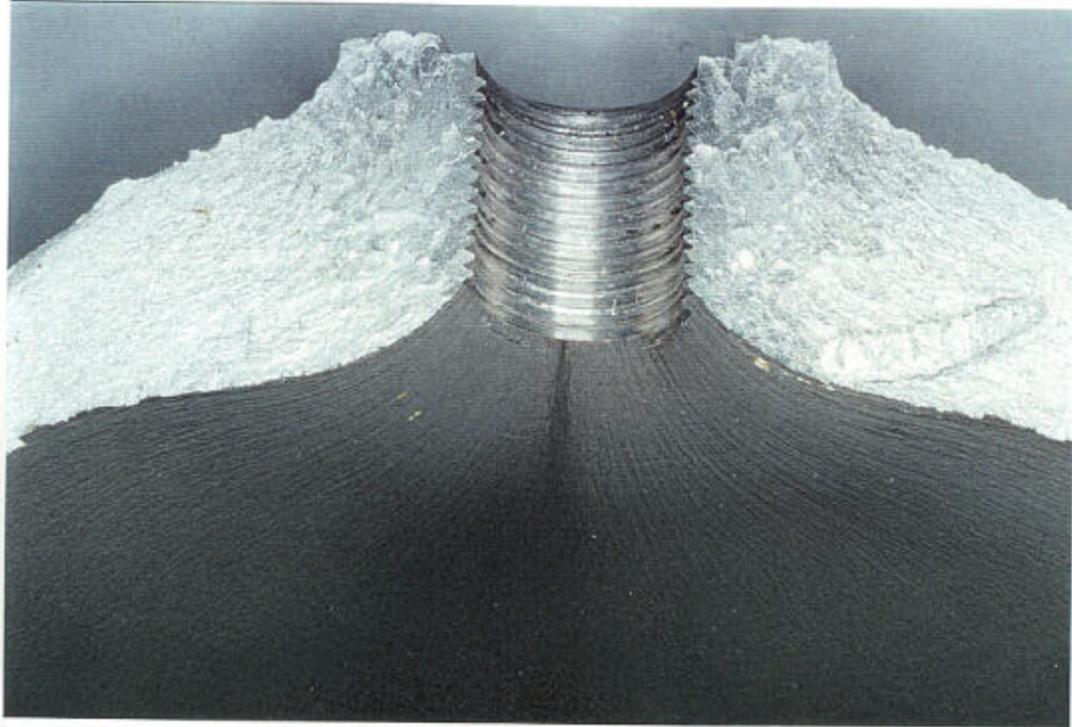
Figure 4: **Folds or cusps at the cylinder neck.**
Note axial and circumferential orientations of the folds on the inner wall of the cylinder.

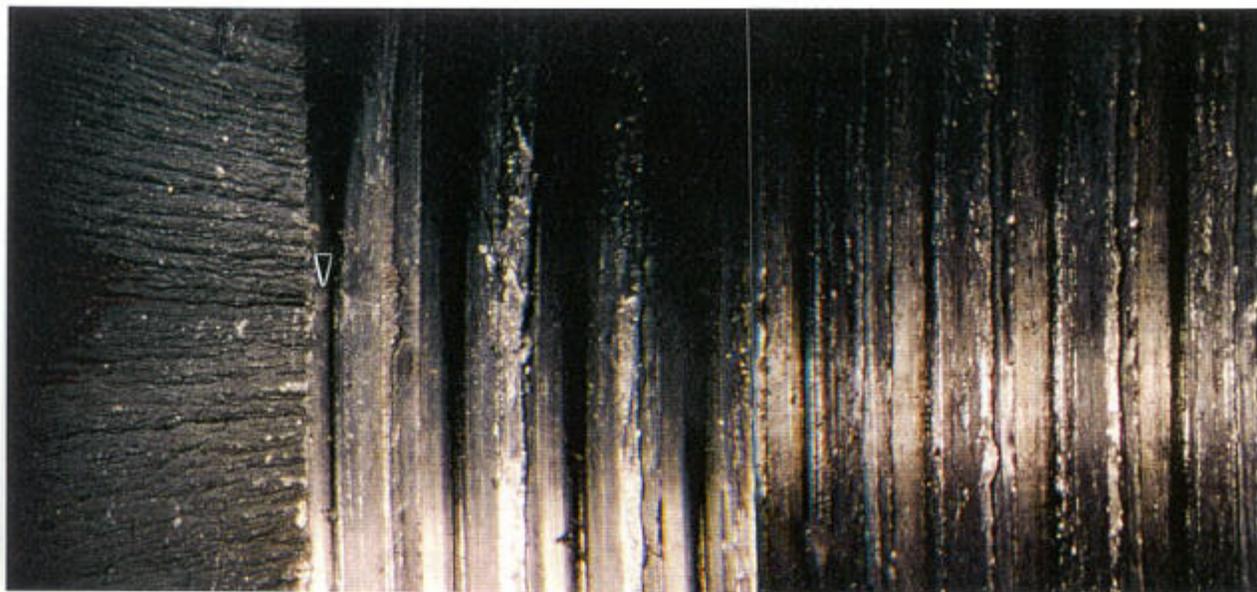
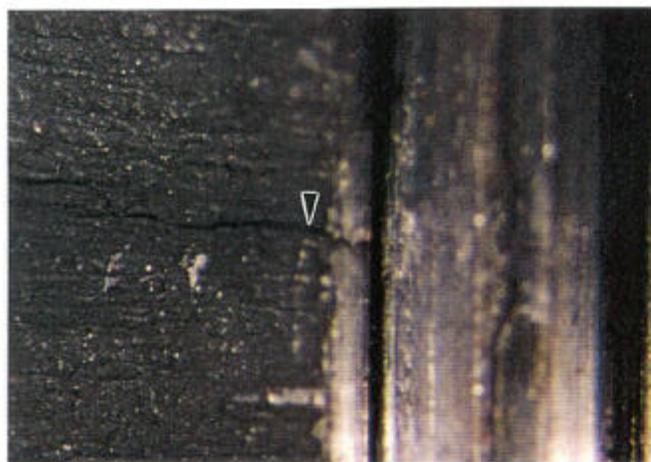
Figure 5: Crack from a neck fold, extending across the lowest thread. (Photo IDs: DC18234-R5E7, -R5E12, -R5-E15)
Note the crack shown at the arrows.

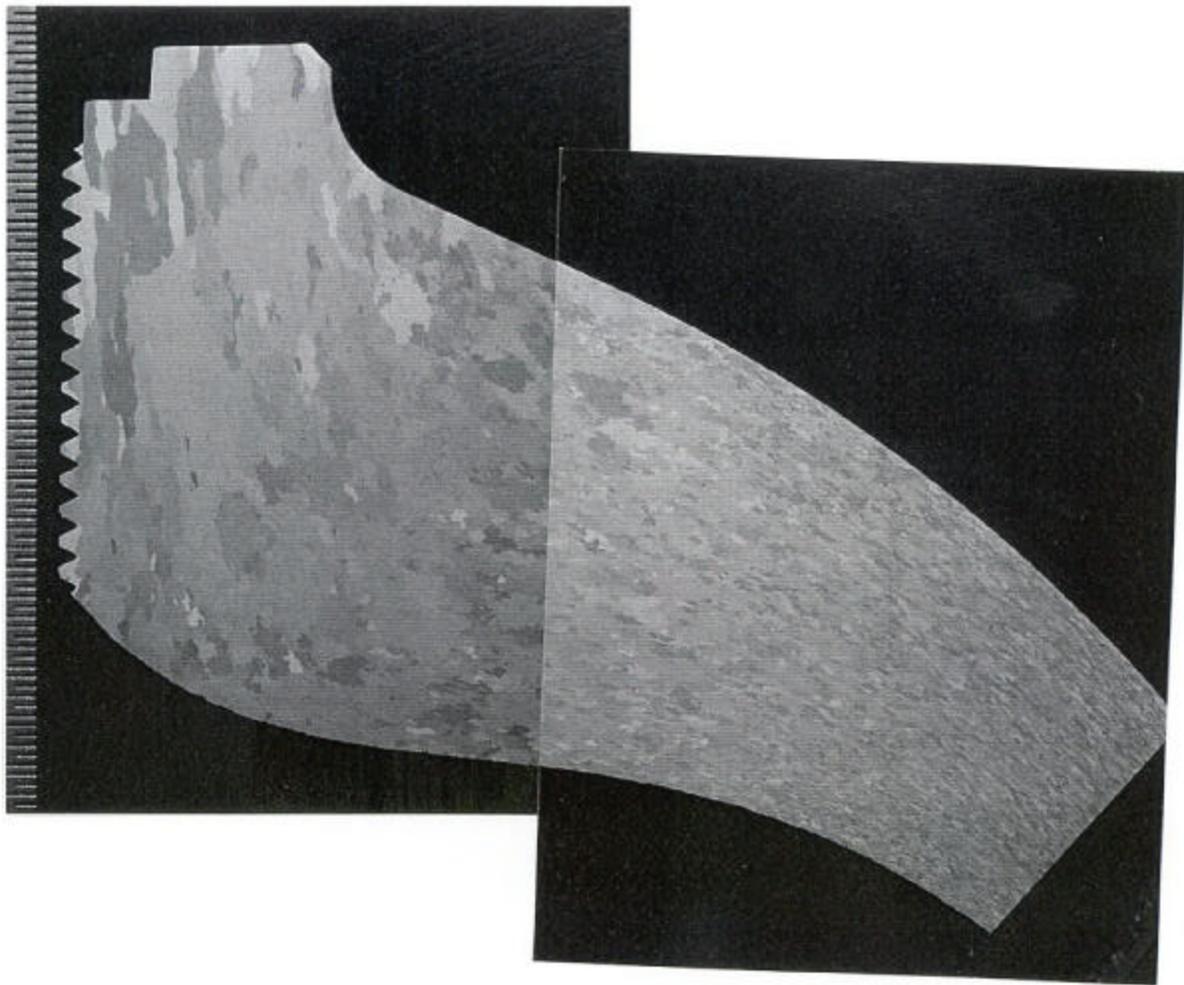
Figure 8: Metallographic section of the cylinder neck, specimen 1A-3. From the thick section near the threads toward the cylinder sidewall, there is significant reduction in grain size and an increase in grain aspect ratio. The grains are oriented in the forming direction of the cylinder.

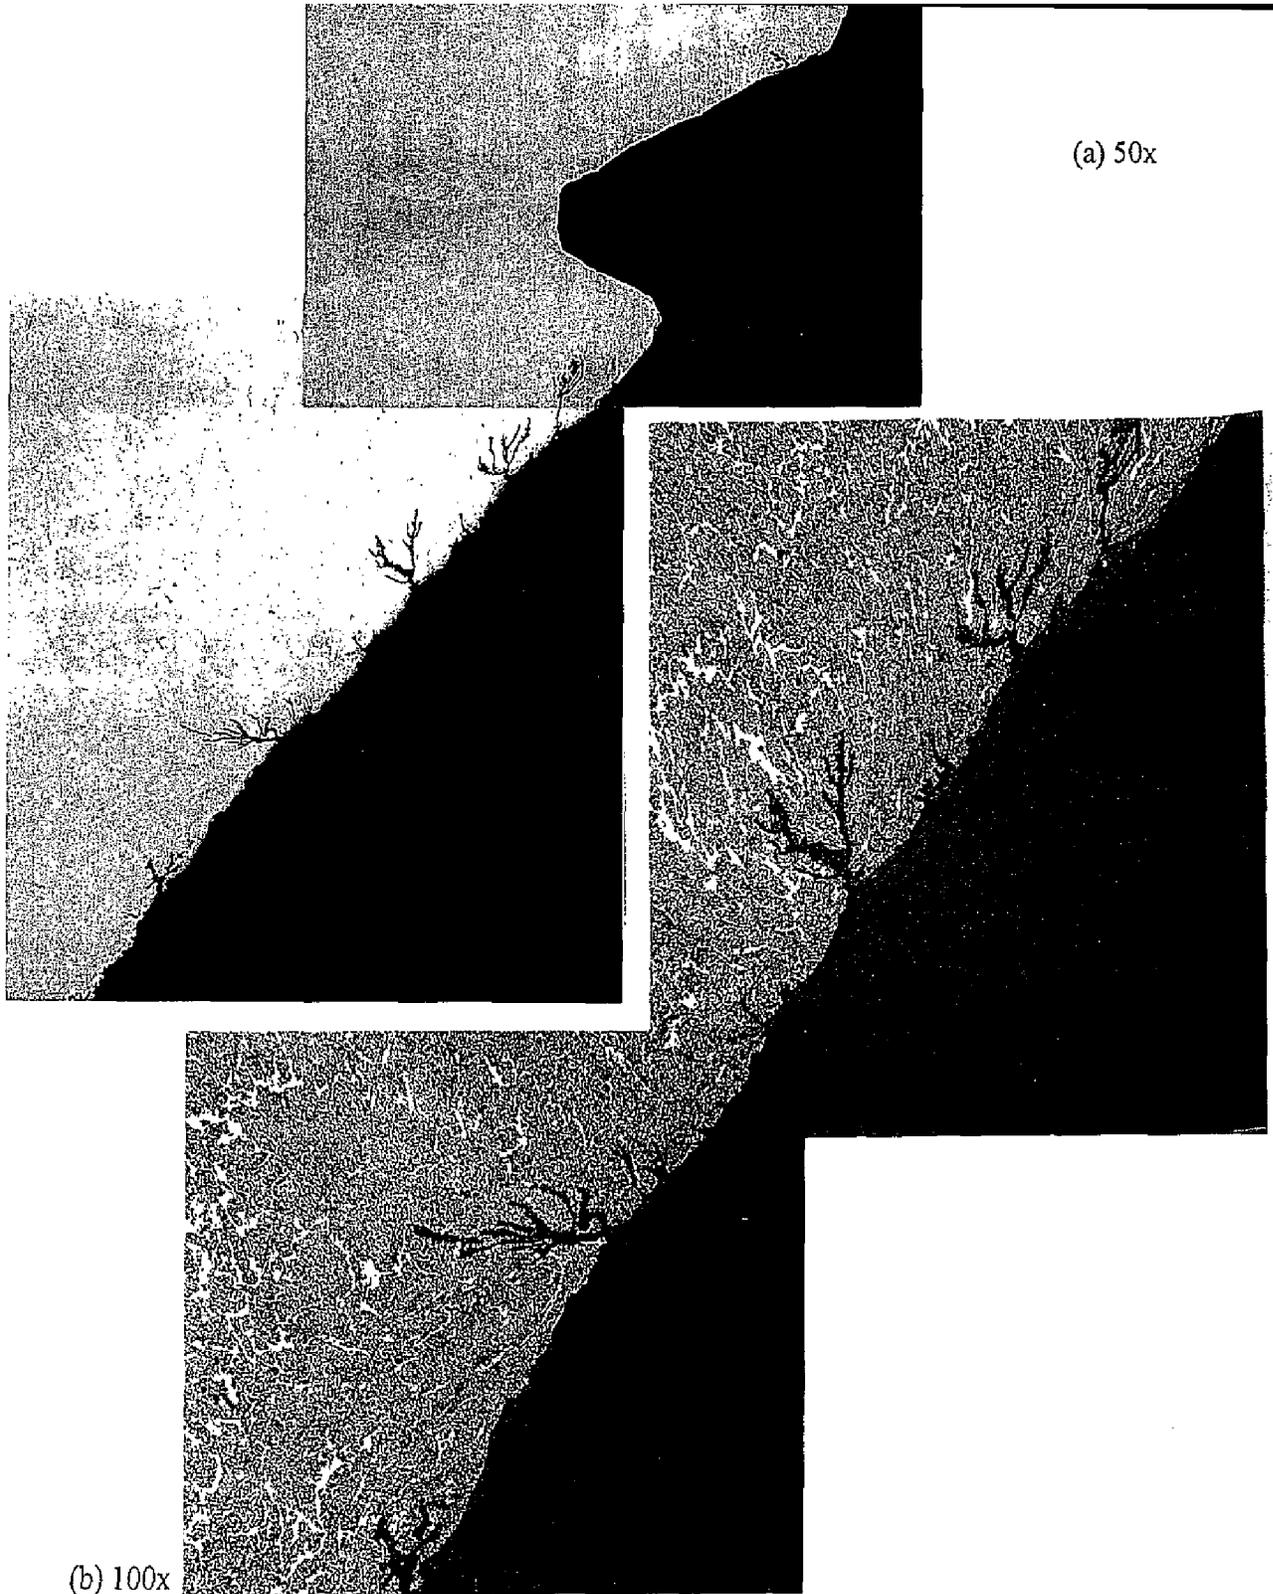
Figure 10: Branching cracks at the inside of the cylinder wall.

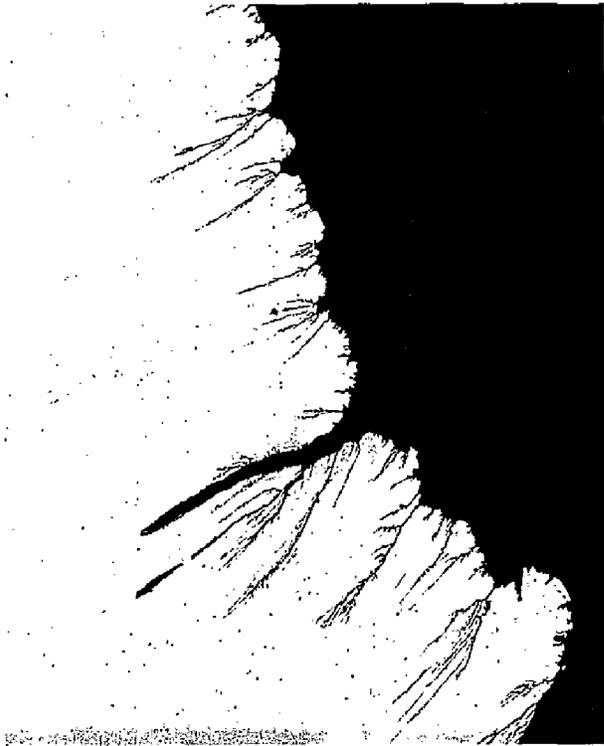
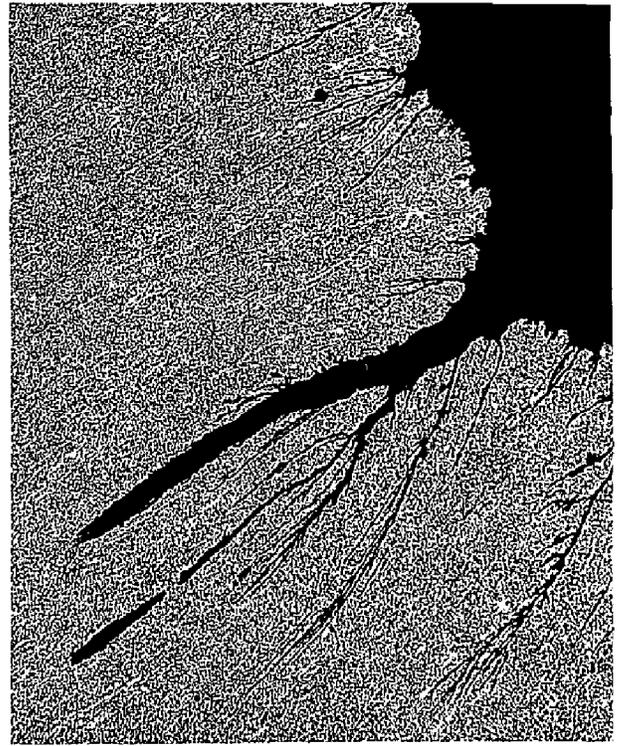
Figure 11: Metallographic section at the base of the neck threads.

(b) (c) Branching cracks extend from the base of the threaded region into the cylinder neck.

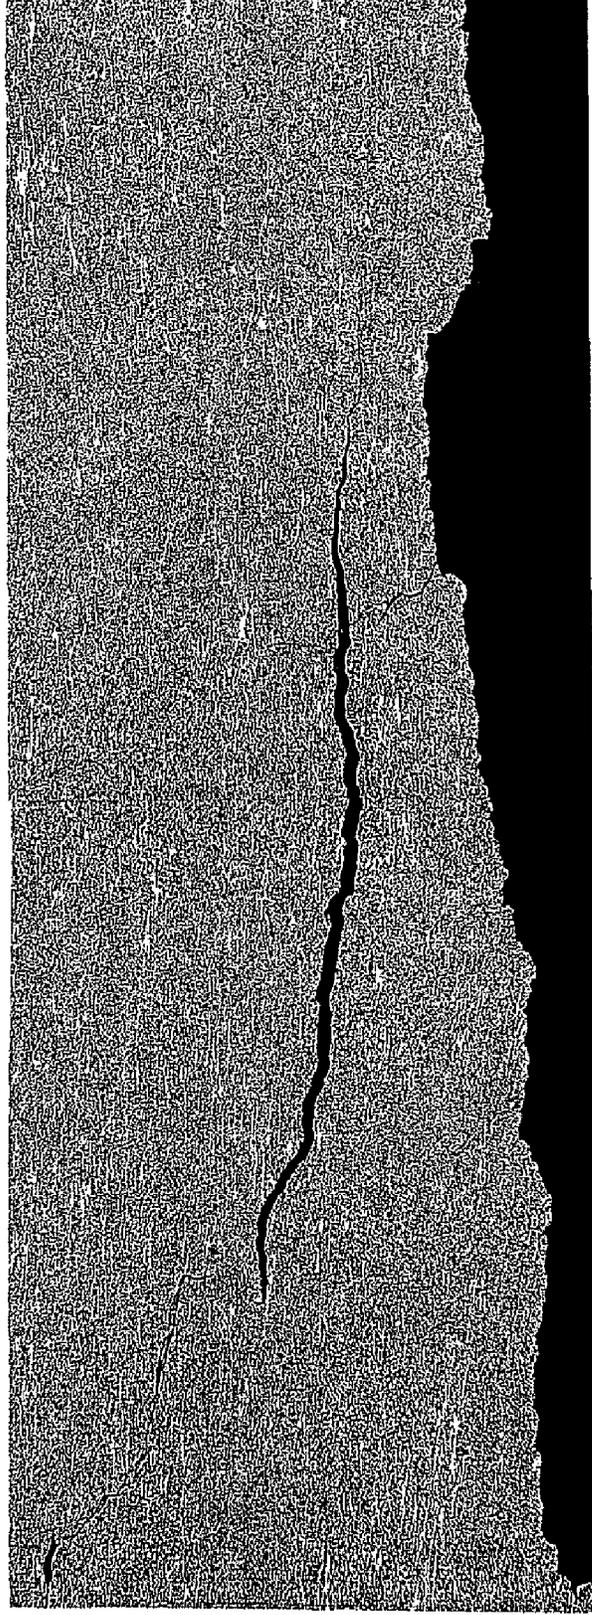
Figure 12: Cracking parallel to a flat-faced fracture surface at the neck, 100x.
