Figure 5. Sectioning of fragment 4A.

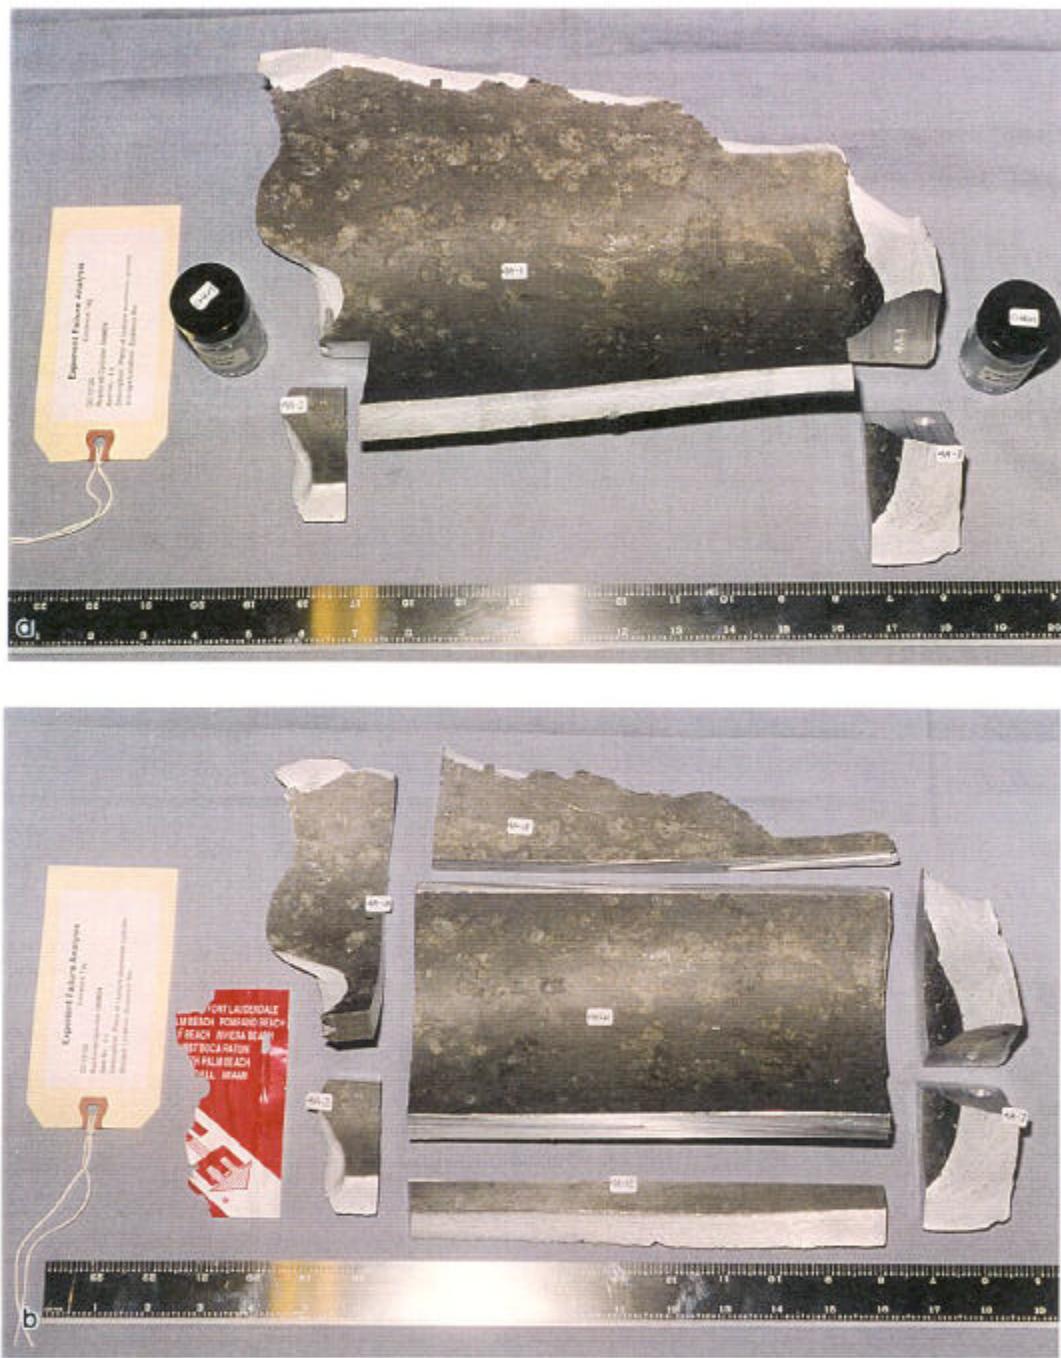
- Initial cuts showing the locations of drilling for chemical composition determination. Photo ID: DC18129-R3E16.
- Sectioning showing separated fracture surfaces and the portion used for tensile testing. Photo ID: DC18129-R5E3.

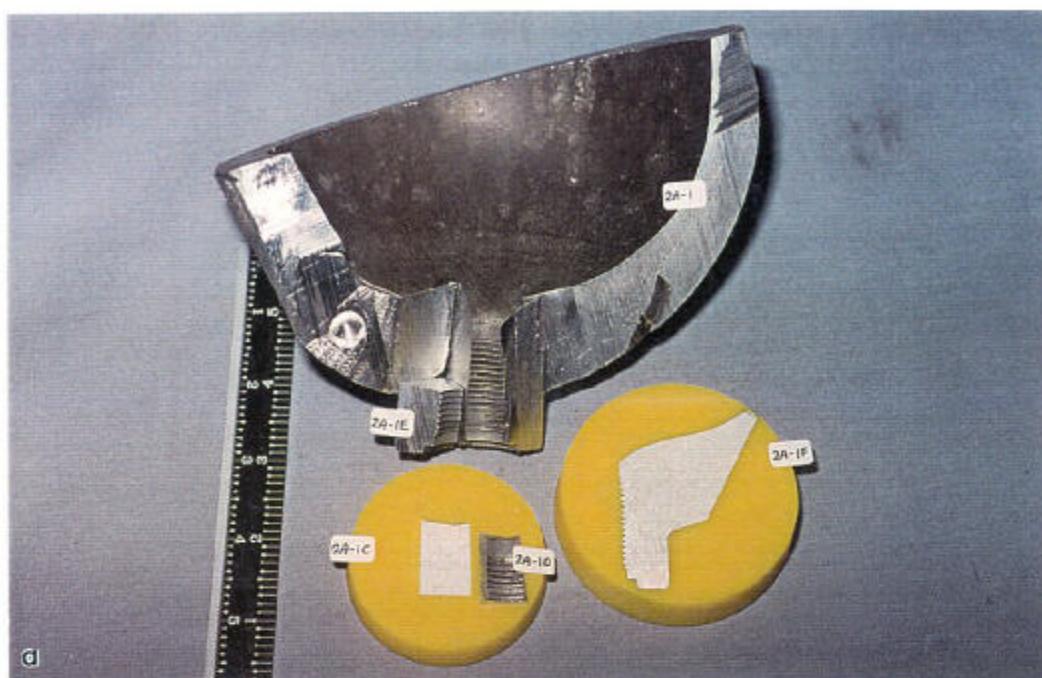
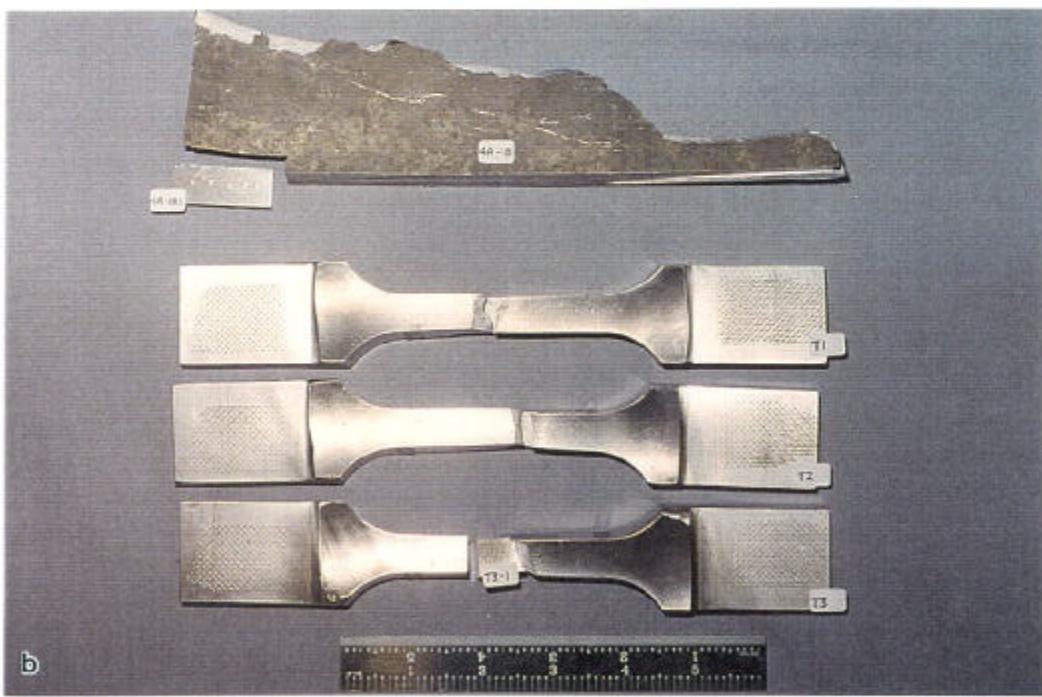
Figure 6. Additional sectioning of fragments 2A and 4A.

- (a) Fragment 2A, neck region. Photo ID#: DC18129-R6E7.
- (b) Fragment 4A, mechanical property samples.
Photo ID#: DC18129-R6E5.

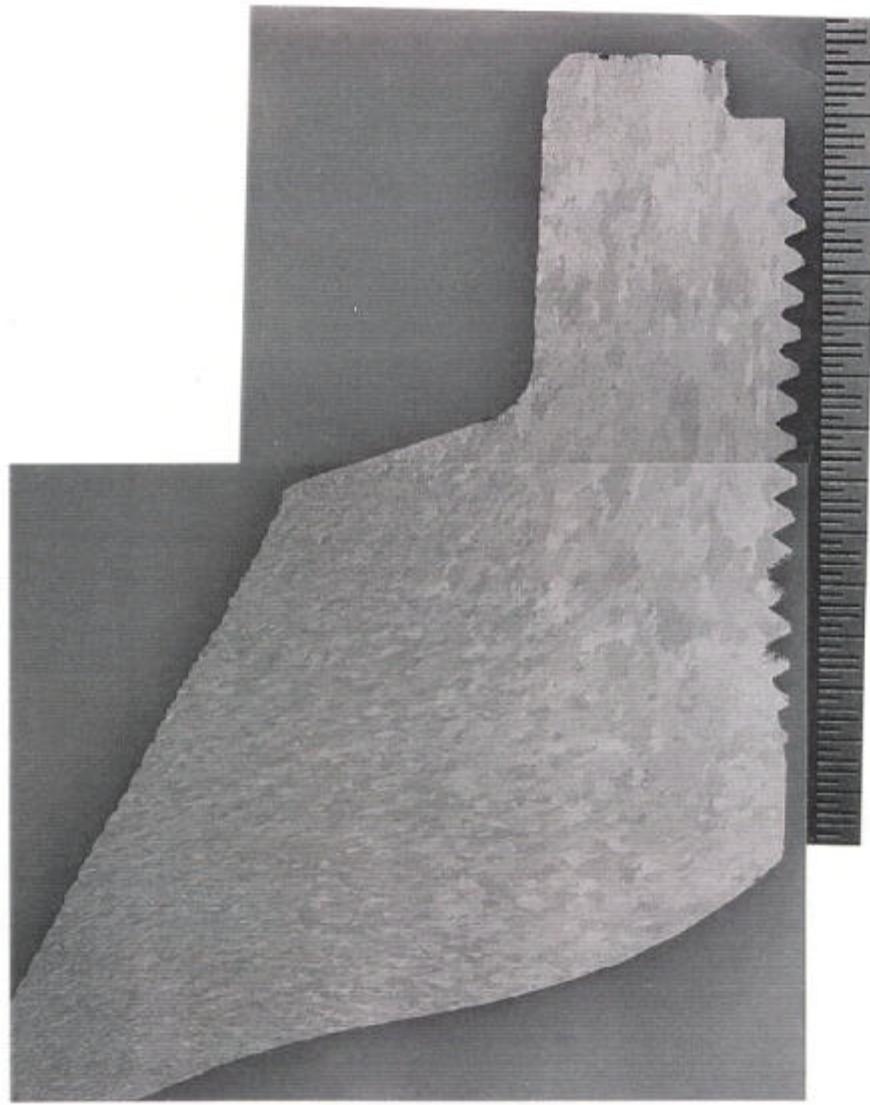
Figure 7. Section 2A-1F showing the microstructure in the neck region.
Note the scale is in 0.05 inch increments. HF-H₂SO₄-H₂O etch.
Photo ID: DC18129-PAL-1,2-7/28/98.

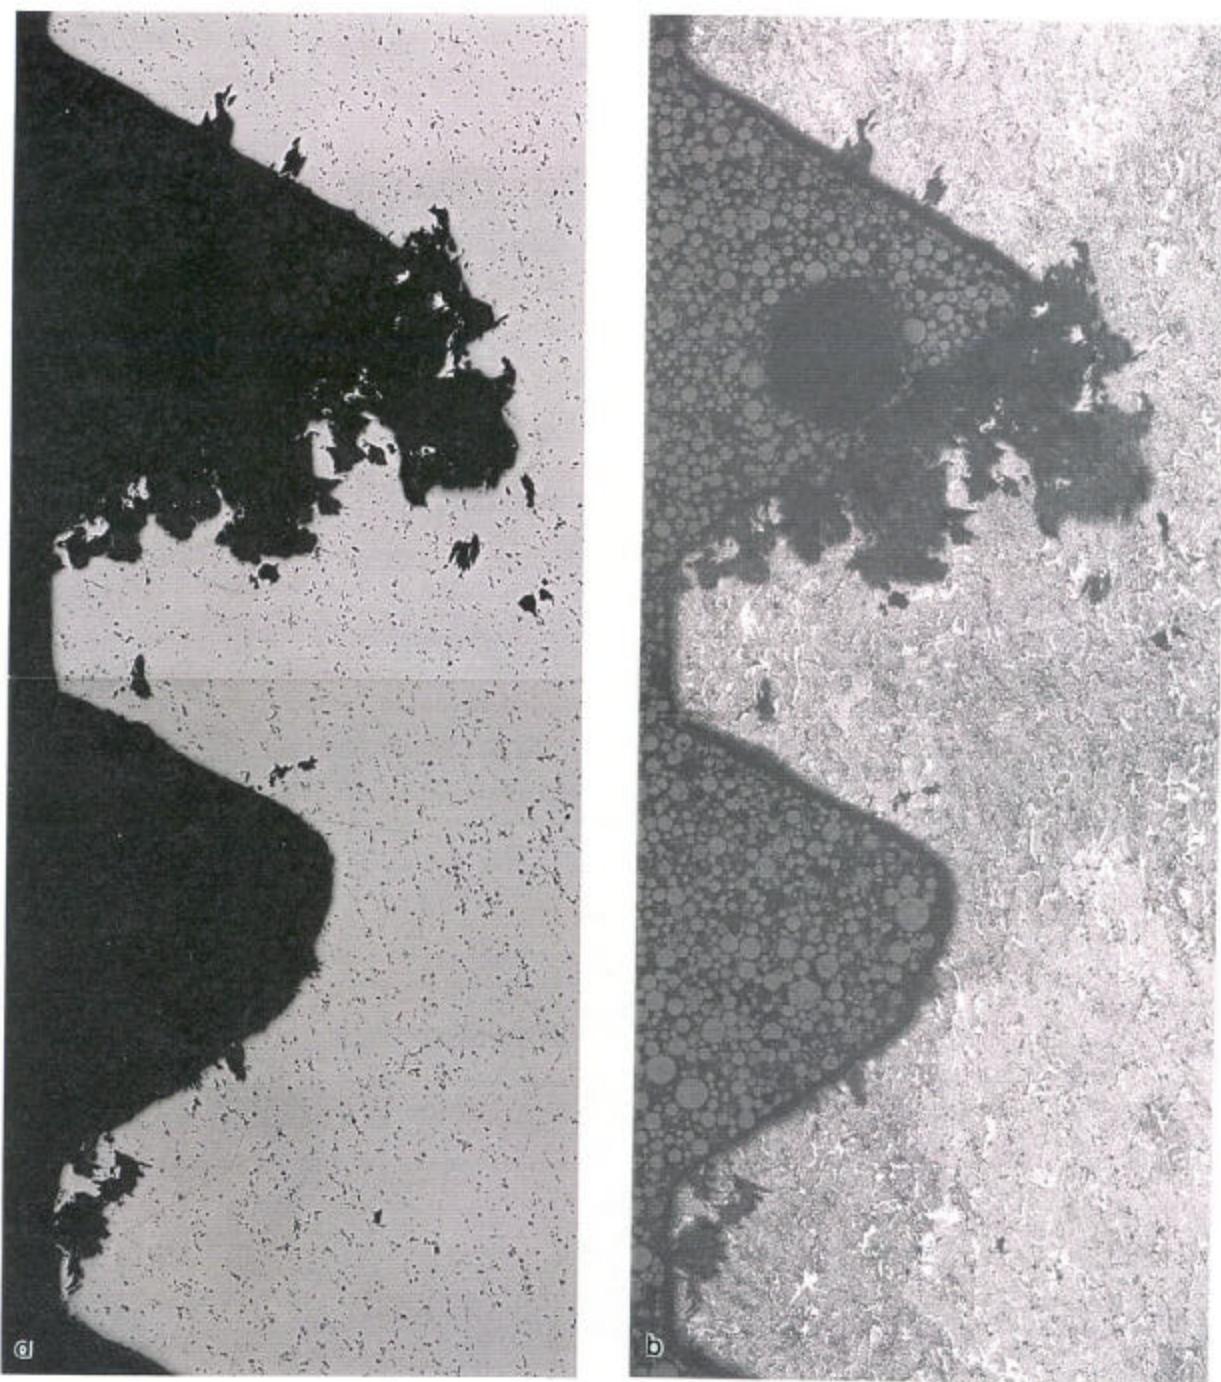
Figure 8. Close-up of thread area shown in Figure 7.

- (a) 50X. Photo ID: DC18129-PAL-5,6-7/28/98.
- (b) 50X. HF-H₂SO₄-H₂O etch. Photo ID: DC18129-PAL-9,10-7/28/98.
Note the corrosion pitting damage to the thread area.

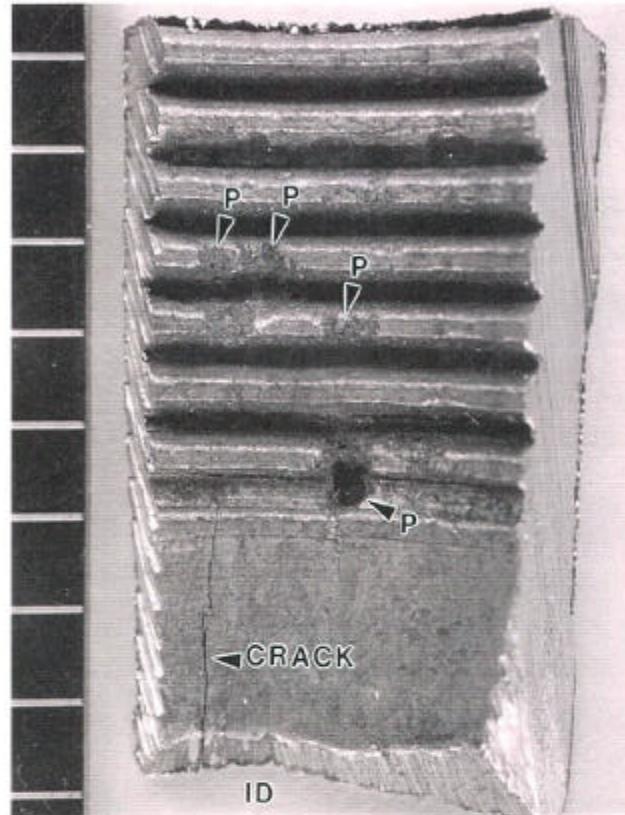
Figure 9. Close-up of portion of the inlet hole threads showing cracking and corrosion pits. Example pits are labeled "P". Scale is in 0.05 inch increments. Section 2A-1C was taken just behind this slice. Note that one pit forms a well-developed hole through this slice. Photo ID#: DC18129-TRS-1-8/5/98.

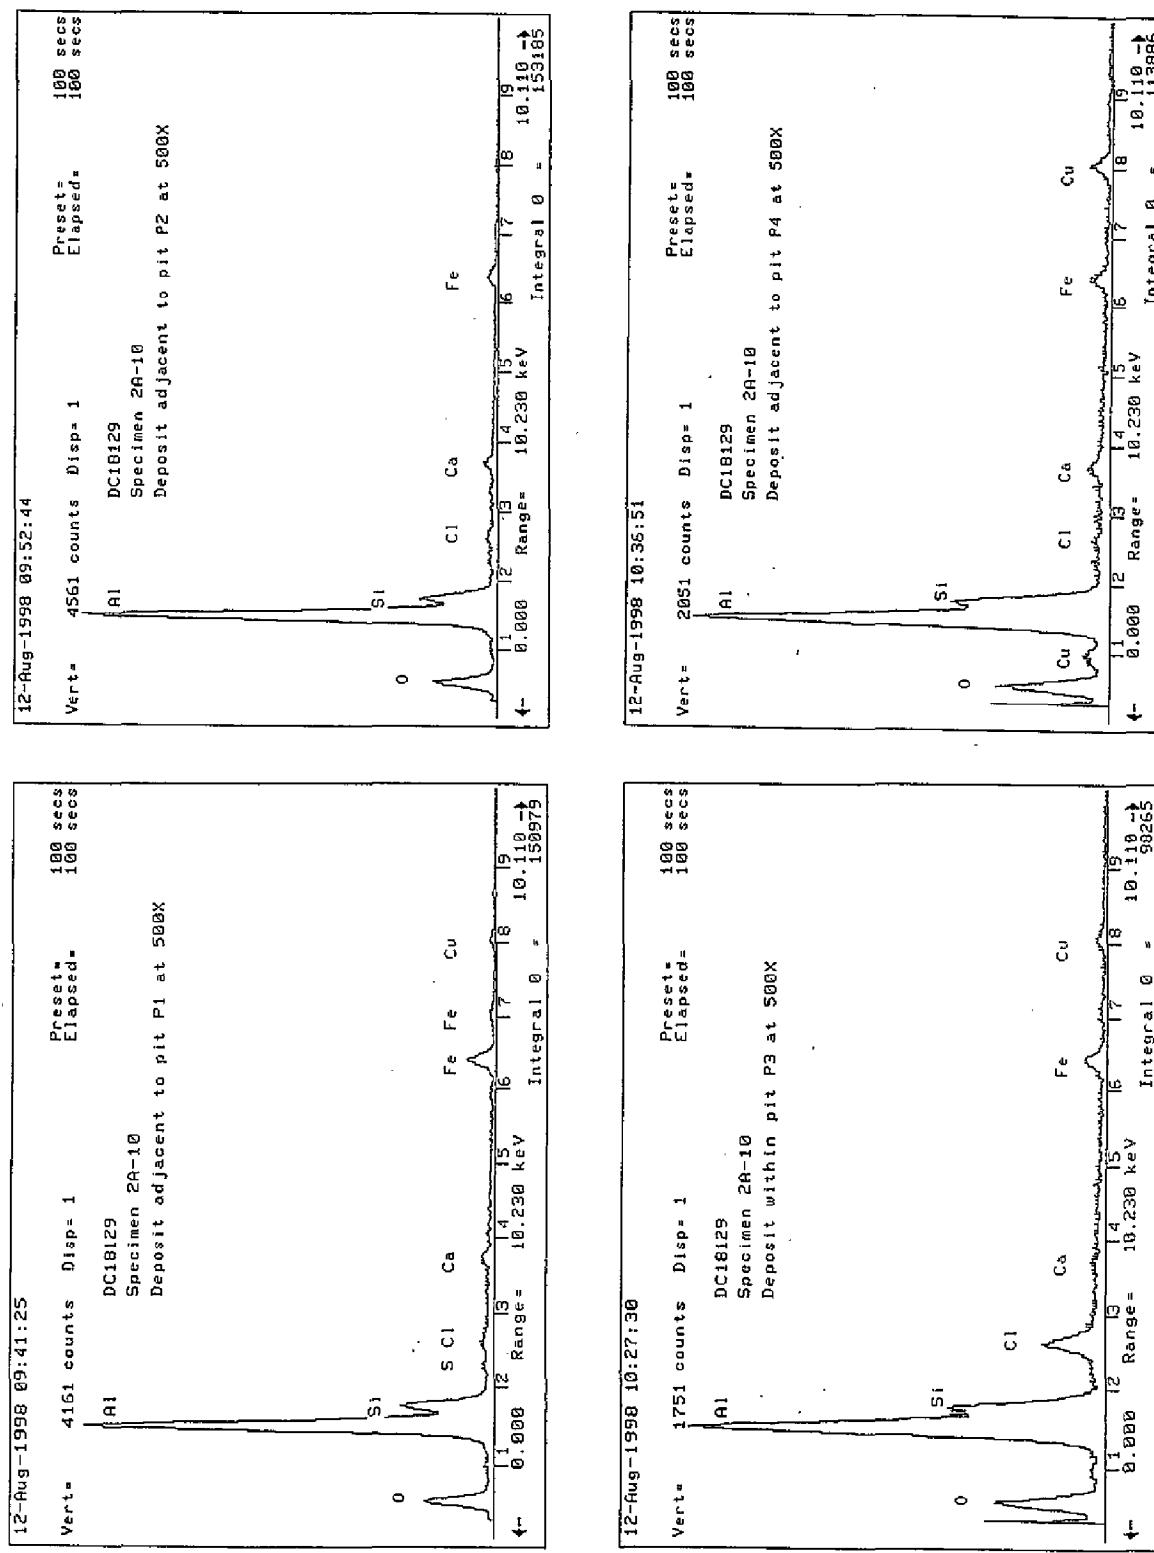
Figure 10. Energy dispersive spectra taken from at or near the pits shown in Figure 9.

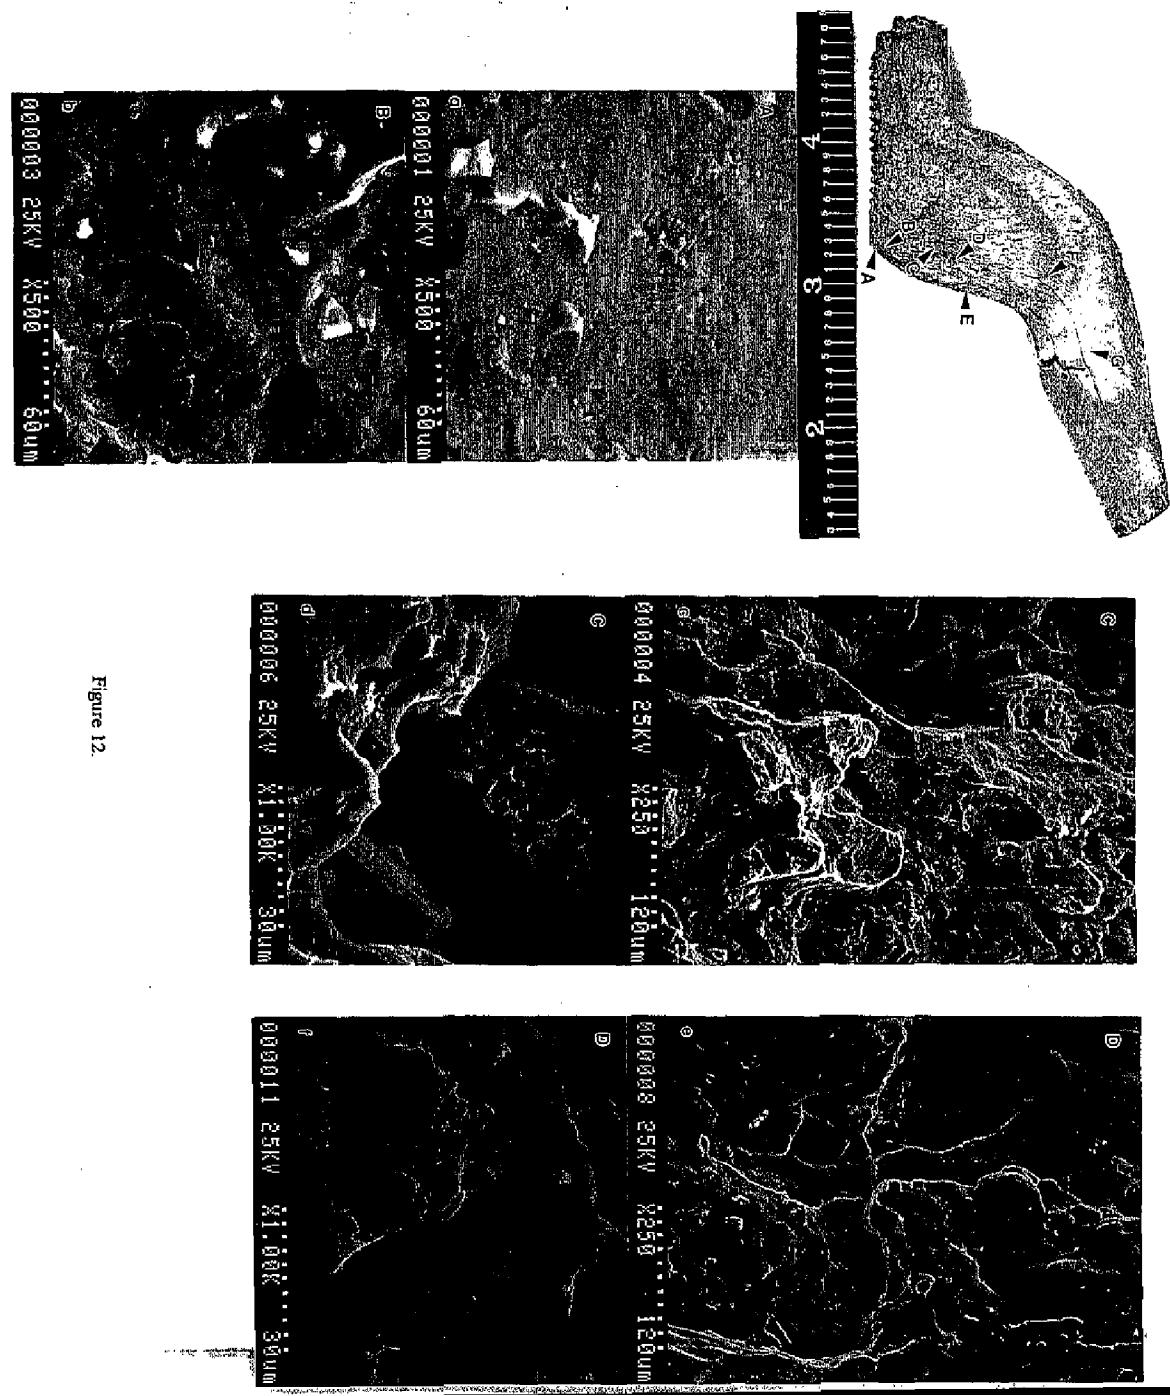
Figure 12. Fractography of section 2A-1A. Overall optical micrograph view shows the regions examined in the SEM. Photo ID: DC18129-TRS-1-6/25/98.

- (a) Region A showing the coating. 500X. Photo ID: DC18129-PAL-1-6/25/98.
- (b) Region B showing deposits on the fracture surface. 500X.
Photo ID: DC18129-PAL-3-6/25/98.
- (c) Region C. 250X. Photo ID: DC18129-PAL-4-6/25/98.
- (d) Region C. 1000X. Photo ID: DC18129-PAL-6-6/25/98.
- (e) Region D. 250X. Photo ID: DC18129-PAL-8-6/25/98.
- (f) Region D. 1000X. Photo ID: DC18129-PAL-11-6/25/98.
- (g) Region E. 250X. Photo ID: DC18129-PAL-15-6/25/98.
- (h) Region E. 1000X. Photo ID: DC18129-PAL-17-6/25/98.
- (i) Region F. 250X. Photo ID: DC18129-PAL-19-6/25/98.
- (j) Region F. 1000X. Photo ID: DC18129-PAL-21-6/25/98.
- (k) Region G. 250X. Photo ID: DC18129-PAL-23-6/25/98.
- (l) Region G. 1000X. Photo ID: DC18129-PAL-25-6/25/98.
