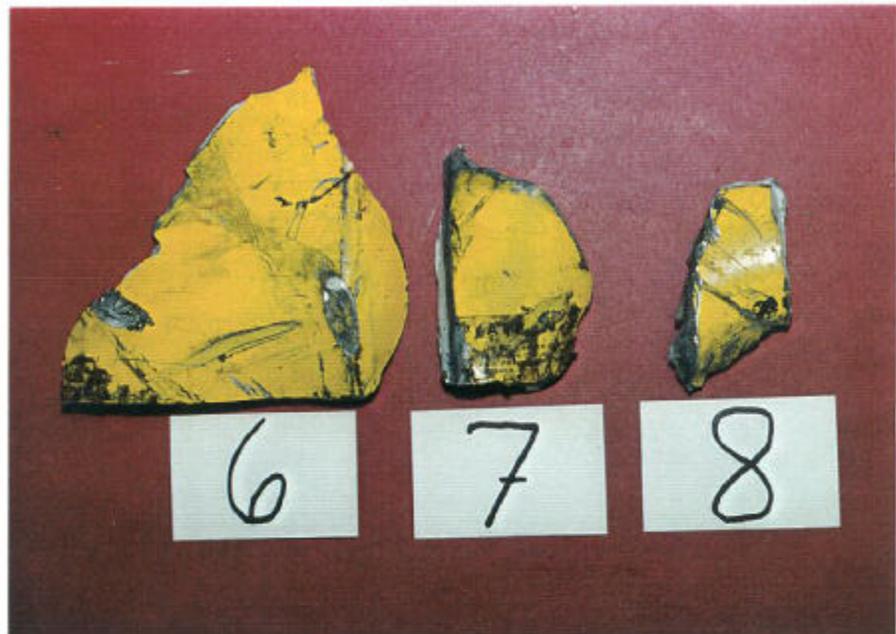
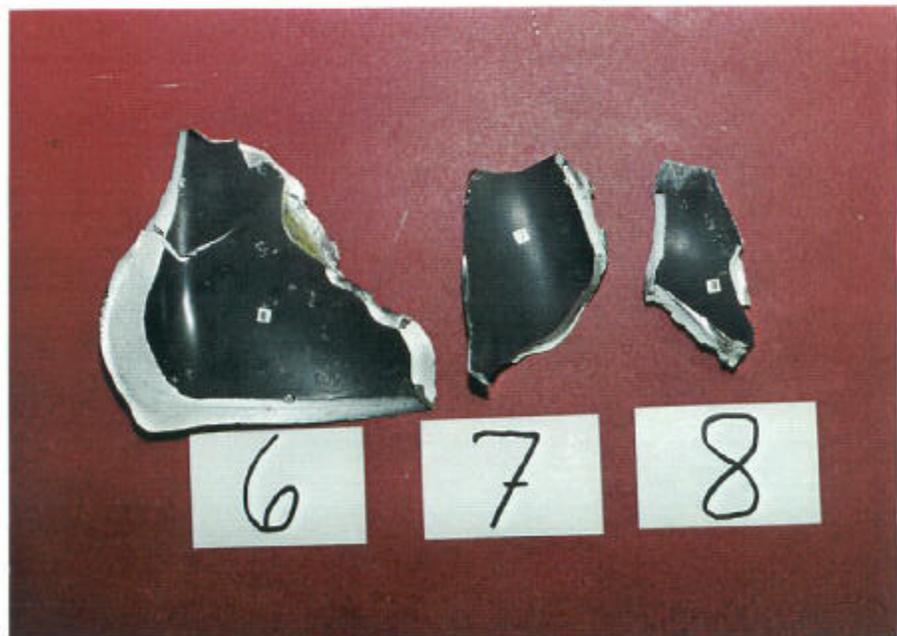
Figure 13.

Fracture pieces (6), (7), and (8) from side-wall area adjacent to bottom of cylinder shown in Figure 1.

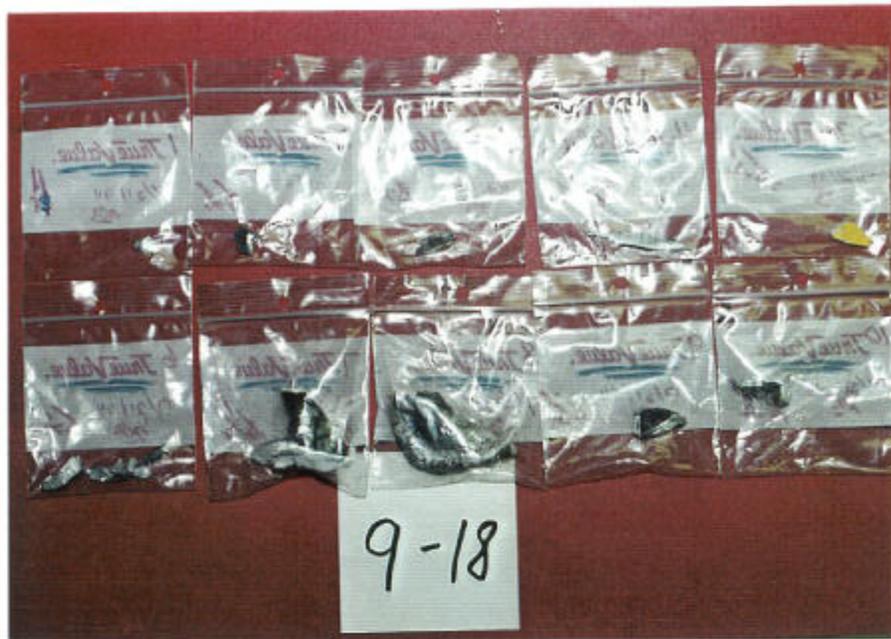
Figure 14. Fracture fragments (9) through (18) whose location was not identifiable due to small size and fracture surface damage.

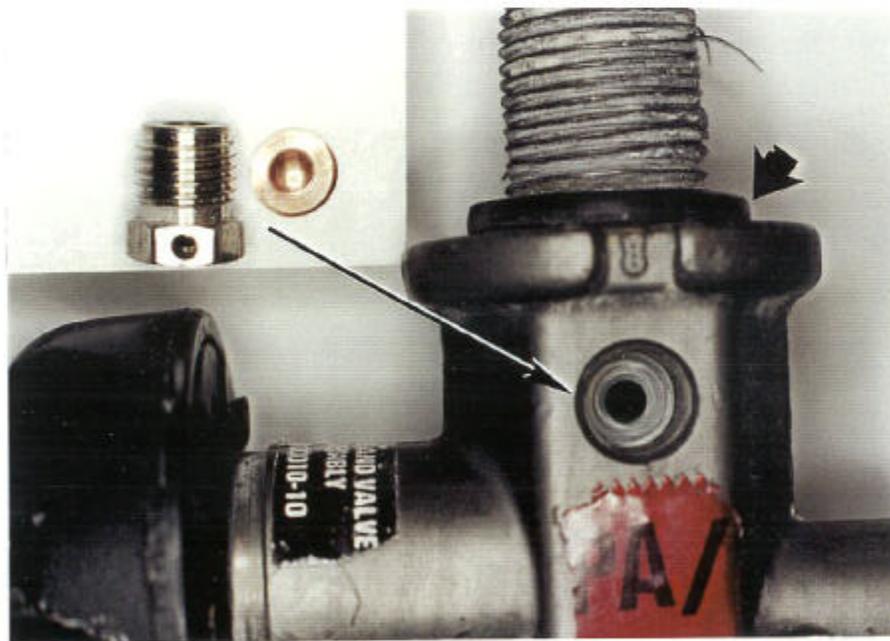
Figure 15. Valve from exploded cylinder showing "O" ring seal (arrow), deformed and several sheared threads, deformed copper rupture disk and retainer. Note white corrosion product on threads.

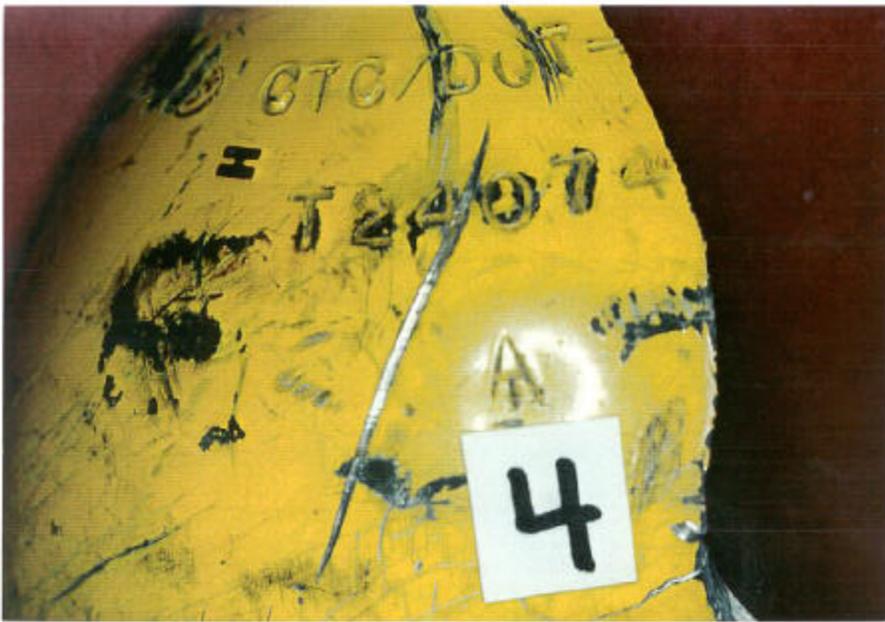
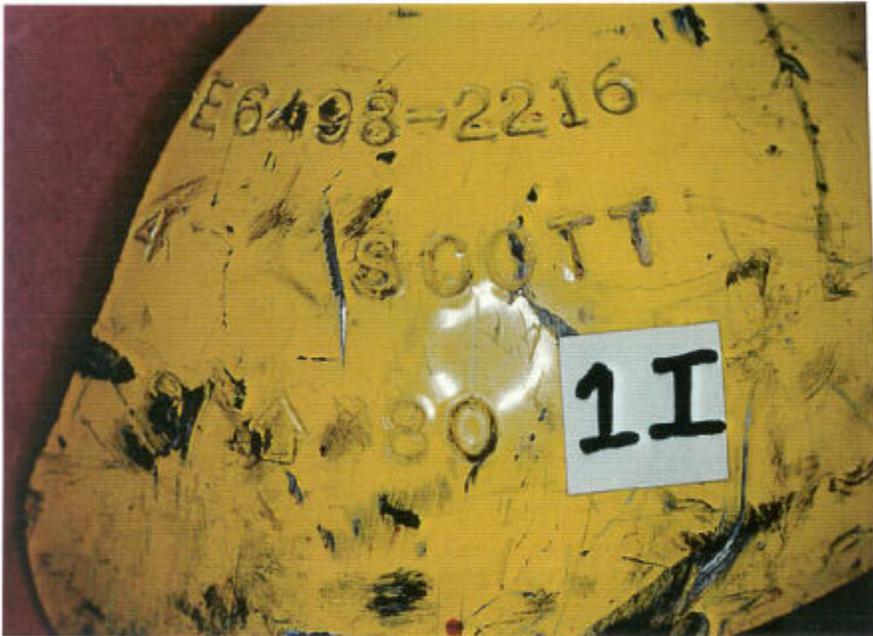
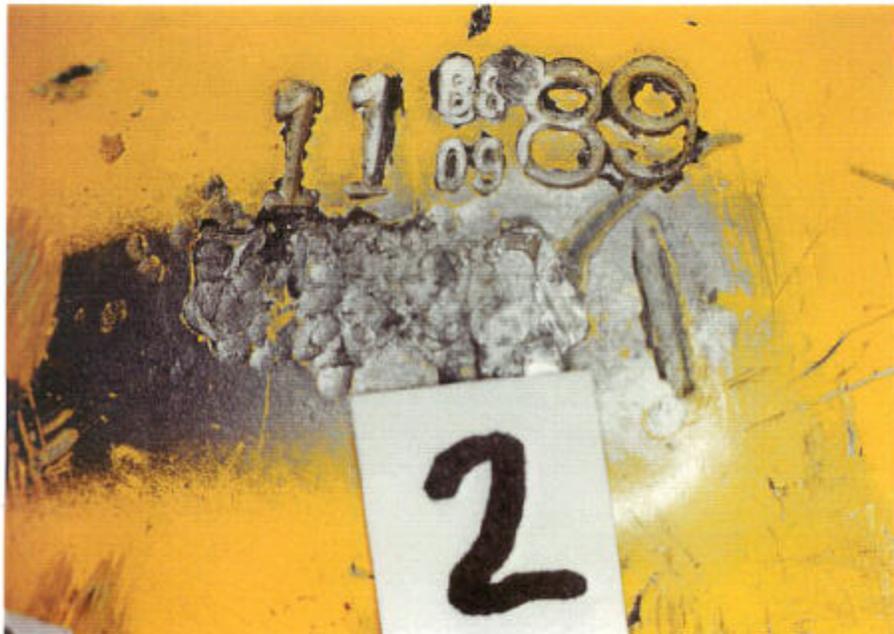
Figure 16.

Identification markings from heavy wall area at top of cylinder. Note ball peened area below the 11-89 Retester Identification Number.

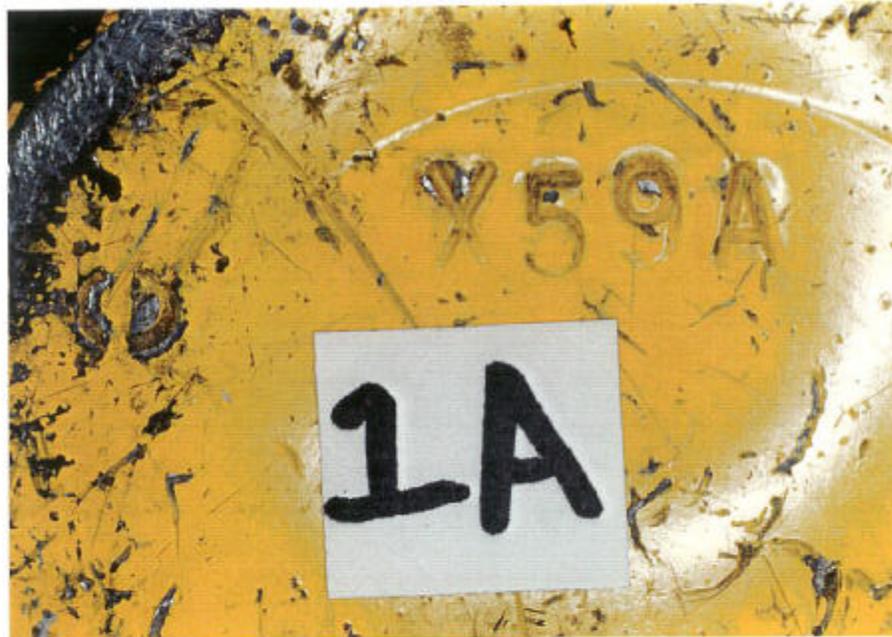
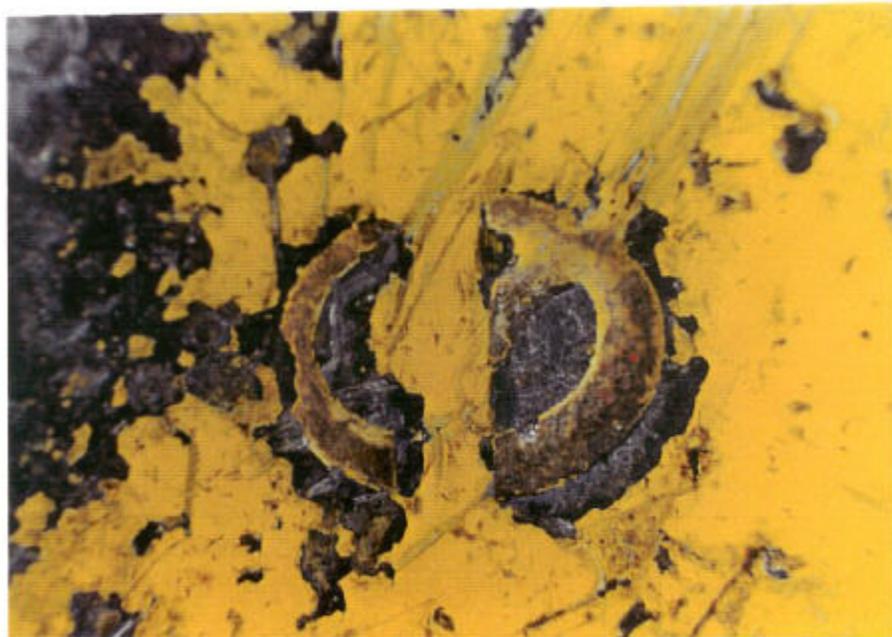
Figure 17.

Identification mark(s) on the bottom of the cylinder. The significance of letter "A" following "X59", the Lot Code, and the unrecognized symbol in the lower photograph is not known at this time.

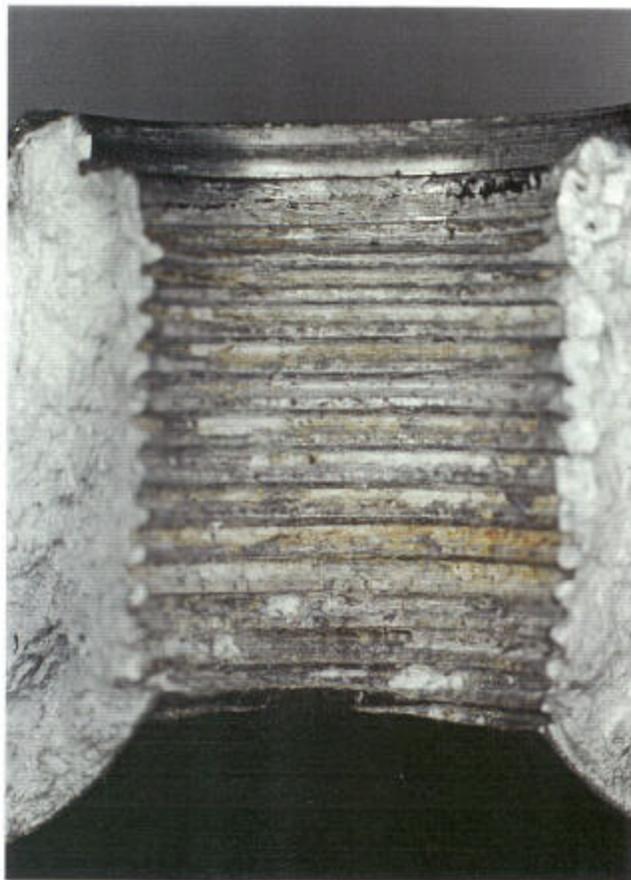
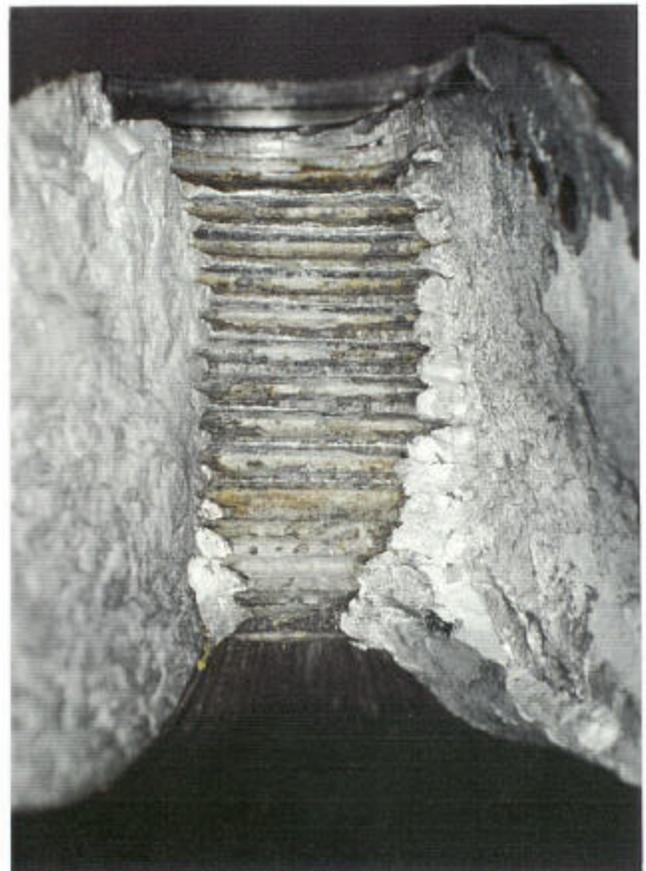
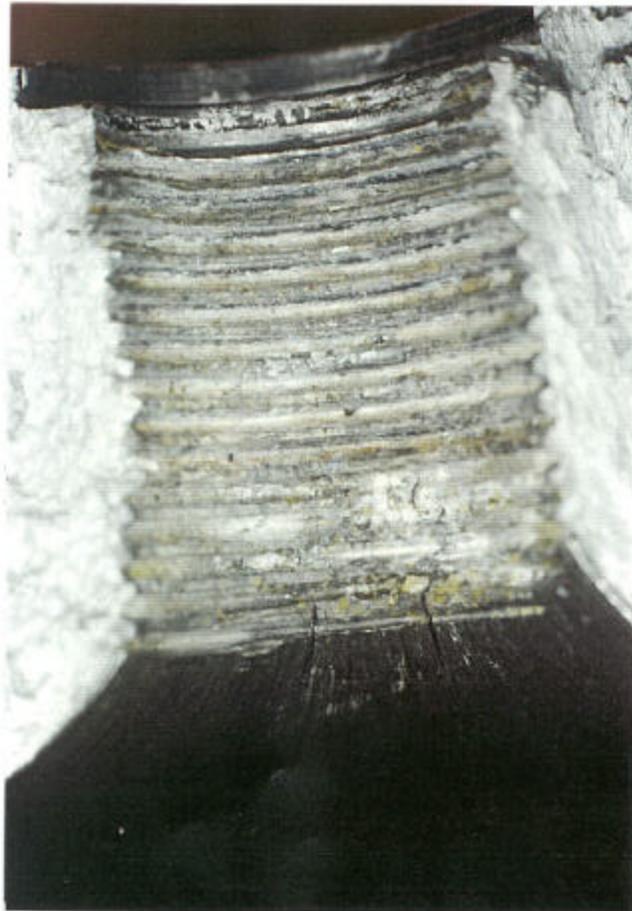
Figure 18.

Enlarged views of the internal thread for receiving the valve revealing the as-received condition of fracture piece (2) at top left, fracture piece (4) at top right, and fracture piece (1I) at lower left. Note the additional cracks in the interior neck area and the more corroded area of the fourth thread from the bottom.

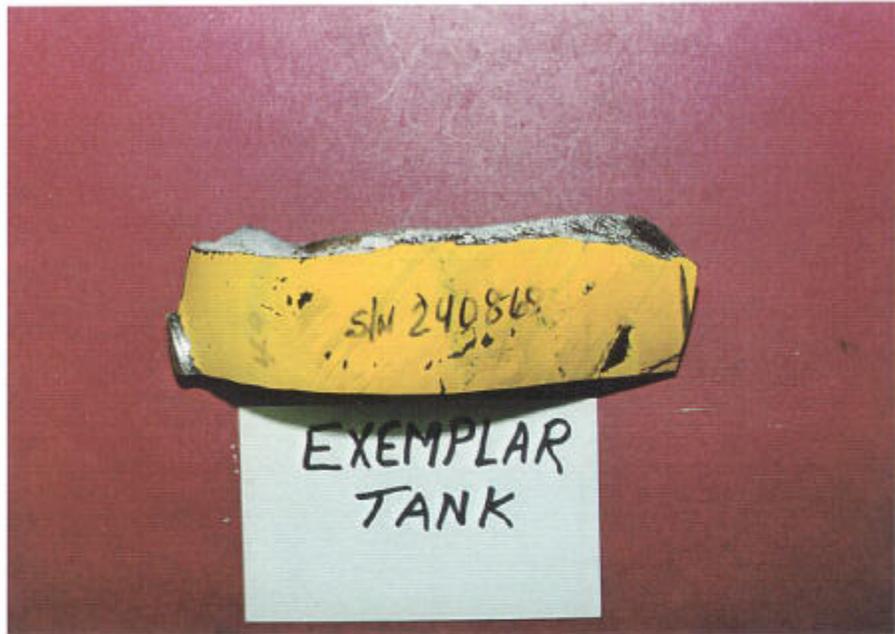
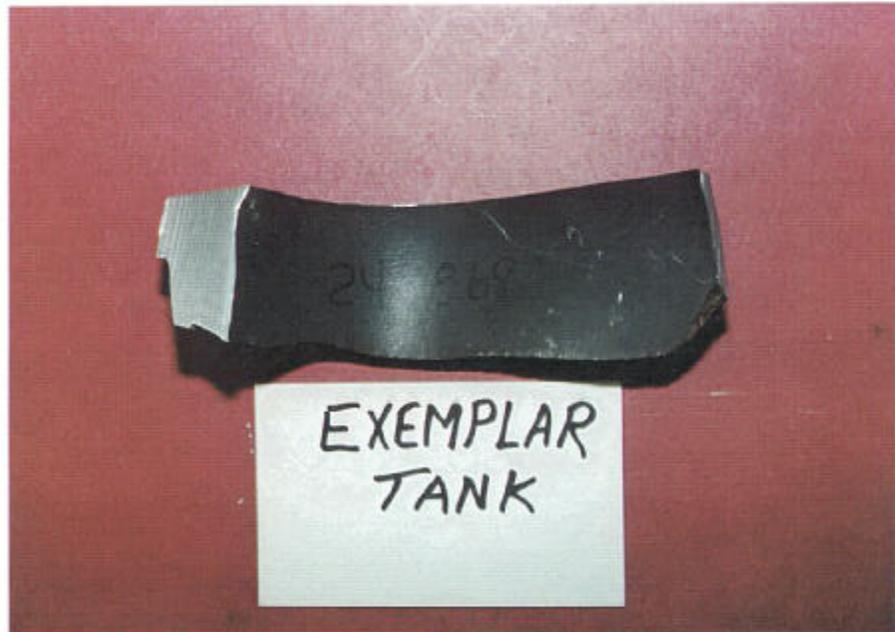
Figure 19.

Fracture specimen from an exemplar cylinder (S/N 240868) from Lot Code X59 that was over-pressurized in excess to the design burst pressure.

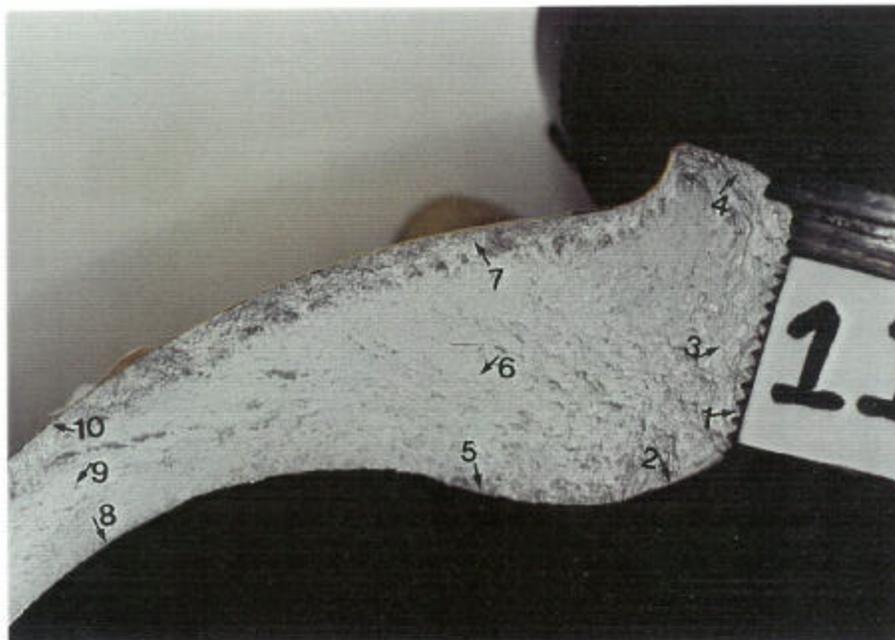
Figure 20. A macro view of the fracture surface #1 which was examined to characterize the fracture features. Areas indicated by arrowed numbers were examined at higher magnifications under the SEM.

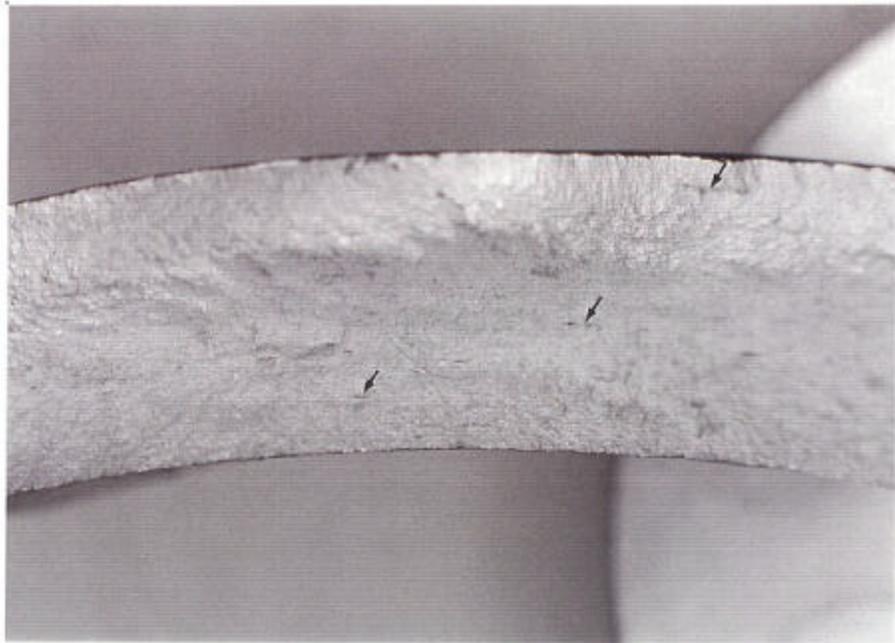
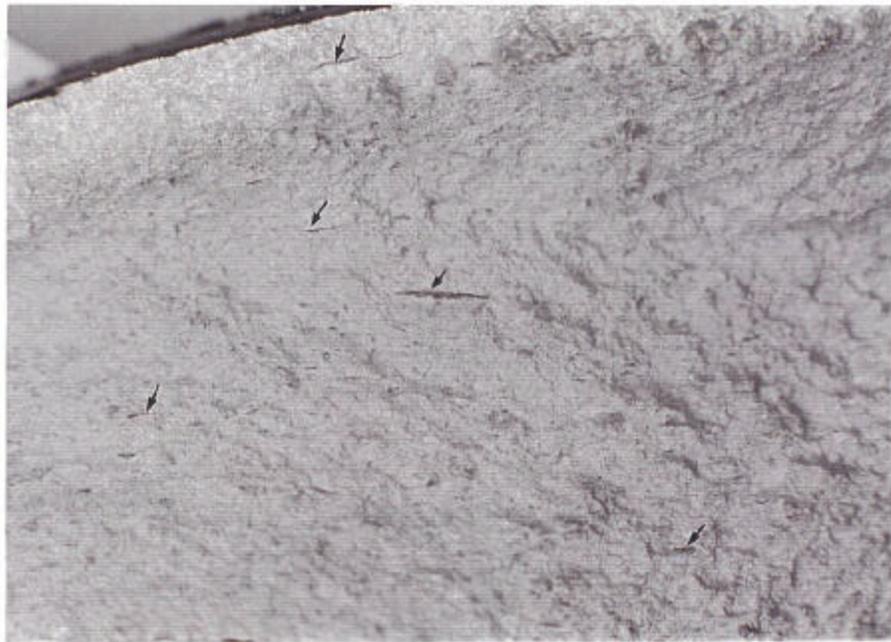
Figure 21. Enlarged photographs of the fracture surface show a large population of dark streaks.
