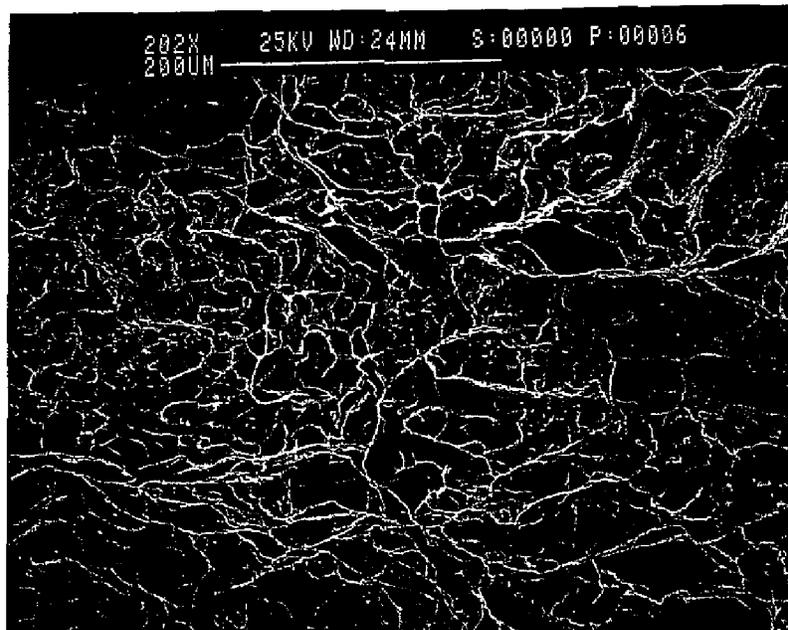
Figure 28. Fractograph from location #6 shows failure due to dimpled (overload) fracture; X202.

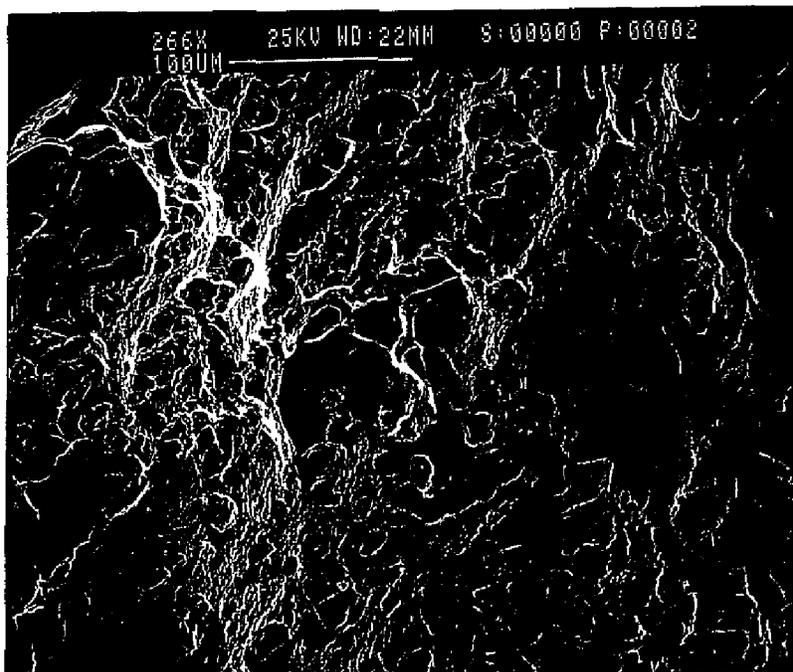
Figure 29. Fractograph from location #7 showing similar features as in Figure 28; X266.

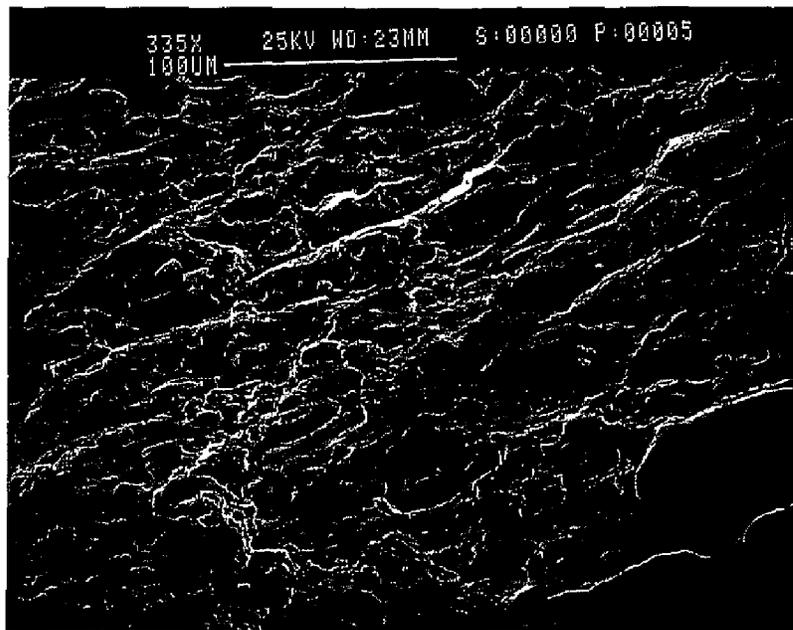
Figure 30. Fractograph from location #8 showing failure due to overload. Some indications of grain boundary failure are evident; X335.

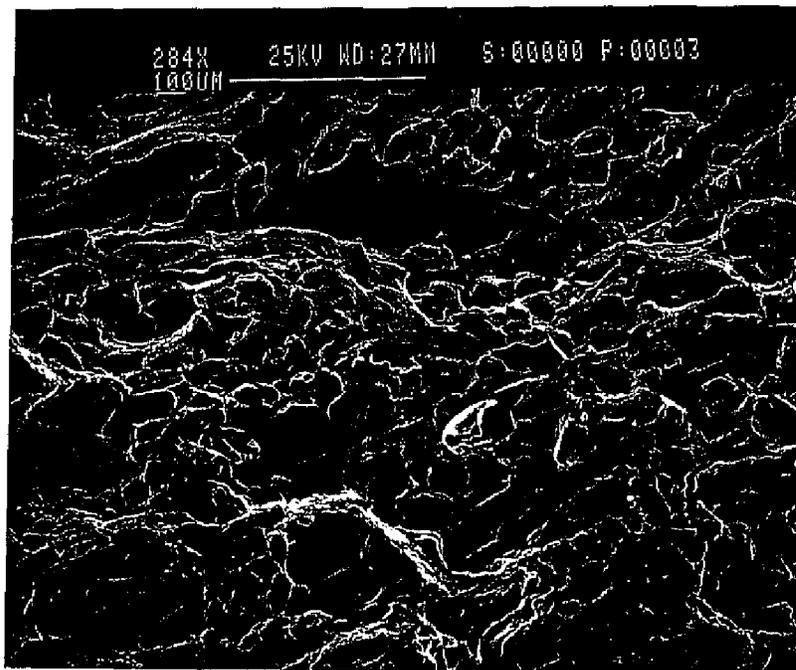
Figure 31. Fractograph from location #9 exhibits similar features as in Figure 30 showing a mixed mode of failure; X284.

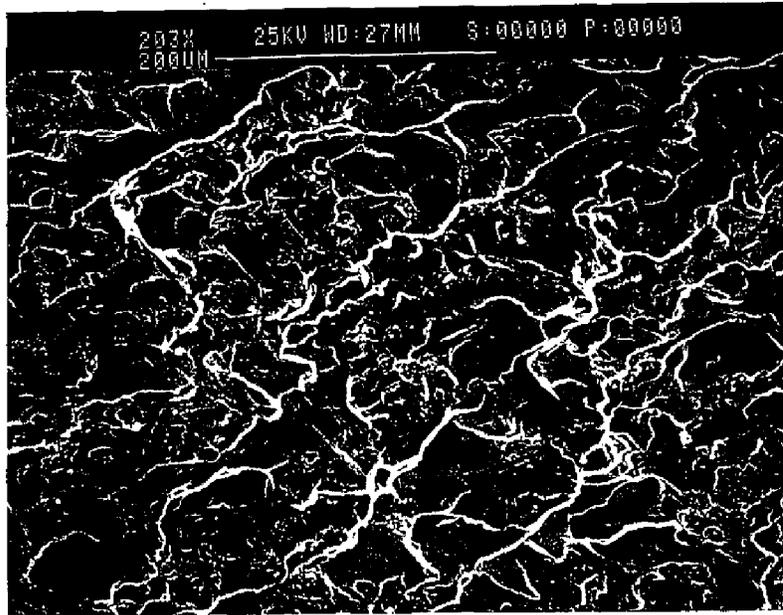
Figure 32.

Fractograph from location #10 shows failure due shear overload; X203.

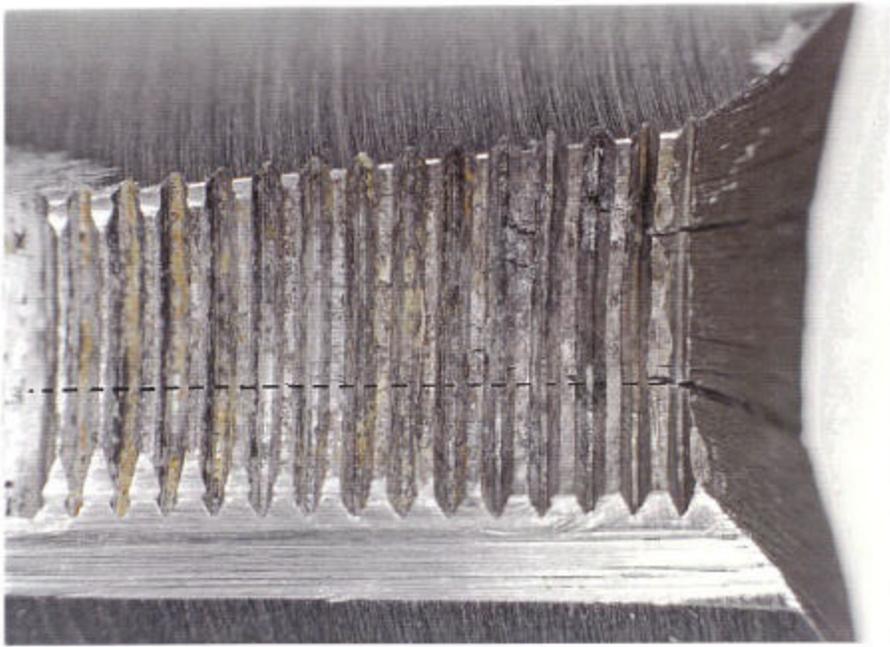
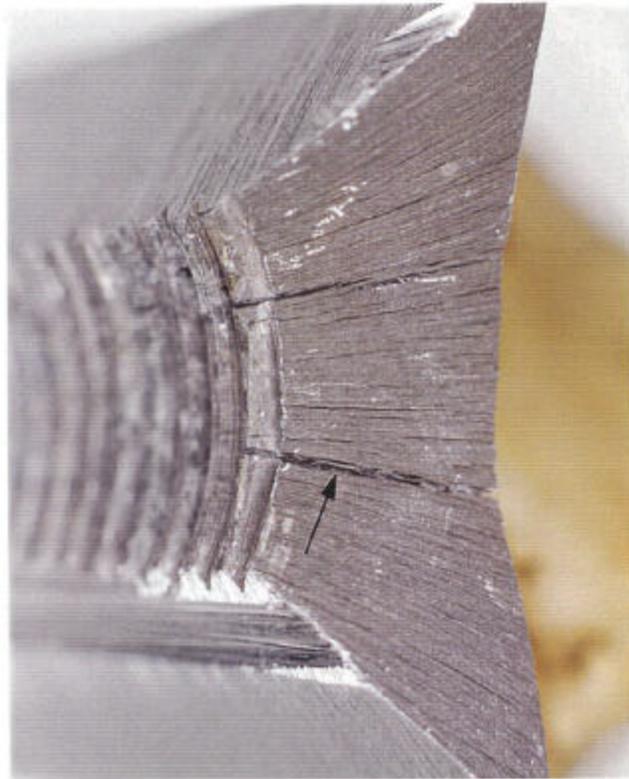
Figure 33.

Photographs of an area from the neck region showing the threaded zone (a) and the adjacent internal surface (b). Note the crack-like features in both photos. The crack indicated by arrow was opened for detailed examination.

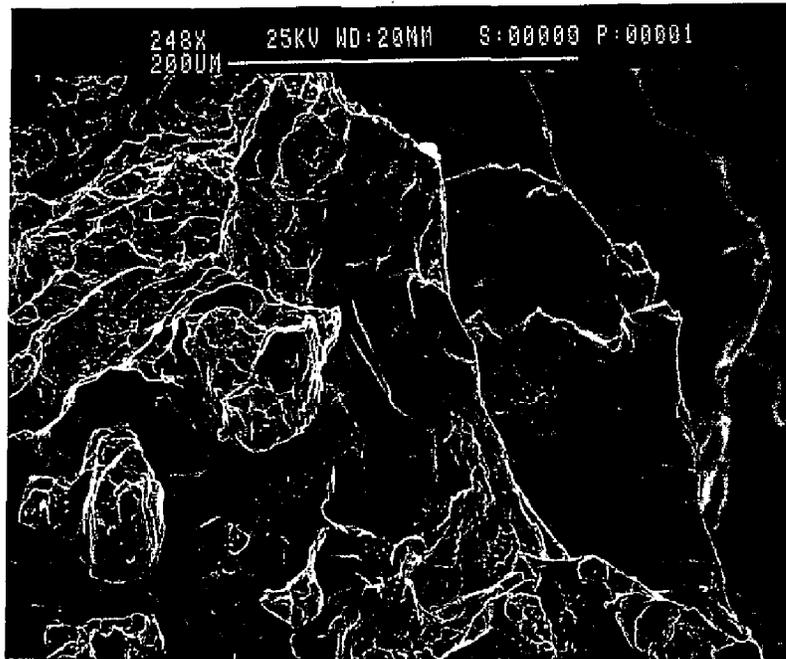
Figure 35. Fractograph, from location #1 in Figure 34, exhibits featureless facets as indicated in Figures 24-27. It also shows some area having dimpled rupture; X248.

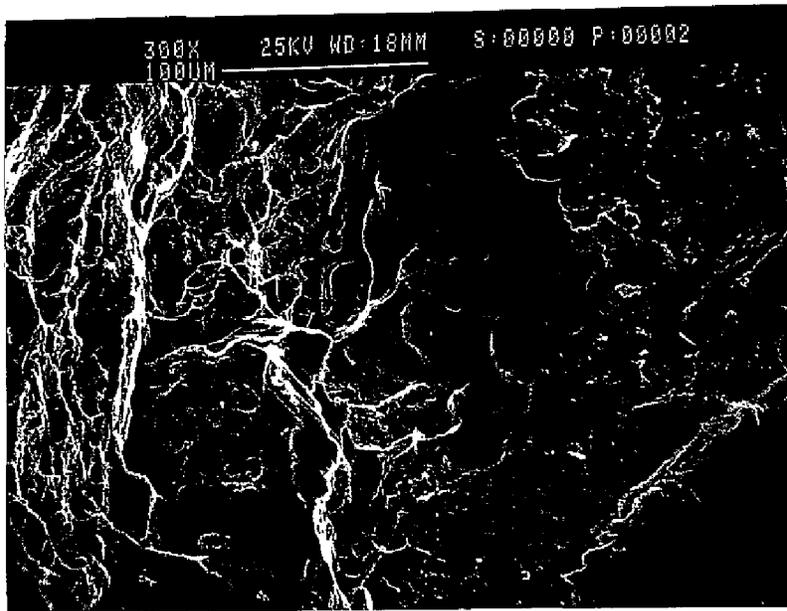
Figure 36. It shows similar features as in Figure 35; X248.

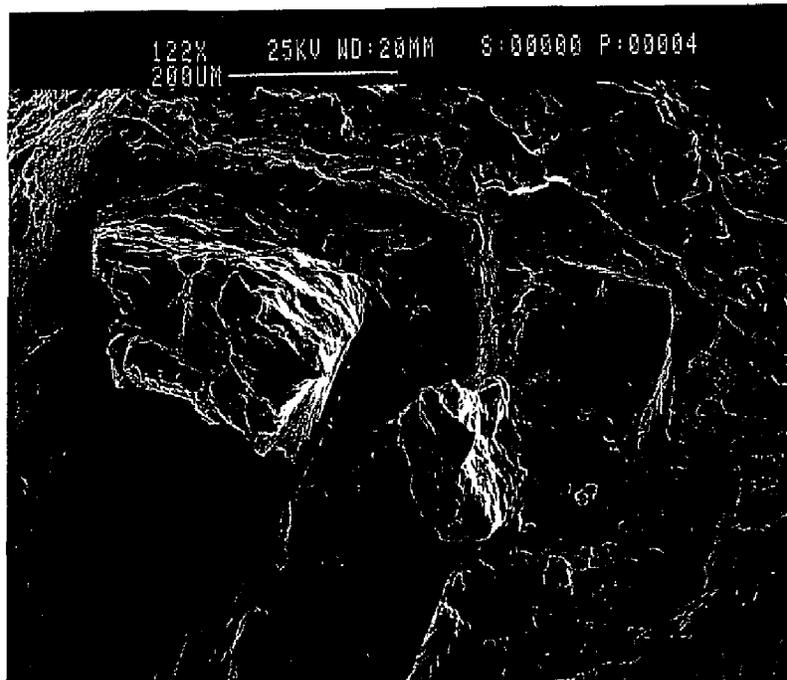
Figure 37. Fractograph exhibits featureless facets and some dimpled rupture. The particle-like object (arrow) appears to be a chunk of dross. X122.

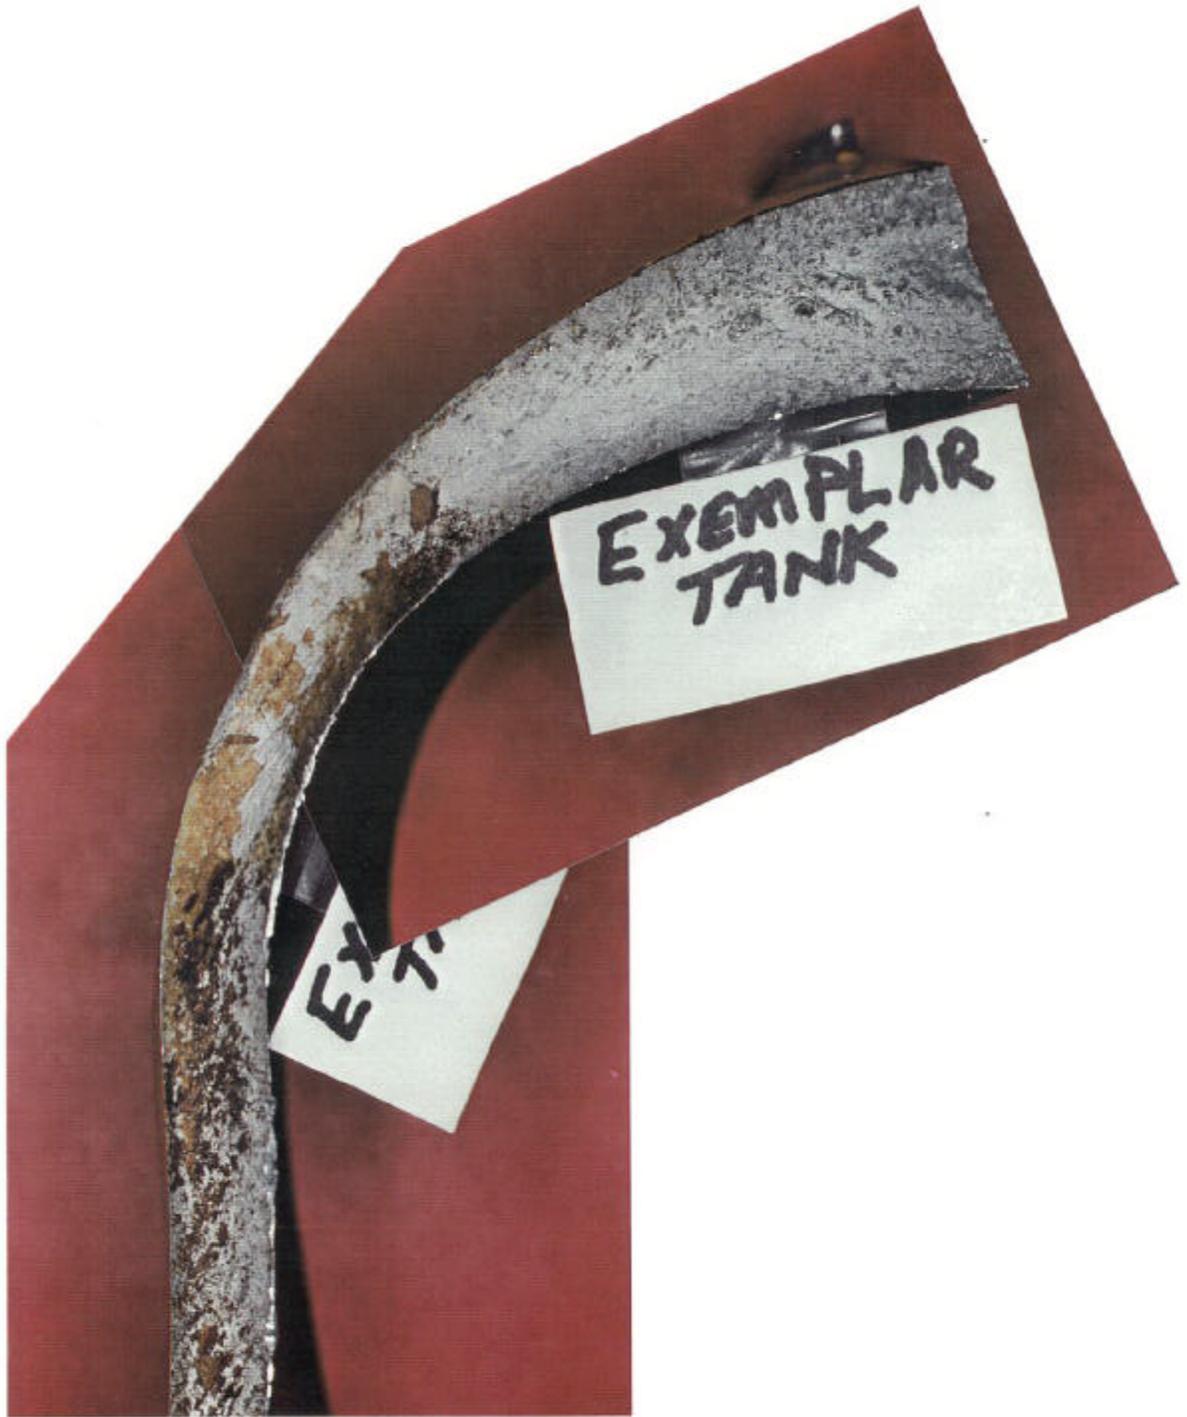
Figure 38. As-received view of the exemplar fracture surface.

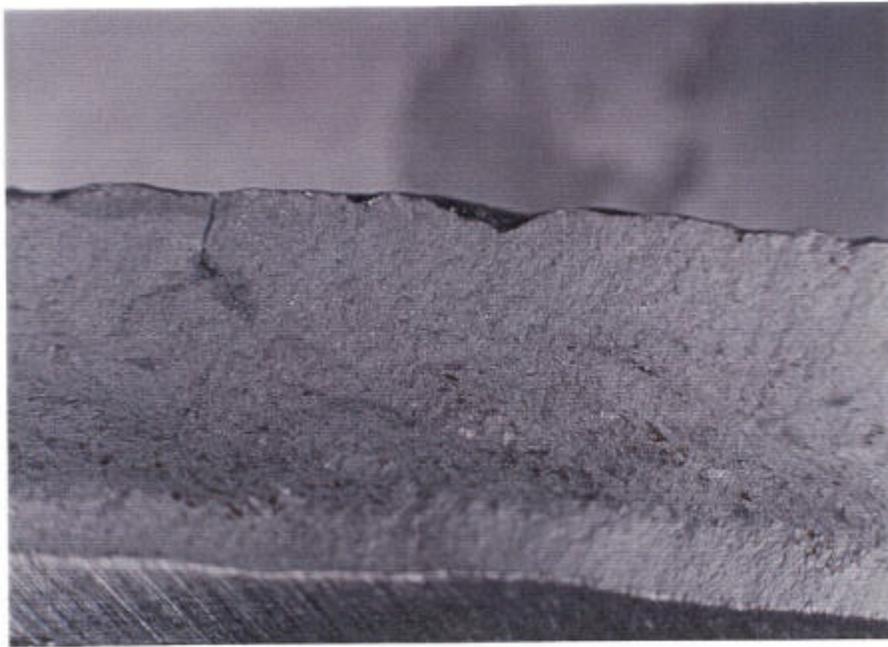
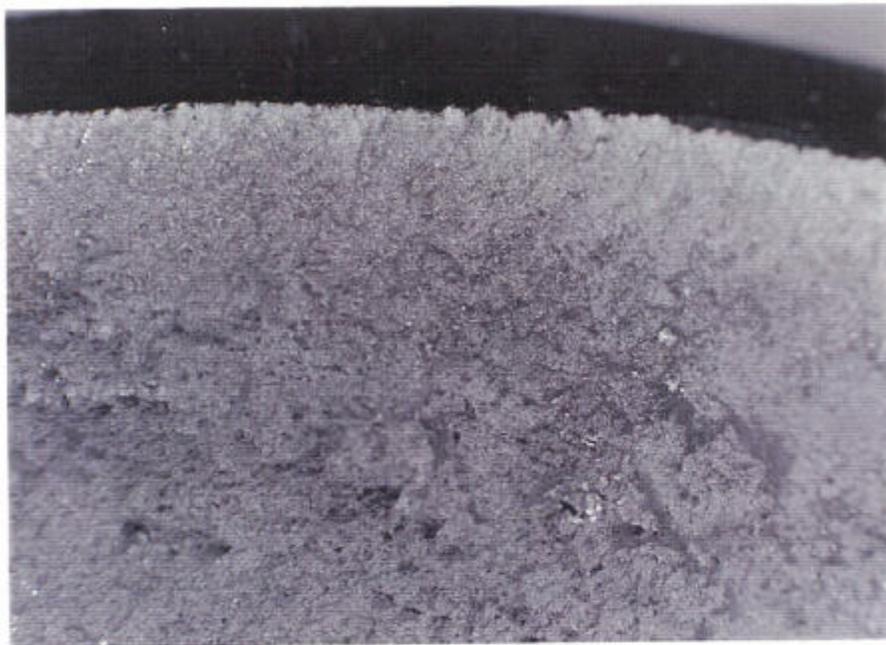
Figure 39. Enlarged views of the fracture surface does not show the presence of dross and voids. Compare this Figure to Figure 21.

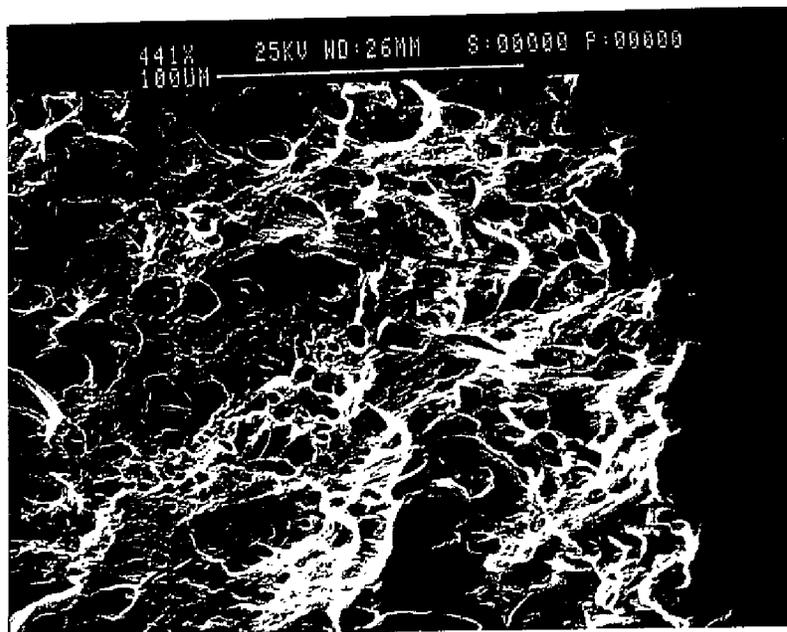
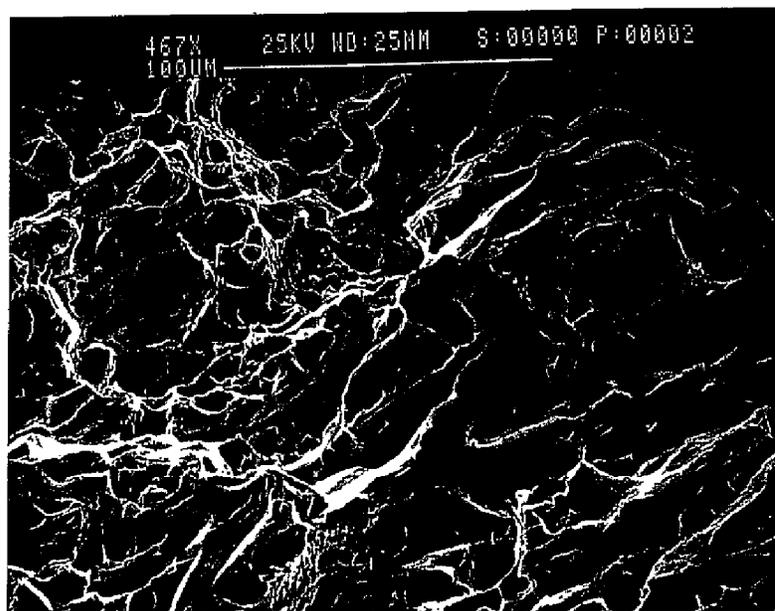
Figure 40.

SEM fractograph shows initiation of the failure occurring by overload tearing near the neck on the inside surface (a); a mixed mode failure consisting of dimpled rupture and intergranular fracture was observed in the region remote from the initiation zone (b). Compare these micrographs to Figures 23 and 30.

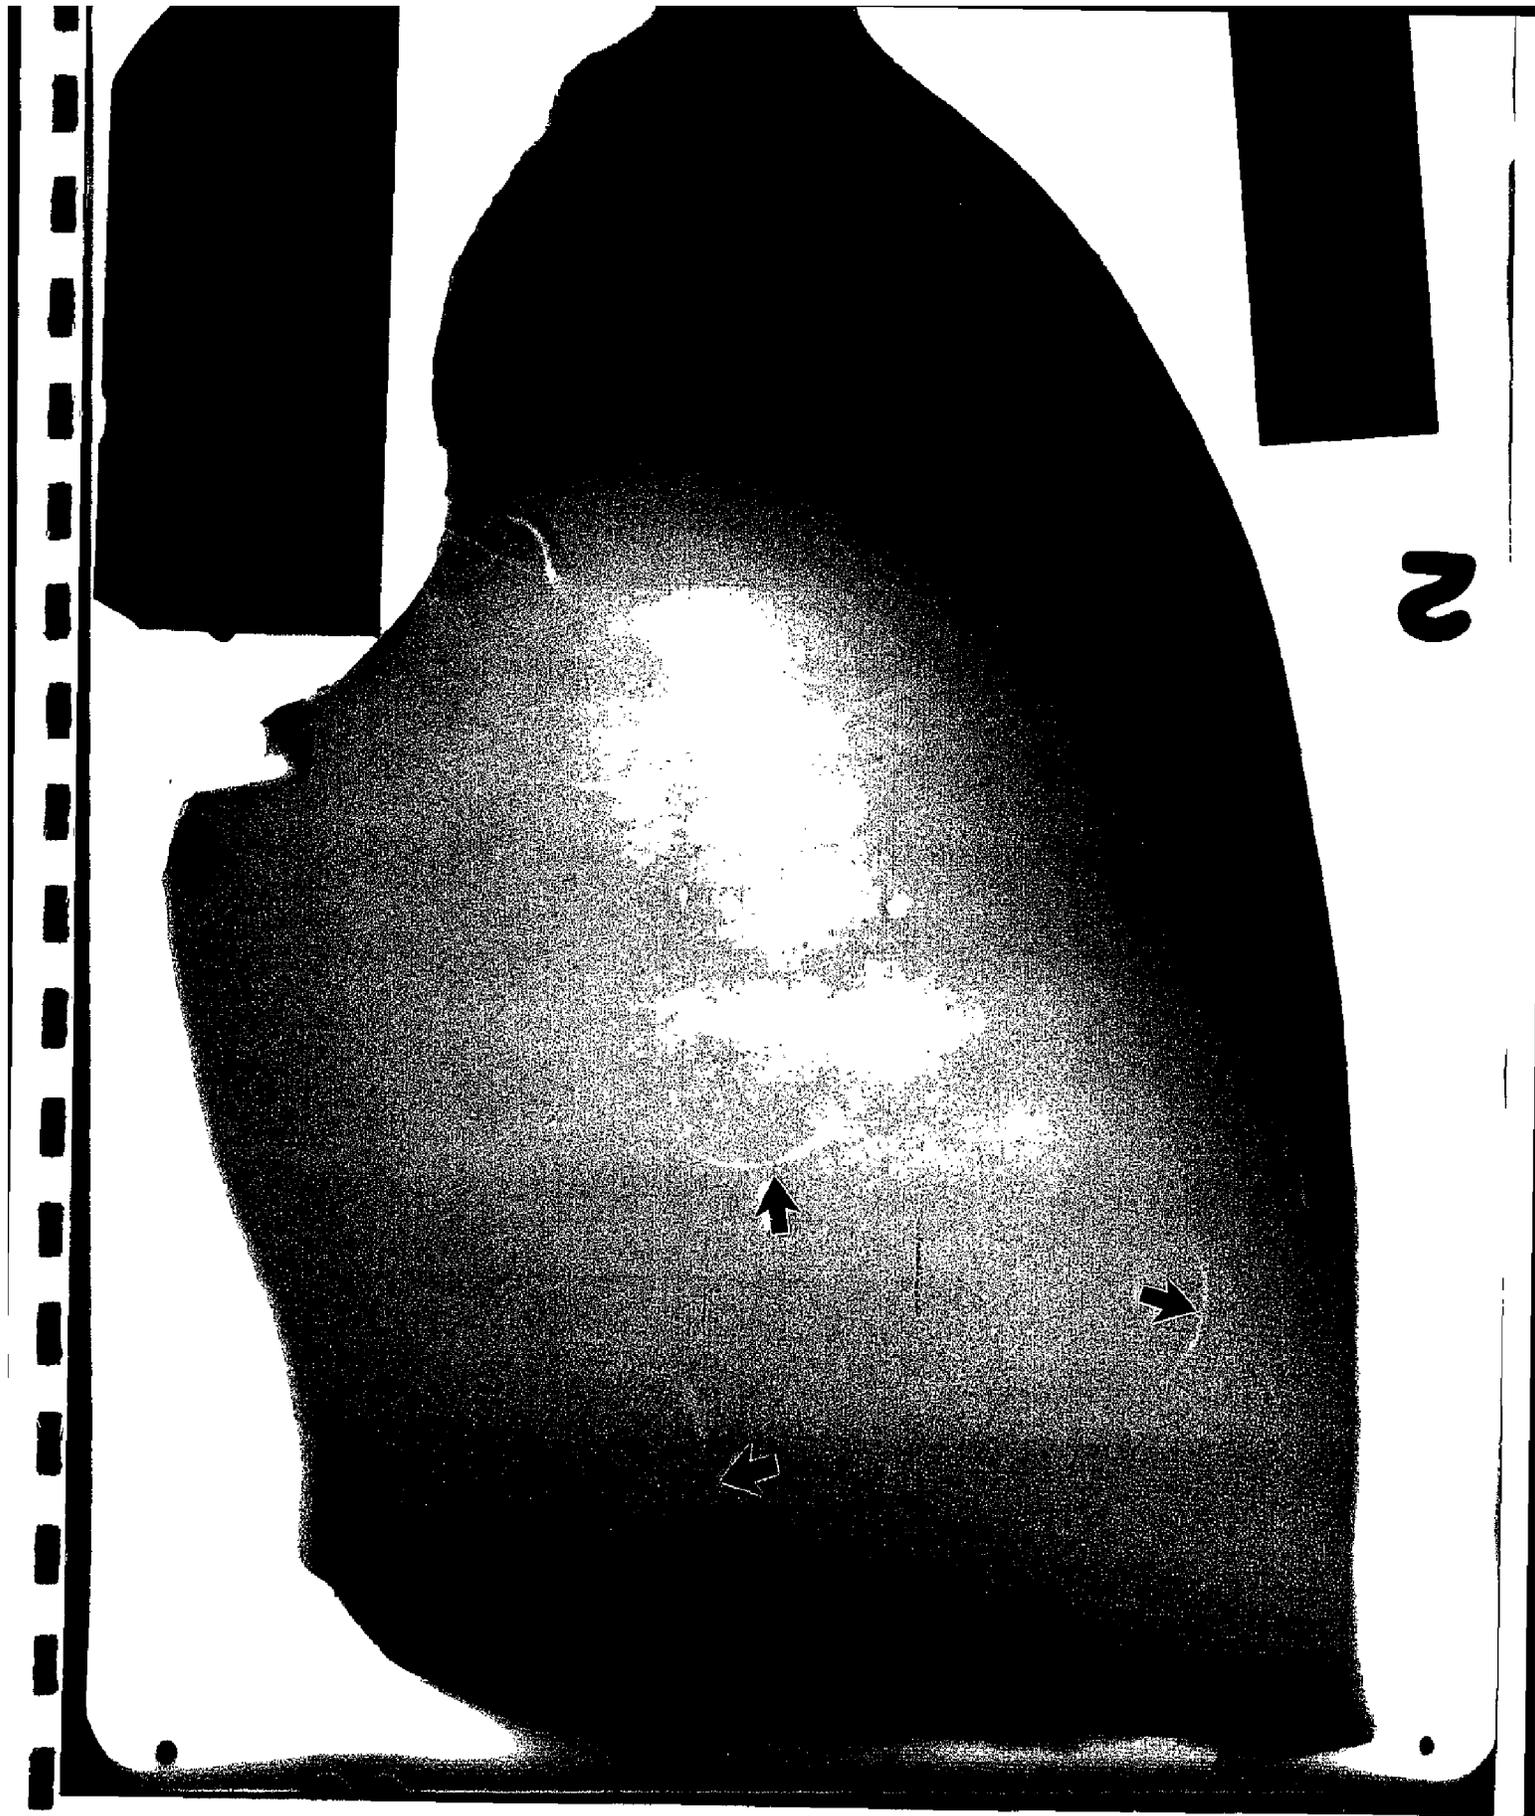
Figure 41. Positive print of an X-ray radiograph of fracture piece (4) showing several indications (arrows) not attributable to surface damage.
