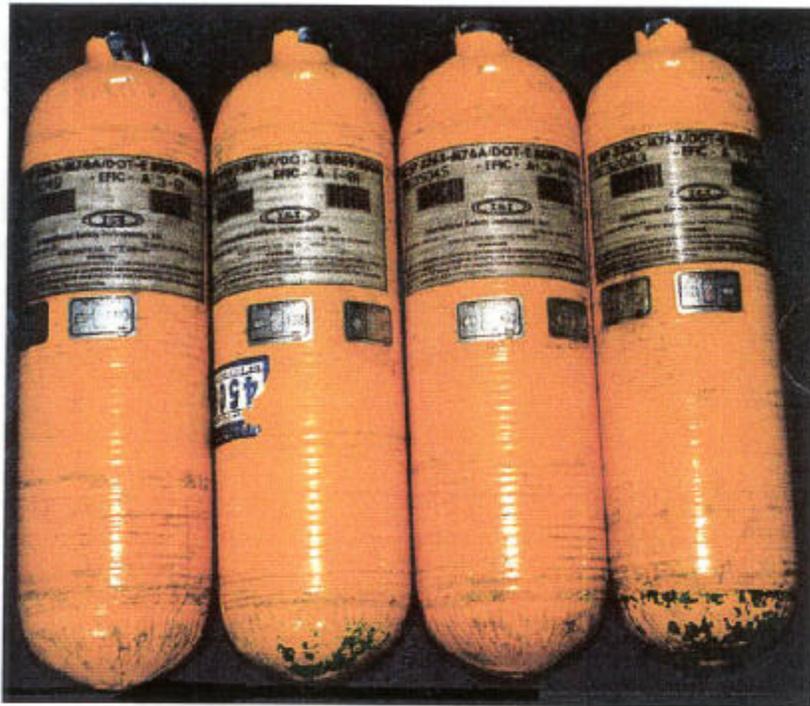
Figure 9. Exemplar Cylinders at Bayview Station (Label Side)

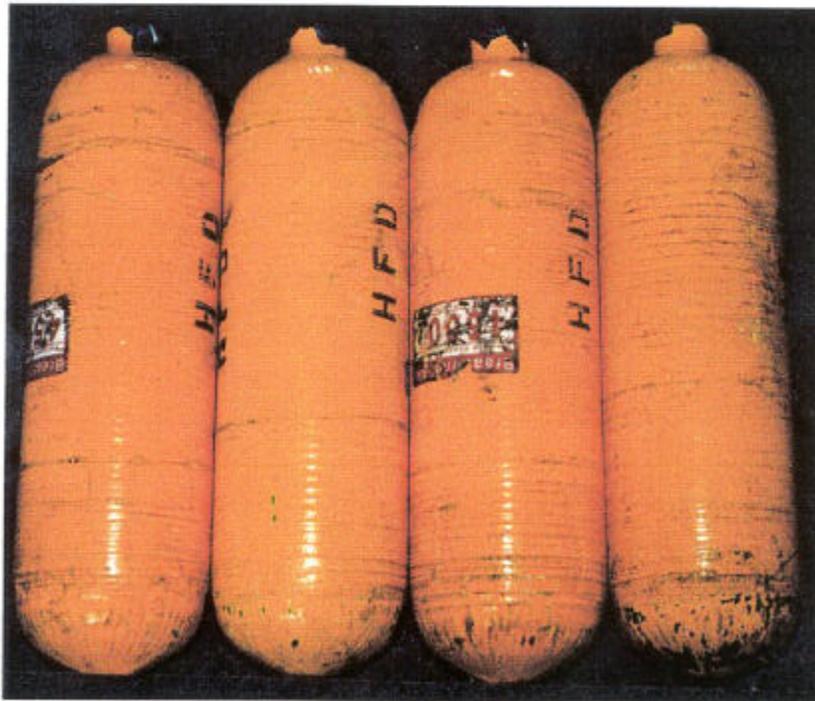
Figure 10. Exemplar Cylinders at Bayview Station (Side Opposite Label)

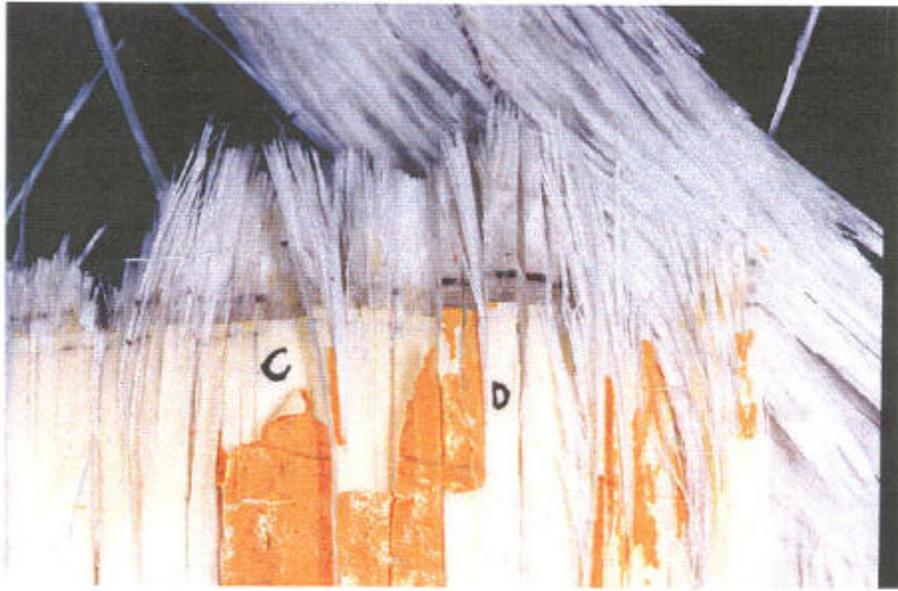
Figure 11. Appearance of Failed Circumferential Fibers at Initial Failure Site  
(Letters refer to Test Specimen Locations)

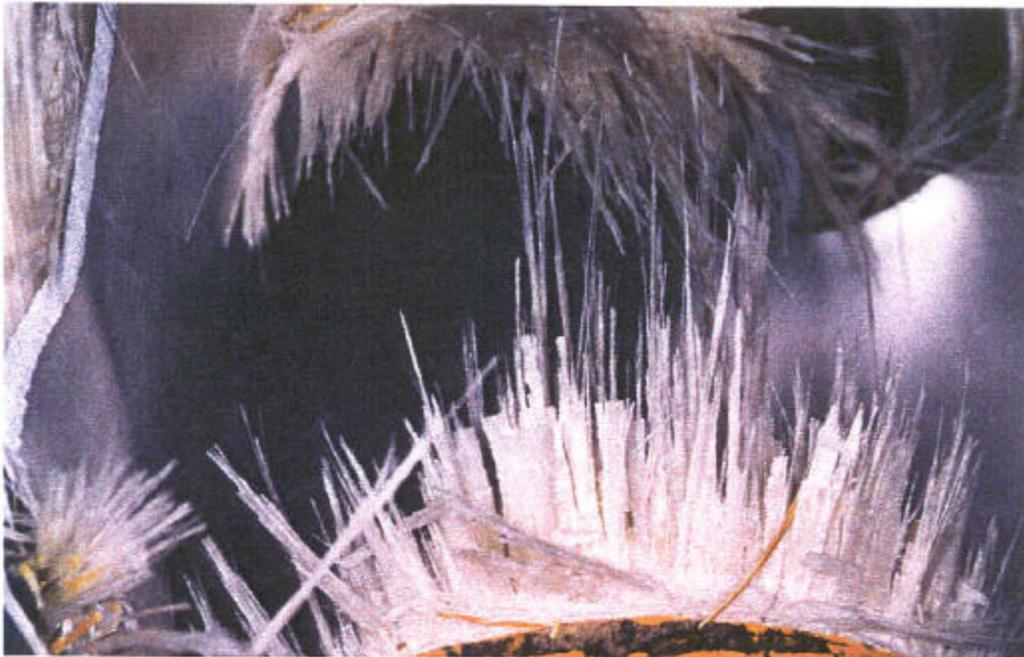
Figure 12. Appearance of Failed Longitudinal Fibers

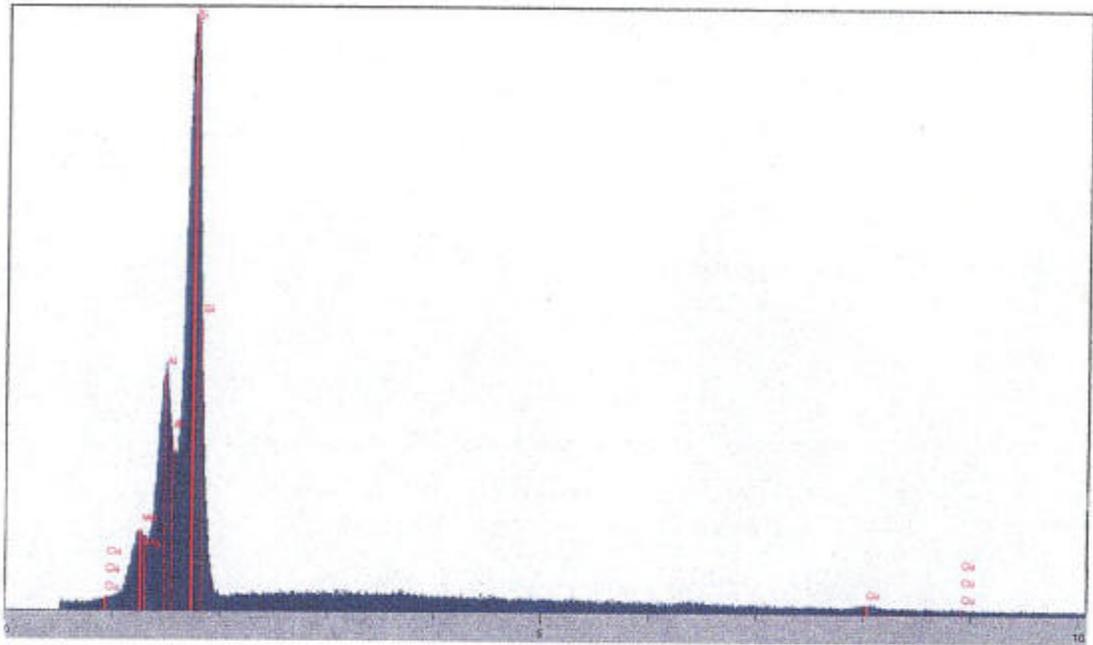
Figure 13. EDS Spectrum of Fiberglass Sample

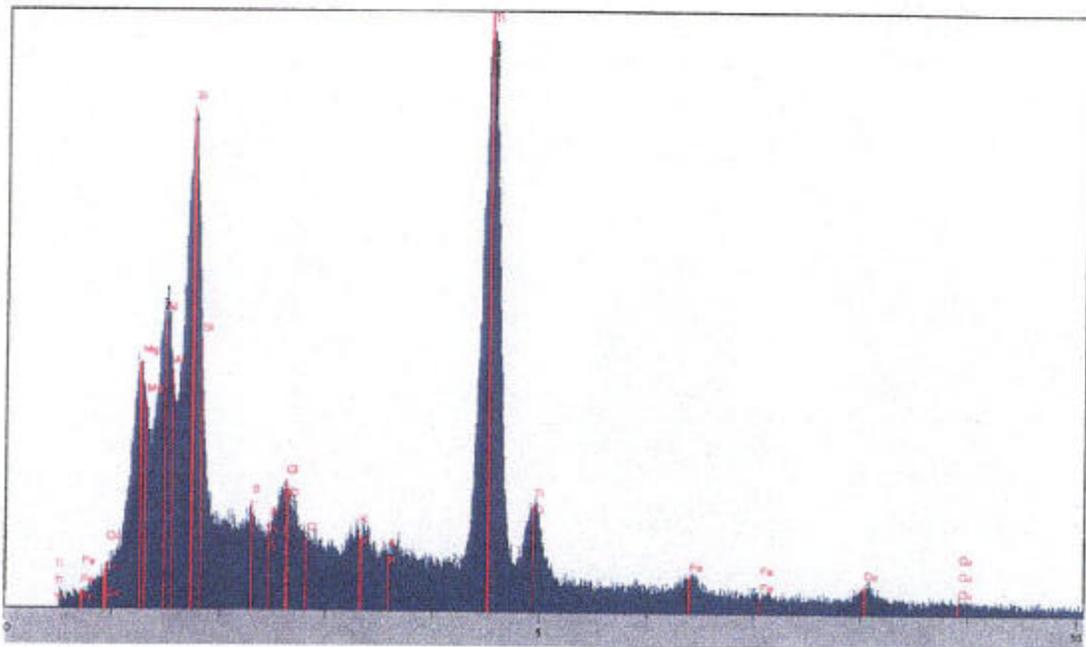
Figure 14. EDS Spectrum of Painted Fiberglass Sample

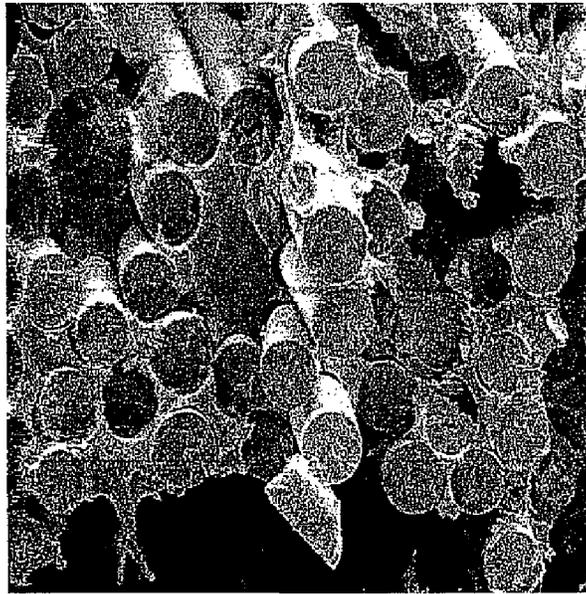
Figure 19. Scanning Electron Micrograph of Circumferential Fibers at Fracture Surface in Sample F after Exposure to Alume™ - 1000x Magnification

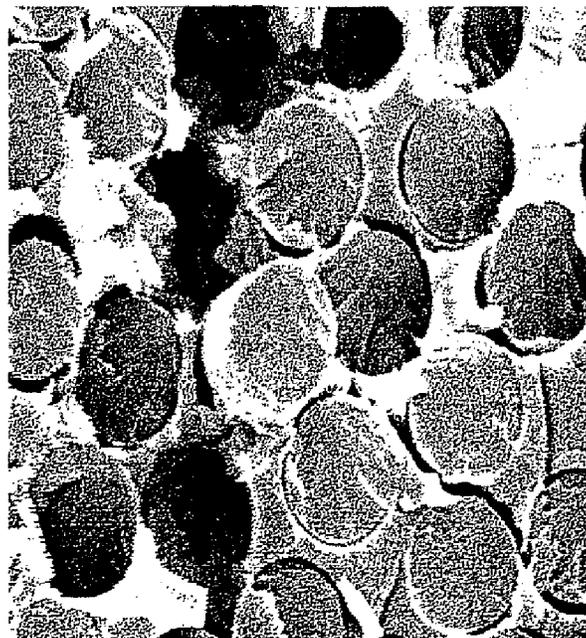
Figure 20. Scanning Electron Micrograph of Circumferential Fibers Fracture Surface in Sample F after Exposure to Alume™ - 2000x Magnification

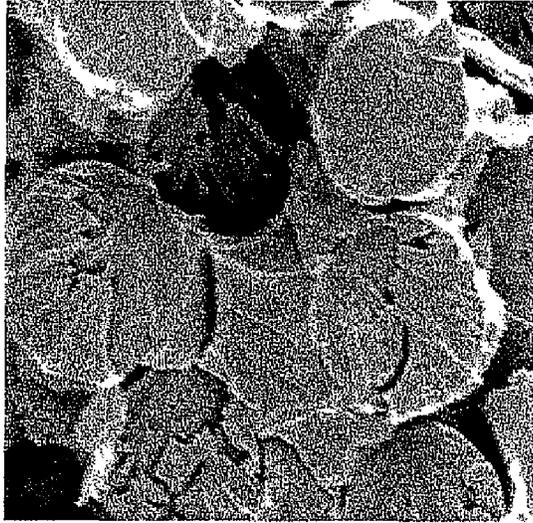
Figure 21. Scanning Electron Micrograph of Circumferential Fibers Fracture Surface in Sample F after Exposure to Alume™ - 3500x Magnification

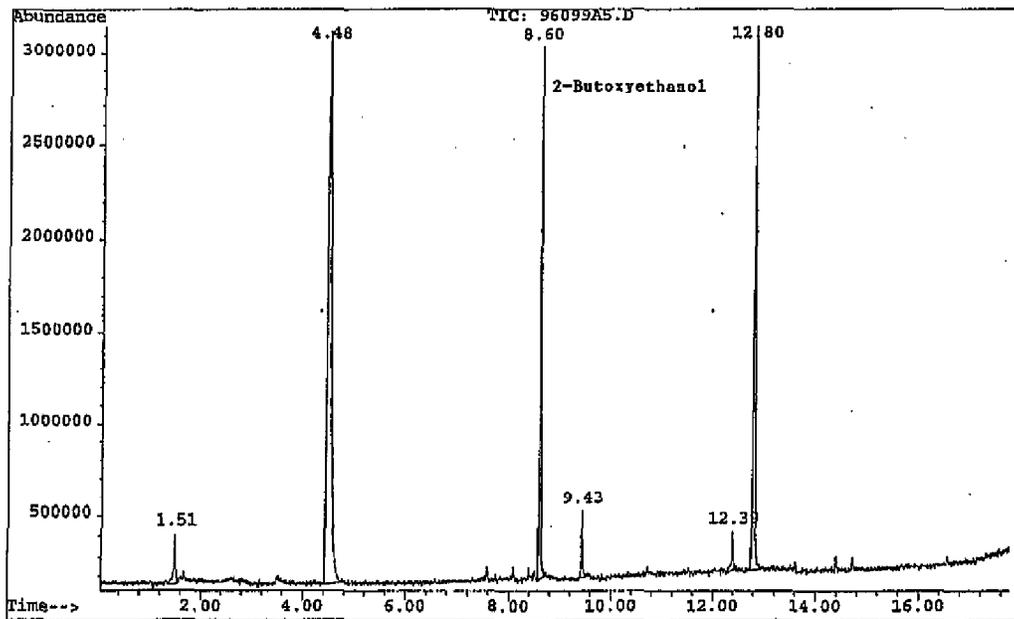
Figure 22. TD-GC-MS Chromatogram for Sample G
