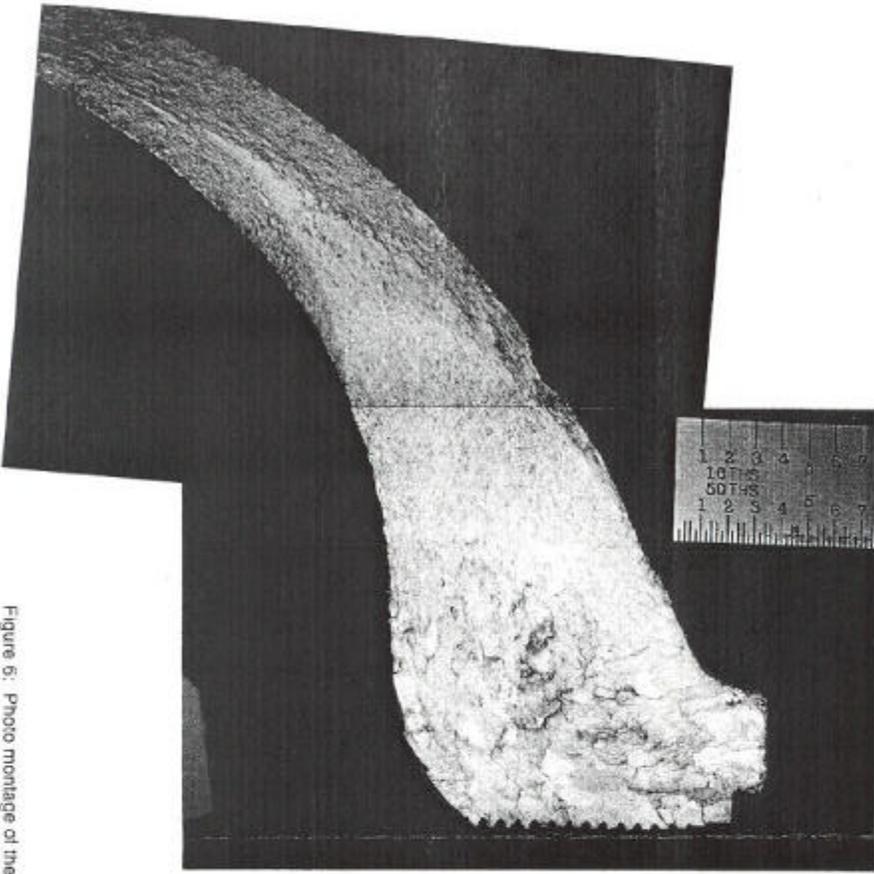
Figure 6: Photo montage of the fracture surface at the neck from fragment 2A, photo id DC18128-R3E1.2,3,4
Regions 1 through 5 represent areas for further study.

Figure 13: Fractography of section 2A-2. Regions 1 through 5 are delineated in figure 6.

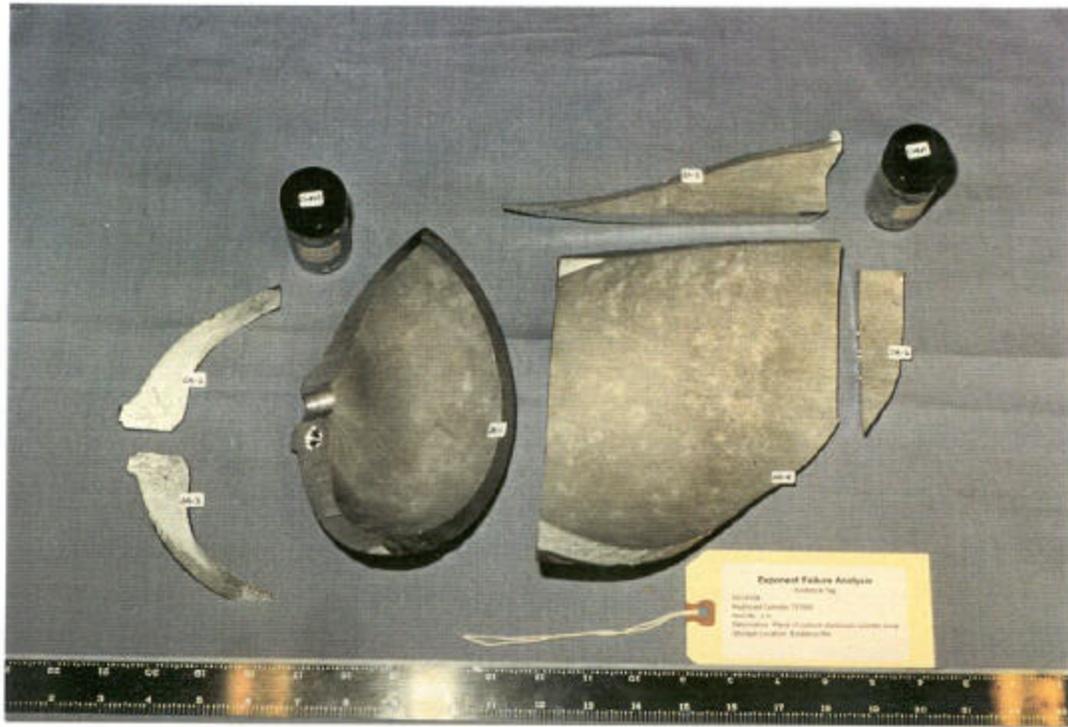
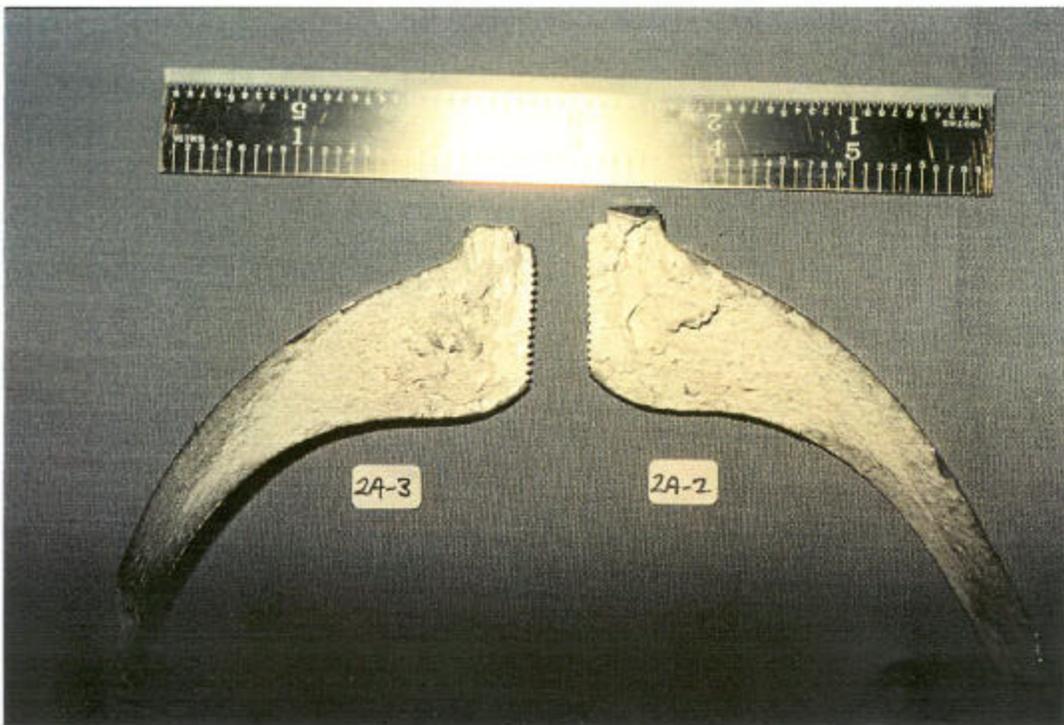
Figure 7: Sectioning of fragment 2A

(a) Overall view. Photo ID: DC18128-R3E2

(b) Close up of neck region. Photo ID: DC18128-R3E11

Note: the fracture surface portions that were removed and the drilling taken to determine chemical composition.

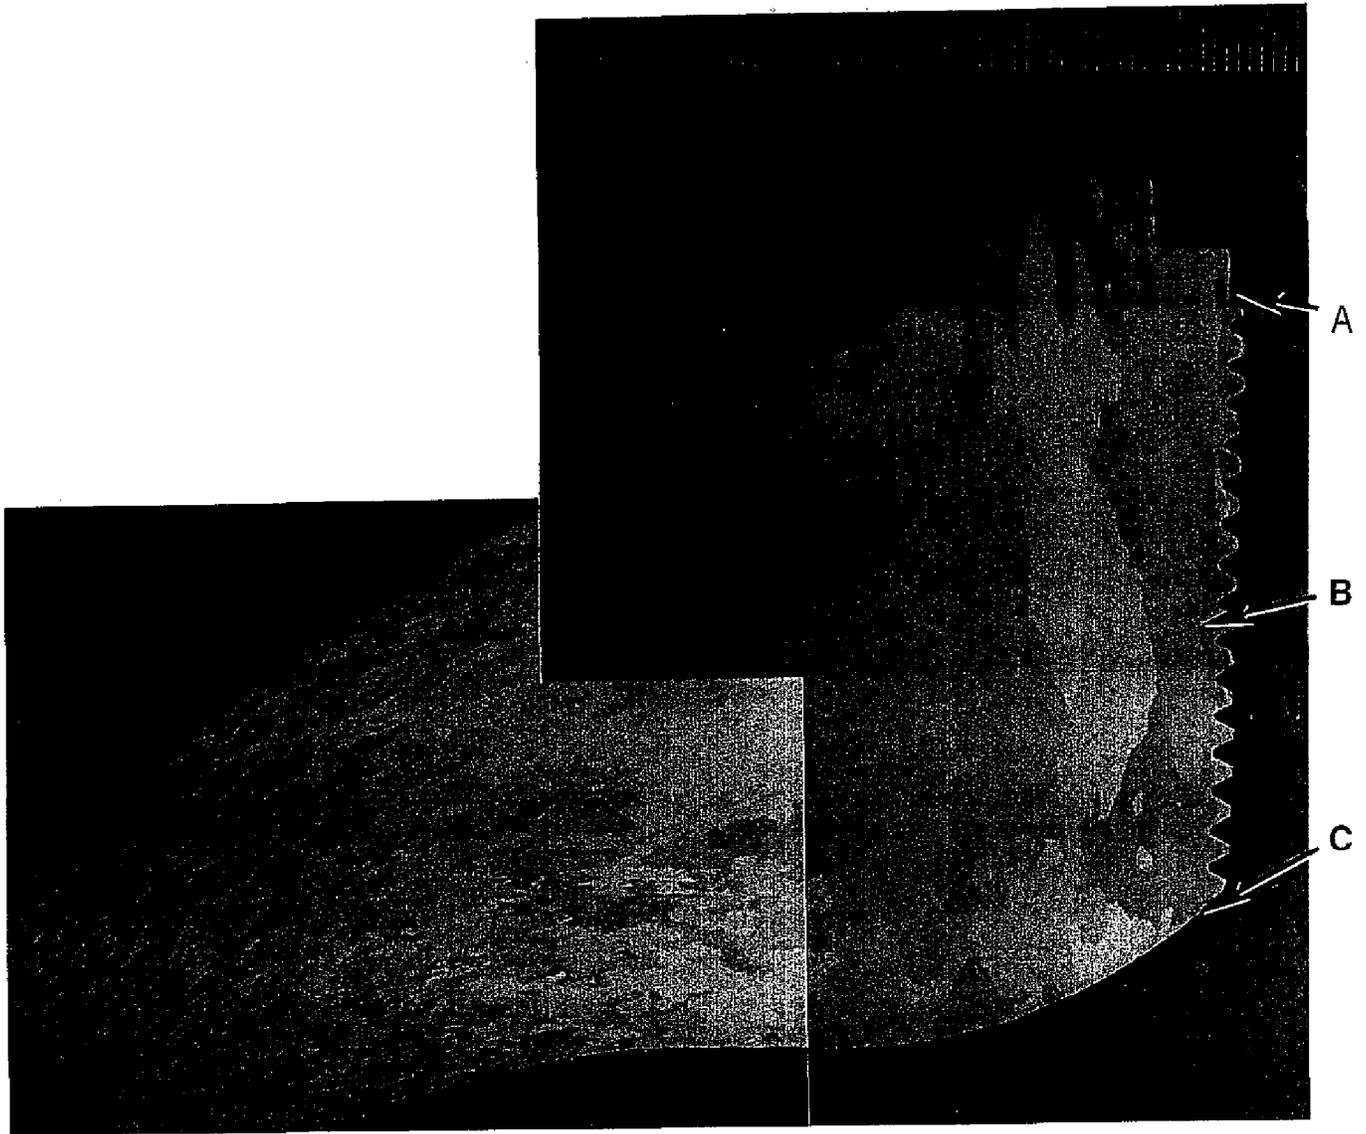
Figure 8: Section 2A-1A showing the microstructure in the neck region. Note the scale is in 0.05 inch increments. HF-H₂SO₄-H₂O etch. Photo ID: DC18128-PAL-1,2,3 8/5/98. Regions A, B, and C are investigated further in figures 9, 10, and 11.

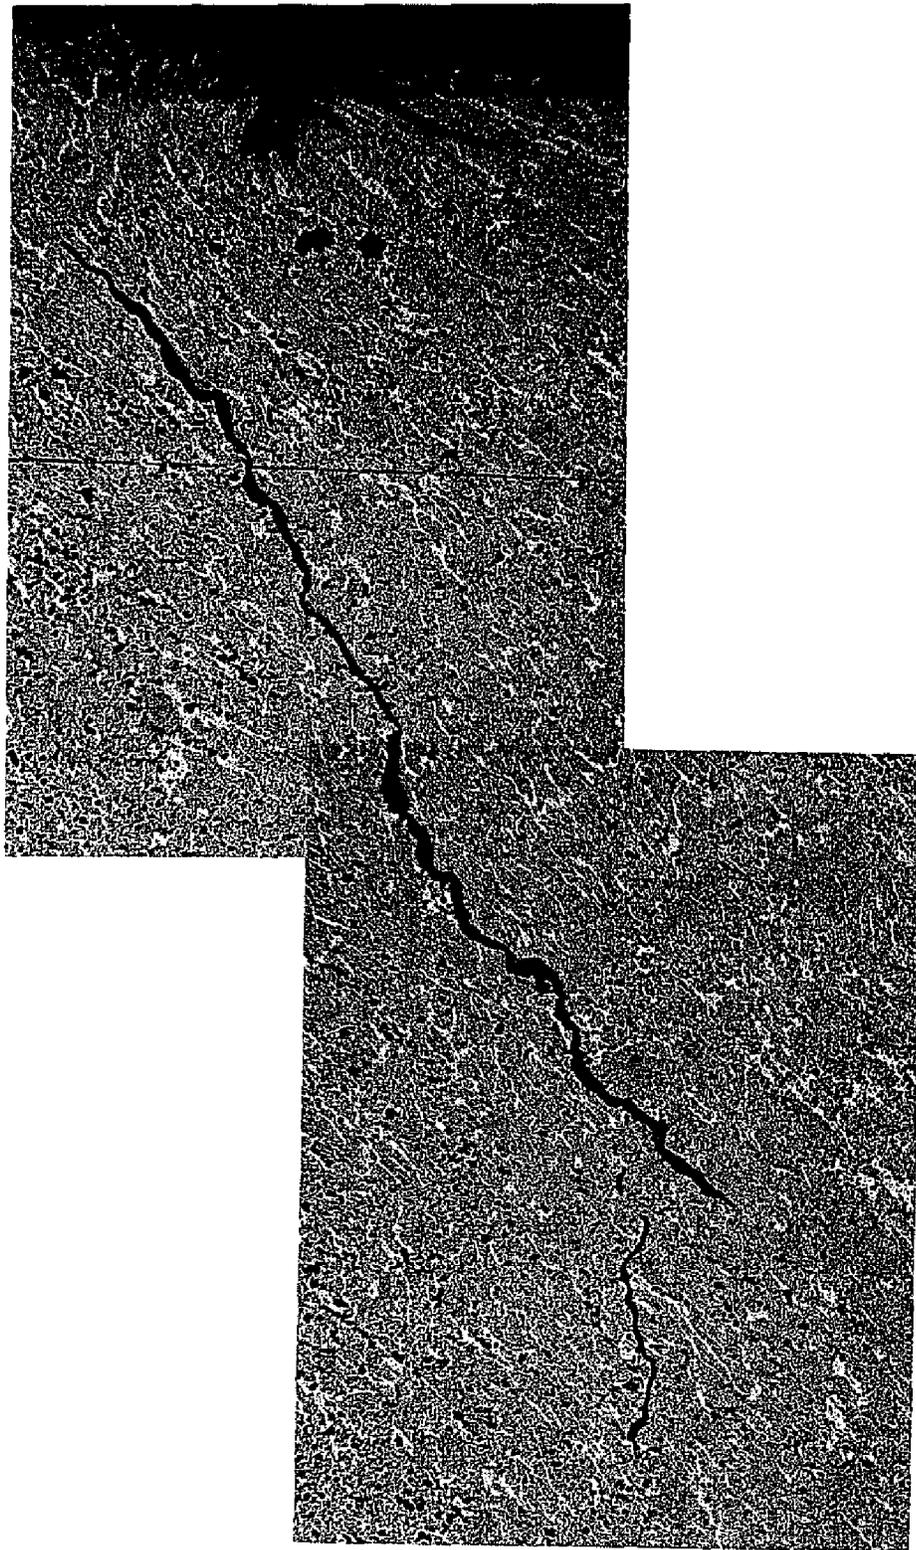
Figure 11: Section 2A-1A region C, photo montage. Photo ID: DC18128-Pal6, 7 8/7/98. Note the discontinuities in the crack.

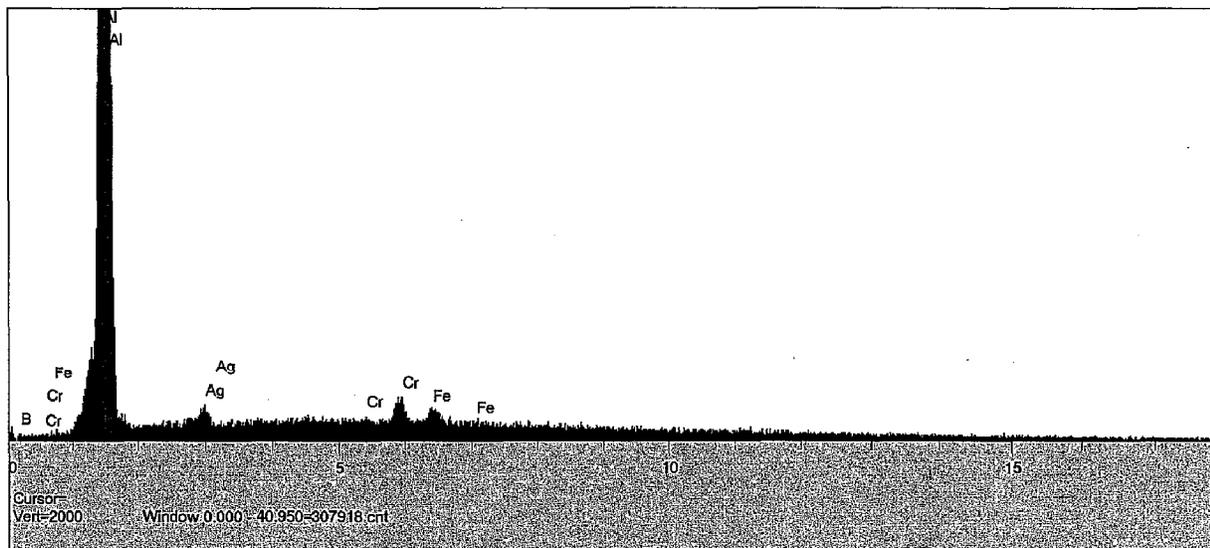
Figure 12: Energy Dispersive Spectrum taken near the corrosion product in the thread region.
Photo ID: DC18128 10/6/98 2:19:43 PM

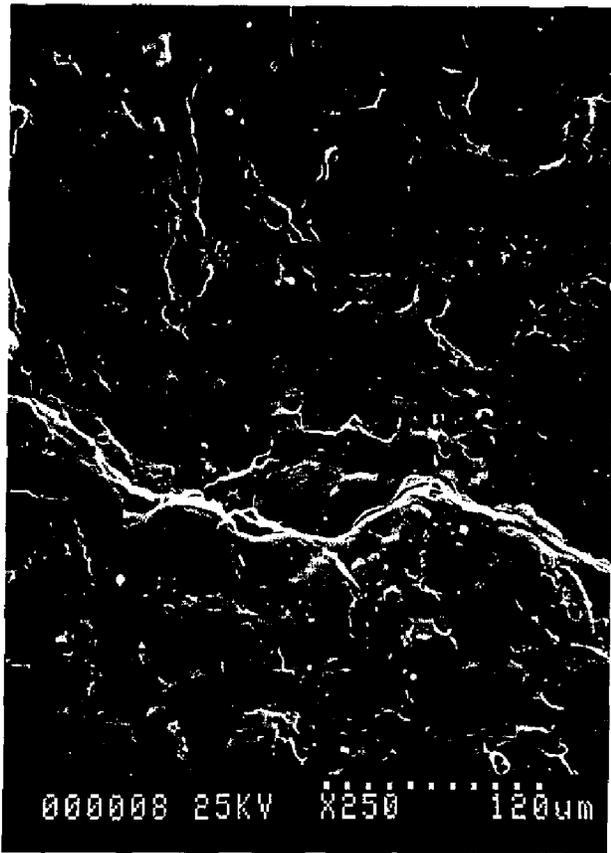
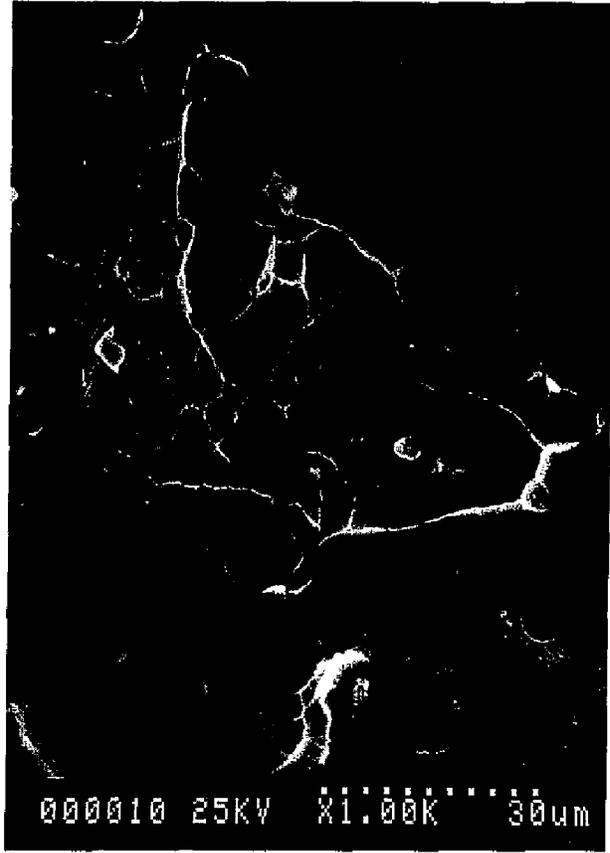
Region 2

| (c) Region 2. 250X. Photo ID: DC18128-PAL8 6/25/98 | (k) Region 6. 1000X. Photo ID: DC18128-PAL21 6/25/98 |
| (d) Region 2. 1000X. Photo ID: DC18128-PAL10 6/25/98 | |

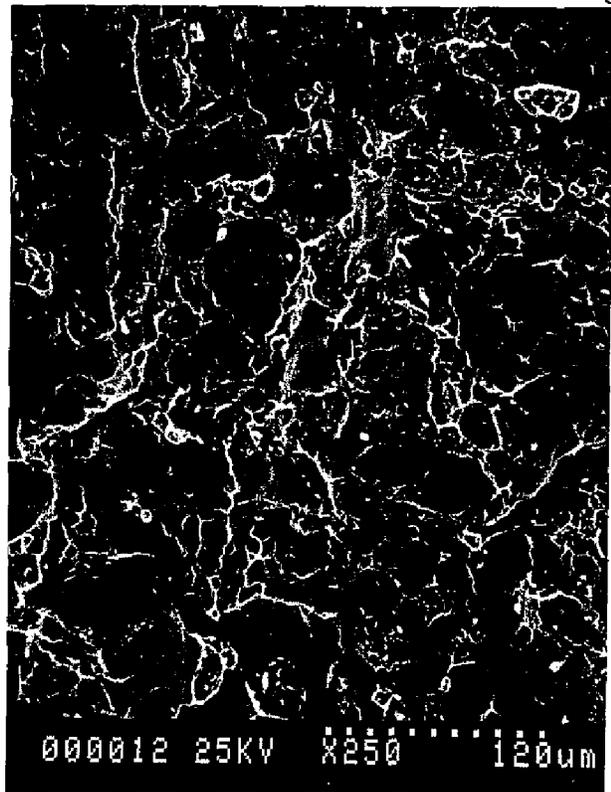
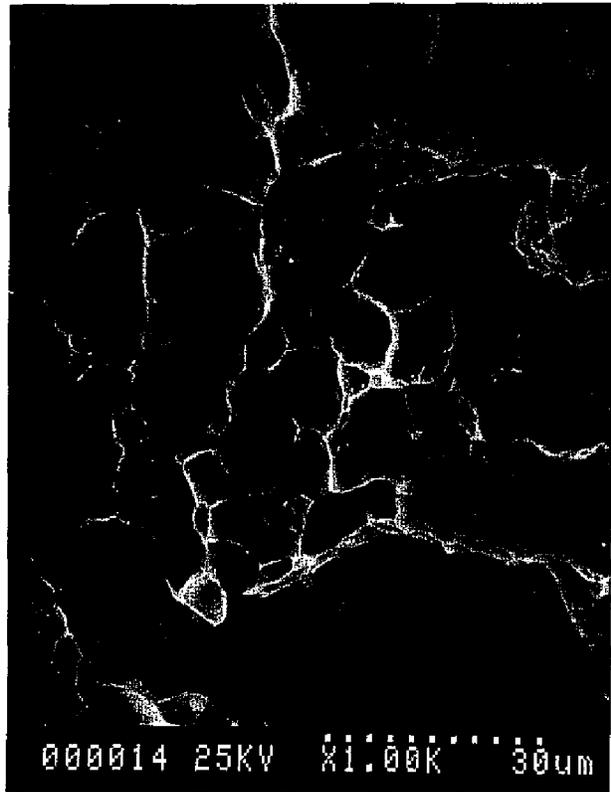
Region 3

| (e) Region 3. 250X. Photo ID: DC18128-PAL12 6/25/98 | |
| (f) Region 3. 1000X. Photo ID: Dc18128-PAL14 6/25/98 | |

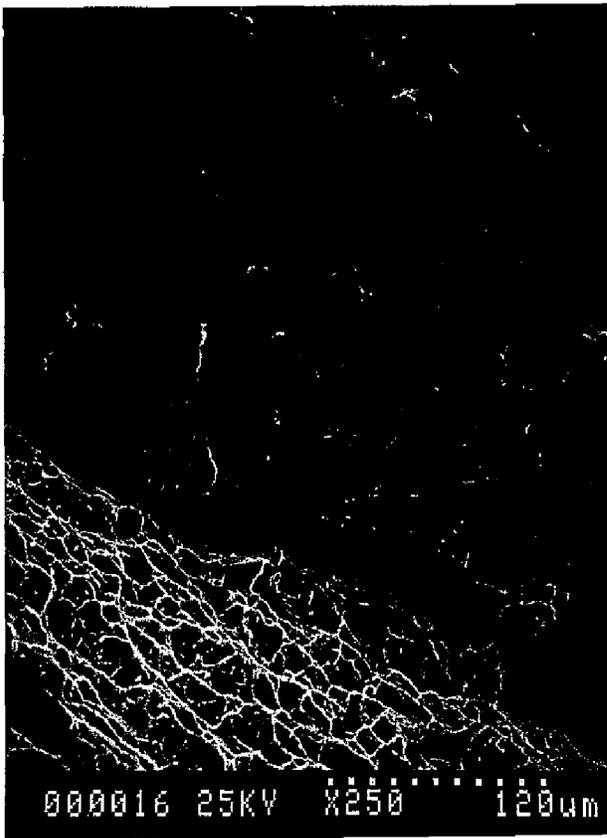
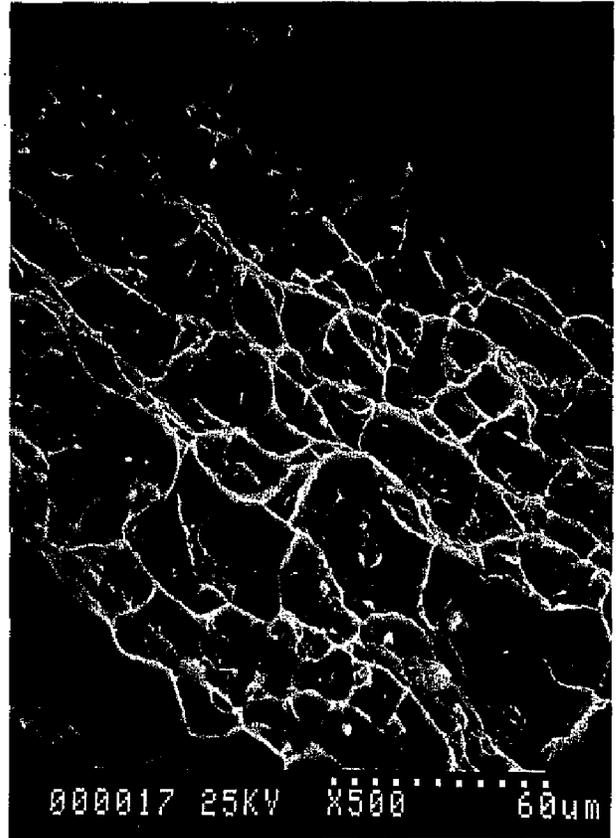
Region 4

| (a) Region 1. 250X. Photo ID: DC18128-PAL4 6/25/98 | (i) Region 4. 1000X. Photo ID: DC18128-PAL18 6/25/98 |
| (g) Region 4. 250X. Photo ID: DC18128-PAL16 6/25/98 | |
| (h) Region 4. 500X. Photo ID: DC18128-PAL-17 6/25/98 | |
