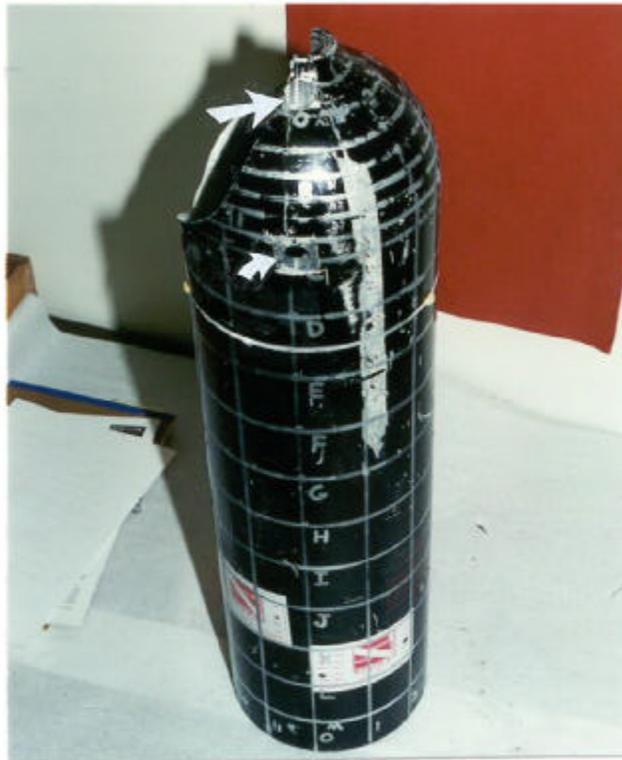
Figure 18A: Locations of chemical samples from near OC grid point (small arrow), and from near OA2 grid point (large arrow).

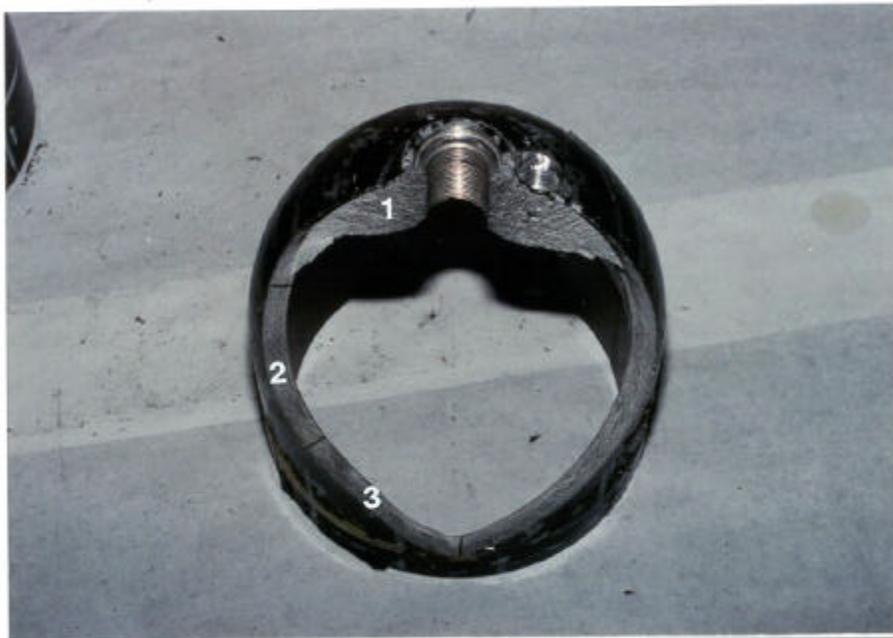
Figure 18B: View of the fractured dome part cut from the cylinder. It shows locations of fracture surface sections 1, 2 and 3, which were removed for examination.

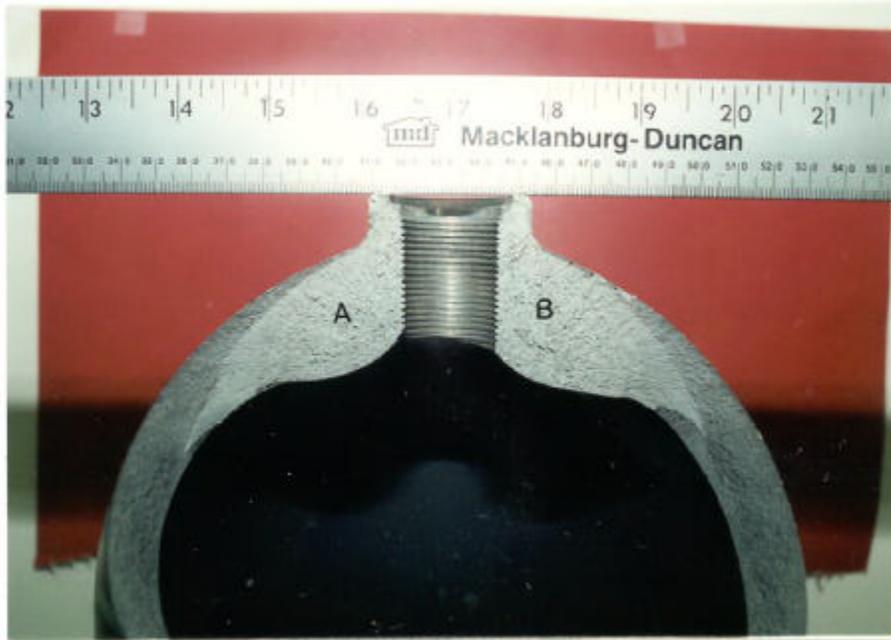
Figure 19: A macro view of the fracture surface. Side A was used for fractography and side B for metallography.

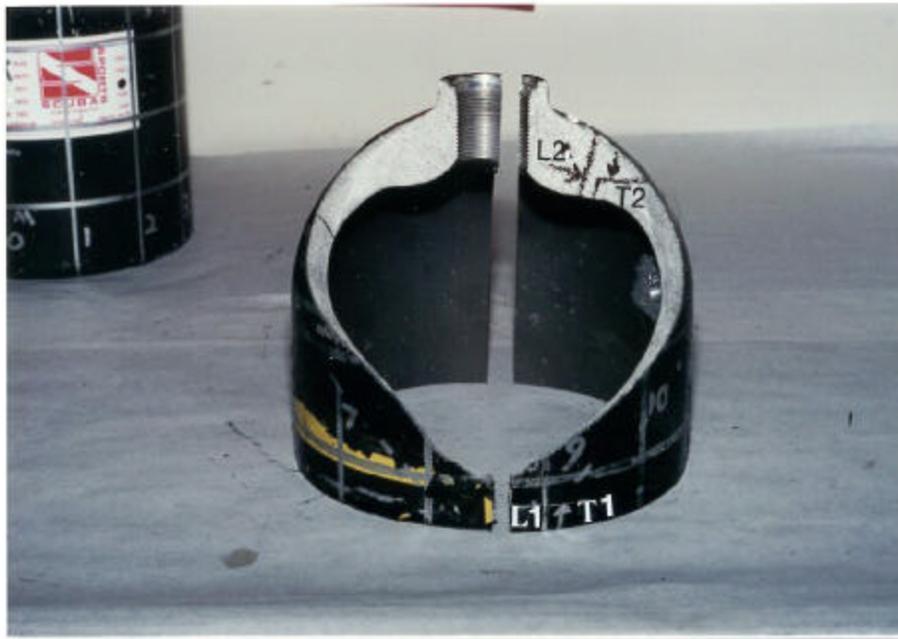
Figure 29: Locations of longitudinal (L1 and L2) and transverse (T1 and T2) sections cut for metallographic examination, shown by arrows.

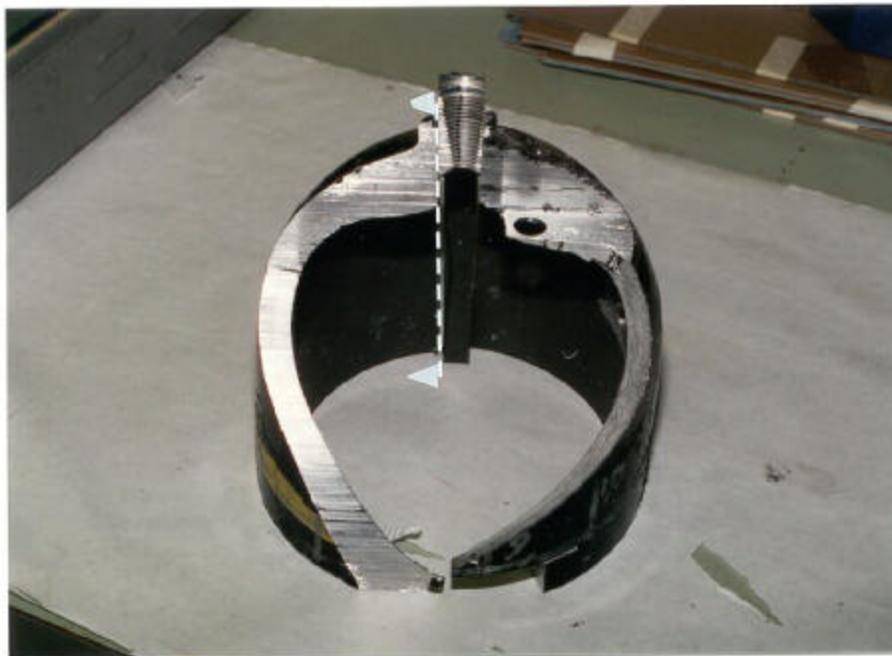
Figure 30: Photograph indicating the section used for macro analysis.
